Stockton Beach Coastline Works

May 2024 This information is subject to change.

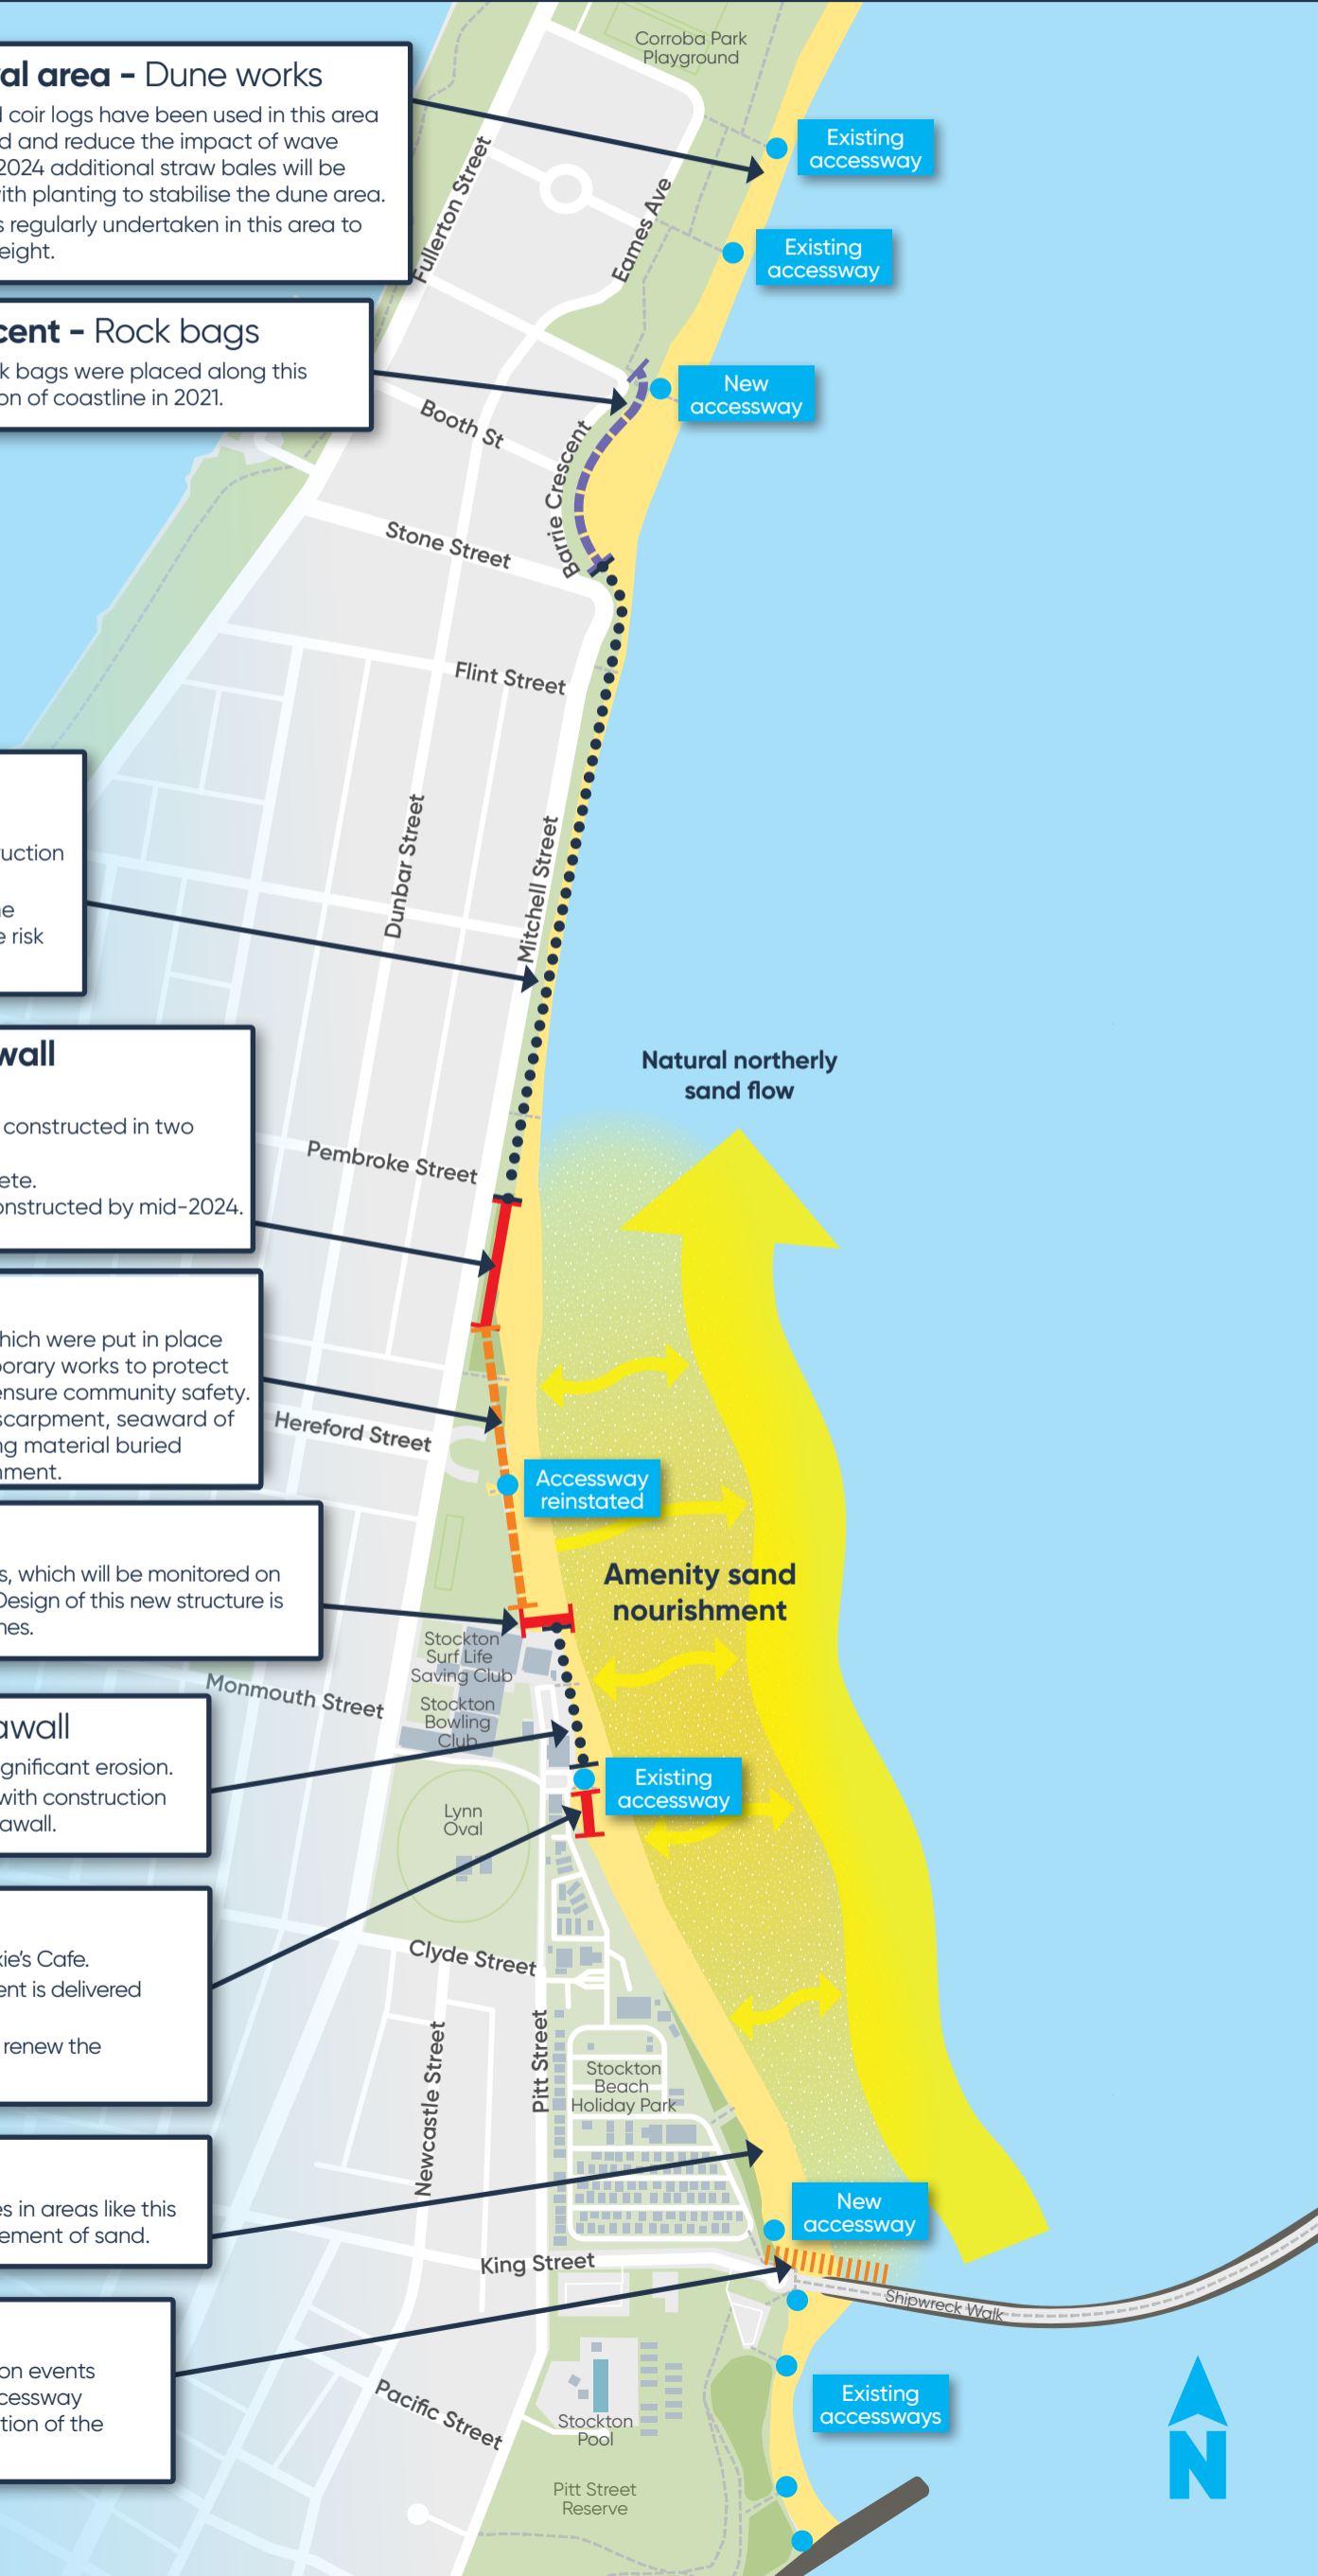
- Rockwall
- ▬▬▬▬ Rockbags
- ▬ Buried Seawall
- ▬▬▬▬ Emergency Repair Works
- ▬▬▬▬ Repair Works
- ⚠️ Emergency Works
- 📄 Actions from the 2020 CMP

- Straw bales and coir logs have been used in this area to help trap sand and reduce the impact of wave overtopping. In 2024 additional straw bales will be placed, along with planting to stabilise the dune area.
- Sand scraping is regularly undertaken in this area to increase dune height.

- 1,294 Kyowa rock bags were placed along this 210-metre section of coastline in 2021.

- The seawall was built in 1991, and covers 600m of coastline.
- Planning is underway to increase protection following construction of the new buried structure at the southern end.
- In advance of this, rock bags have been placed on top of the seawall at the northern end of Mitchell Street to minimise the risk of overtopping until the seawall works are complete.

- Work on the new structure to protect this site, which will be constructed in two stages, started in September 2023.
- The first stage, construction of a new seawall, is now complete.
- The second stage will see a 50-metre rock bag structure constructed by mid-2024.

- Weather events have exposed historic building materials which were put in place in the 1970's to minimise erosion. We have undertaken temporary works to protect the dune edge, including relocating fencing in this area to ensure community safety.
- A rock bag structure will be constructed along the dune escarpment, seaward of The Pines, to contain the further exposure of historic building material buried throughout this area, ahead of the delivery of mass nourishment.

- Repair work has taken place on the existing emergency works, which will be monitored on an ongoing basis, ahead of construction of a new structure. Design of this new structure is being assessed in line with adjacent works planned at The Pines.

- The seawall in front of the SLSC was built in 2017 following significant erosion.
- We are currently planning longer term repairs to the seawall with construction planned in 2024 following the repairs to the Mitchell Street seawall.

- Emergency sandbags are located on the seaward side of Lexie's Cafe.
- A new structure to protect the area until mass sand nourishment is delivered will be designed to integrate into adjacent works.
- Until this structure is delivered we will continue to monitor and renew the existing sandbags as needed.

- When weather allows, we undertake sand scraping activities in areas like this to increase dune resilience by accelerating the natural movement of sand.

- We have now completed work to repair damage from erosion events and reinstate access for the community including a new accessway to South Stockton Beach. Work will commence on revegetation of the site and improved pedestrian access in early 2024.
