City of Newcastle

Stockton Beach Nourishment

Review of Environmental Factors for sand placement

Report No: P22218_StocktonNourishmentEA_R3.00

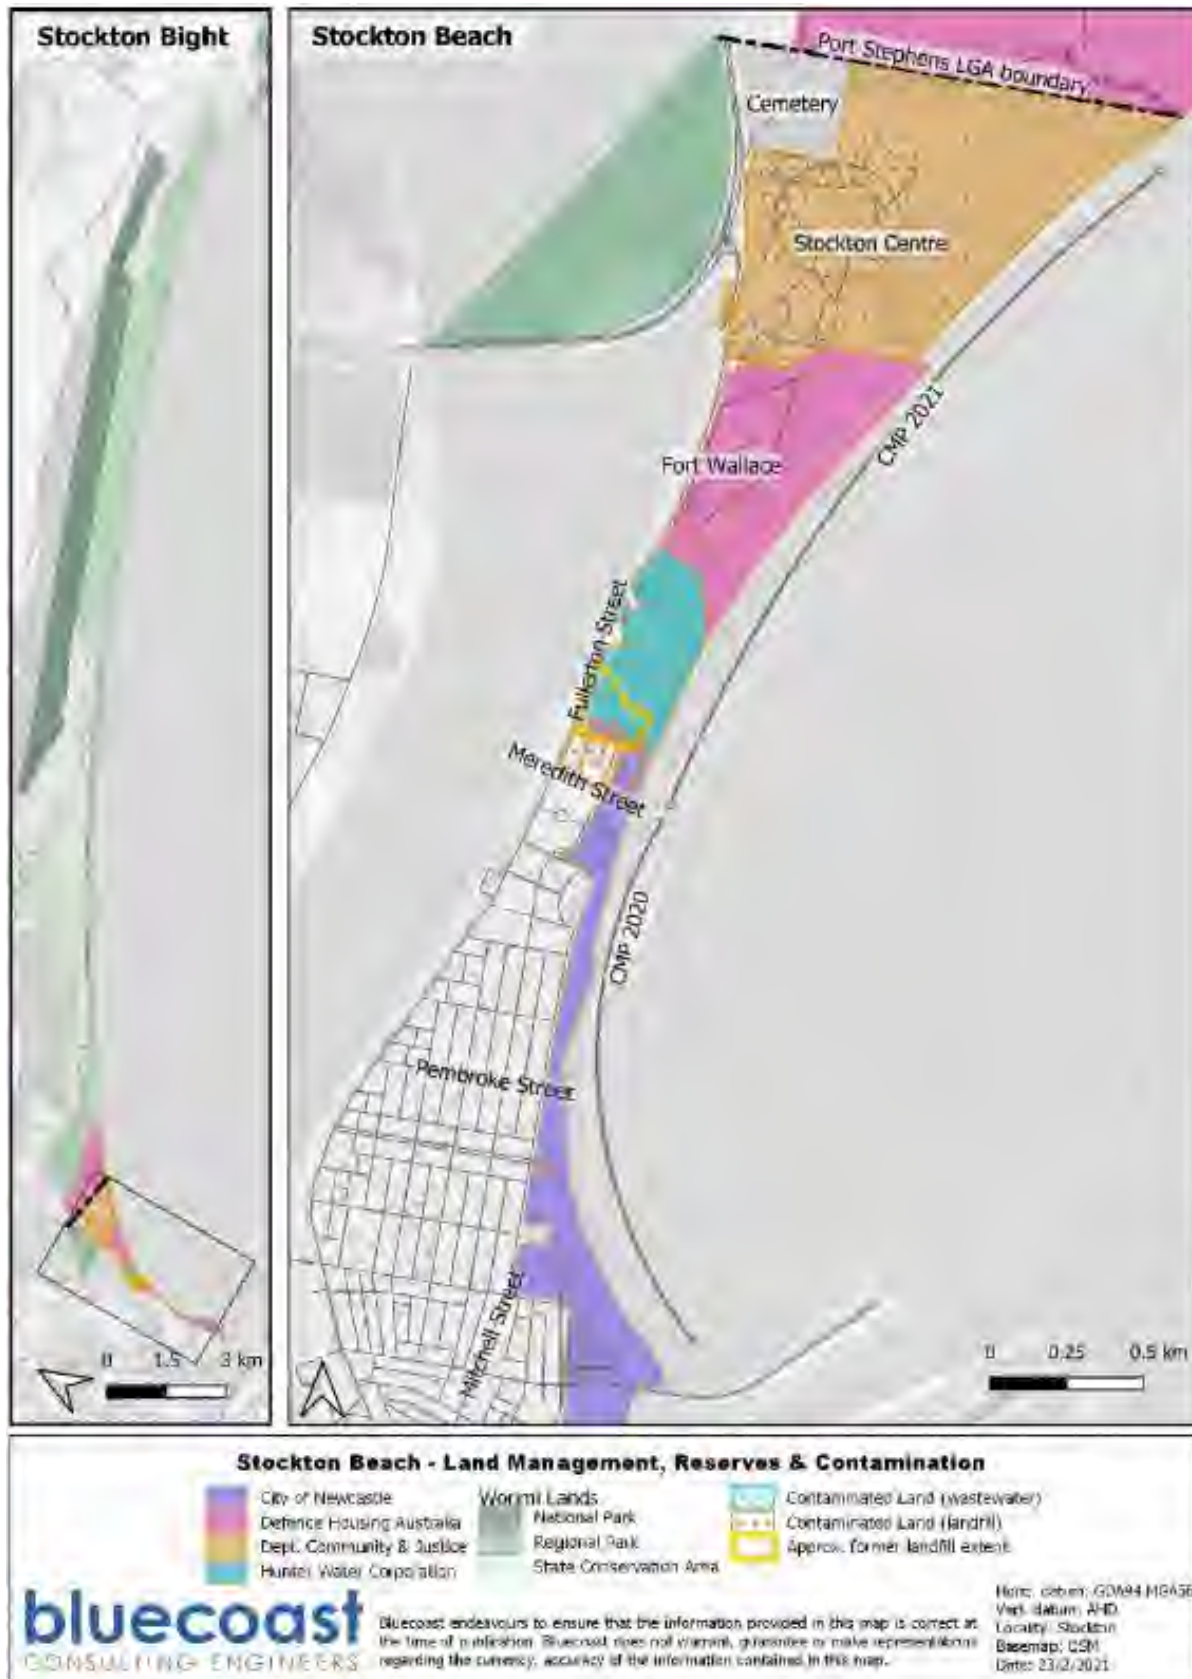
Figure 2: Land ownership.

There are several owners and/ or managers of land along the Stockton foreshore and beach, as shown in Figure 2. The proposed sand nourishment area is predominately on Crown Land. The area shown in purple is Crown land managed by Council (CN). Land below the mean high-water mark to 3 nautical miles out to sea is Crown land. A Crown Land Licence or appointment as Crown Land Manager will be required prior to sand placement works on this land. CN will need to apply for Crown Land licence or request appointment as Crown Land Manager.

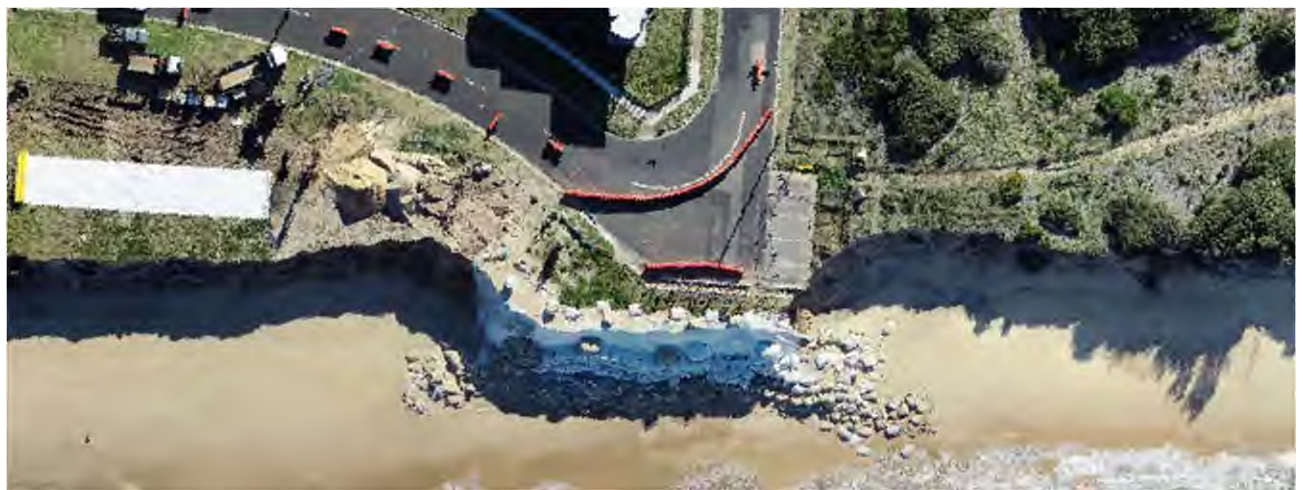
Figure 6: Erosion scarp and failing emergency coastal protection works at Griffith Ave (north of the Mitchell Street seawall) following an east coast low around the 15th July 2020 (source: CN).

- **2021** A rock-bag protection structure was constructed immediately north of Mitchell Street seawall, in front of Barrie Crescent Reserve, to replace emergency sand bagging which failed during an east coast low around the 15 July 2020 (see Figure 6). The structure covers a 210m section of coastline.

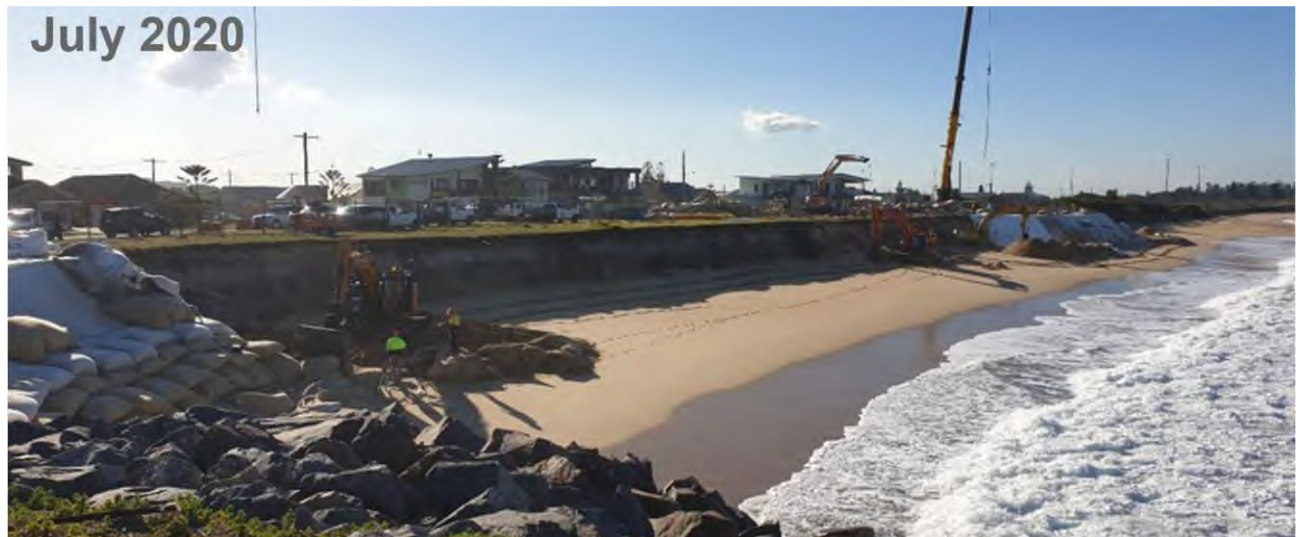
Figure 7: Emergency coastal protection works underway north of SSLSC seawall in preparation for a second east coast low in late July 2020 (source: M. Bardsley).

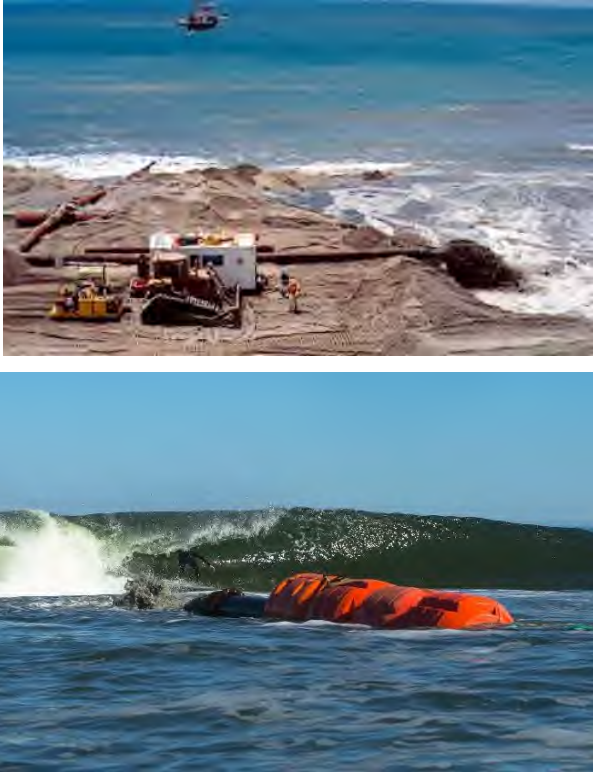
Placement option	Example
<p>Pumping ashore to nourish the visible beach (see 'C' in Figure 13)</p> <p>Pumping sand ashore onto the visible beach aims to broaden the existing beach and the existing dune systems (if present/accessible). The process would likely involve also pumping sand into the surf zone using floating pipe outlets. For this project, a typical approach may consist of:</p> <ul style="list-style-type: none"> • Pump sand slurry directly from dredge up to approximately 1.5km. Sand could be pumped from either a TSHD or CSD across the northern breakwater at southern Stockton and/or across the peninsula at northern Stockton • Additional equipment (e.g., pipeline, earth moving equipment on the beach, floating pipe outlet, slurry booster pumps for pumping beyond 1.5km etc) would be required. Some sections of pipeline could be buried (if conditions allow) and kept in place for future nourishment campaigns. • Sand placement in surf zone via floating pipe outlets to enhance post-nourishment profile for improved (perceived) longevity and swimming / surfing amenity May cause disruption on beach usage during operations • May have temporary visual impact as pumping onto subaerial beach is less effective in washing out fines from source material. Limitation on fines content for subaerial placements are set out in Stockton Beach Sand Management Guideline to minimise the risk of this.

<p>Pump ashore operations for large scale beach nourishment in the USA.</p>

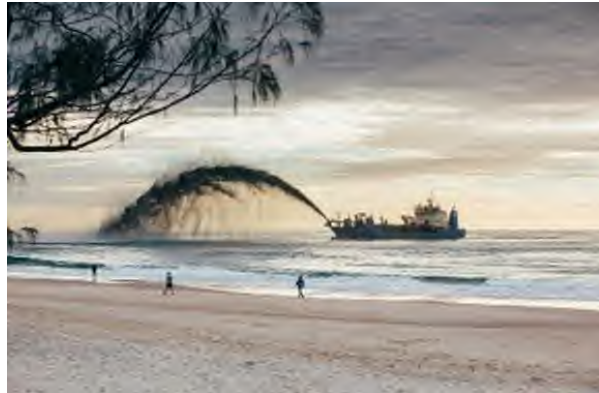
Some TSHD’s have ‘rainbow’ capabilities. This involves a sand slurry being jetted from the bow with the vessel positioned bow-in as close to the shore as possible. The objective is to widen the visible beach by moving the wave breaking zone seaward. The “losses” occur slowly and in a manner more consistent with a natural beach. For Stockton, a typical approach may require:

- **TSHD’s to transport material to the site and rainbow**
- **smaller TSHD’s with reduced draft rainbowing directly onto subaerial beach**
- **rainbowing to the surf zone provides some washing out of fines/ mixing with native sediment prior to arriving on the visible beach**

A medium sized TSHD rainbowing on the Gold Coast (source: City of Gold Coast).

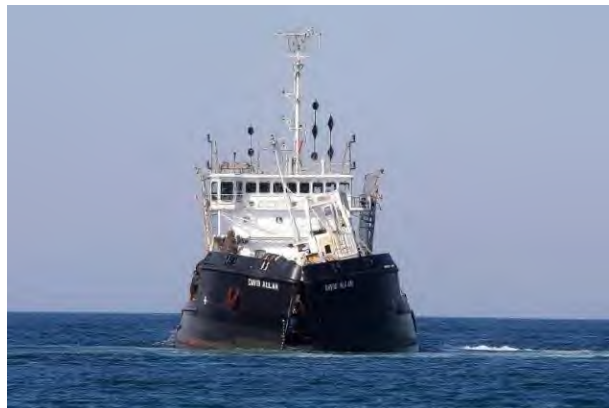
Bottom dumping of nourishment material is suitable in the outer surf zone and nearshore area depending on vessel draft. After the dredge (or barge) has filled its hopper, it travels to the sand placement area and it either opens hopper doors located at the bottom of the vessel or splits its hull (split-hopper). Split hopper is generally preferred as it allows for shallower placements. Nearshore placement aims to emulate a natural storm bar formation. If a storm arrives soon after beach nourishment, wave breaking may be triggered and thereby help protect the coast. However, if no storm arrives, the waves will redistribute the sand onshore.

Split hopper TSHD, the David Allan, placing material at Stockton Beach in August 2018 (RHDHV, 2020; photo: Peter Cousins).

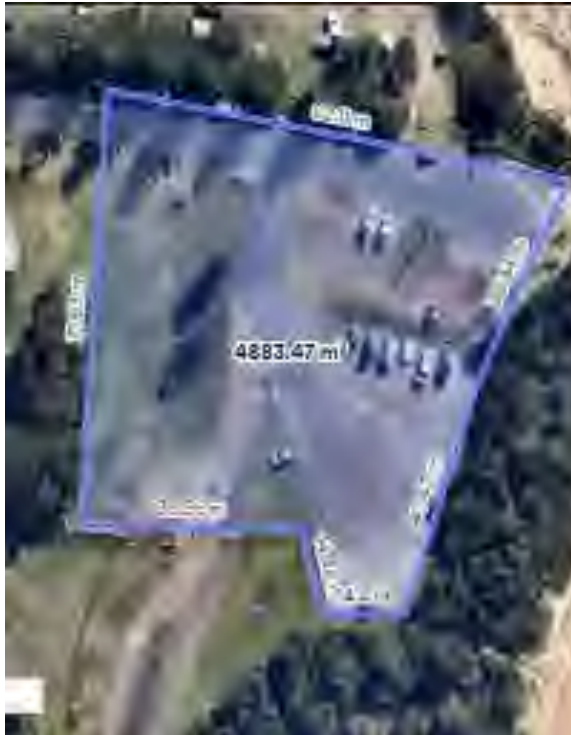
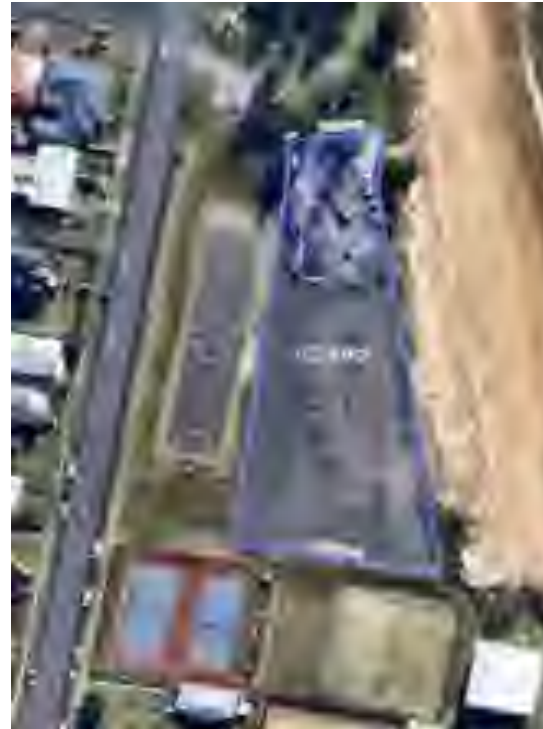
Figure 15: Aerial view of proposed compound sites.

It is proposed to make two compound sites available for use during sand placement activities. These sites are the car parking area located near Little Beach and the open area near Dalby Oval. These are shown in the photographs below. The areas would be used for storage of machinery and equipment, sites offices and amenities and vehicle parking for workers.

The compound sites will remain open to the public when not in use but will be closed off for short periods when they are required for the proposed works. This will be intermittent and infrequent. Pedestrian and traffic controls will be in place during the use of the proposed compound sites, and the community will be notified in advance of the sites being used. Note that the actual area to be used for each campaign is unlikely to encompass the entirety of each space outlined below.

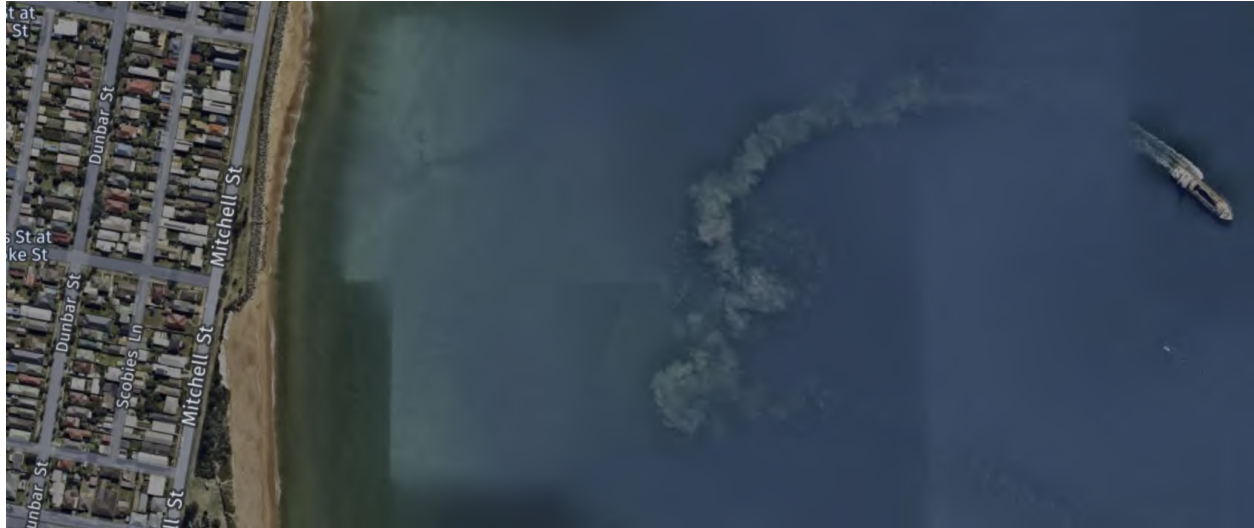
Figure 22: Aerial photograph capturing placement of nourishment material by David Allan on 23 April 2020 at Stockton Beach (source: Nearmaps).

Since 2010, about 20,000 to 30,000m³ of dredged sand from the harbour entrance (Area E) has also been placed each year off Stockton Beach (Royal Haskoning, 2021). Figure 22 shows an aerial photograph that captures a sand placement at Stockton by means of bottom-dumping. It is notes that this

material is likely to be from Area E and clean marine sand. The surface plume appears as occurring in a discrete area at the placement site and as it is sand, it would be expected to settle rapidly with little residual turbidity.

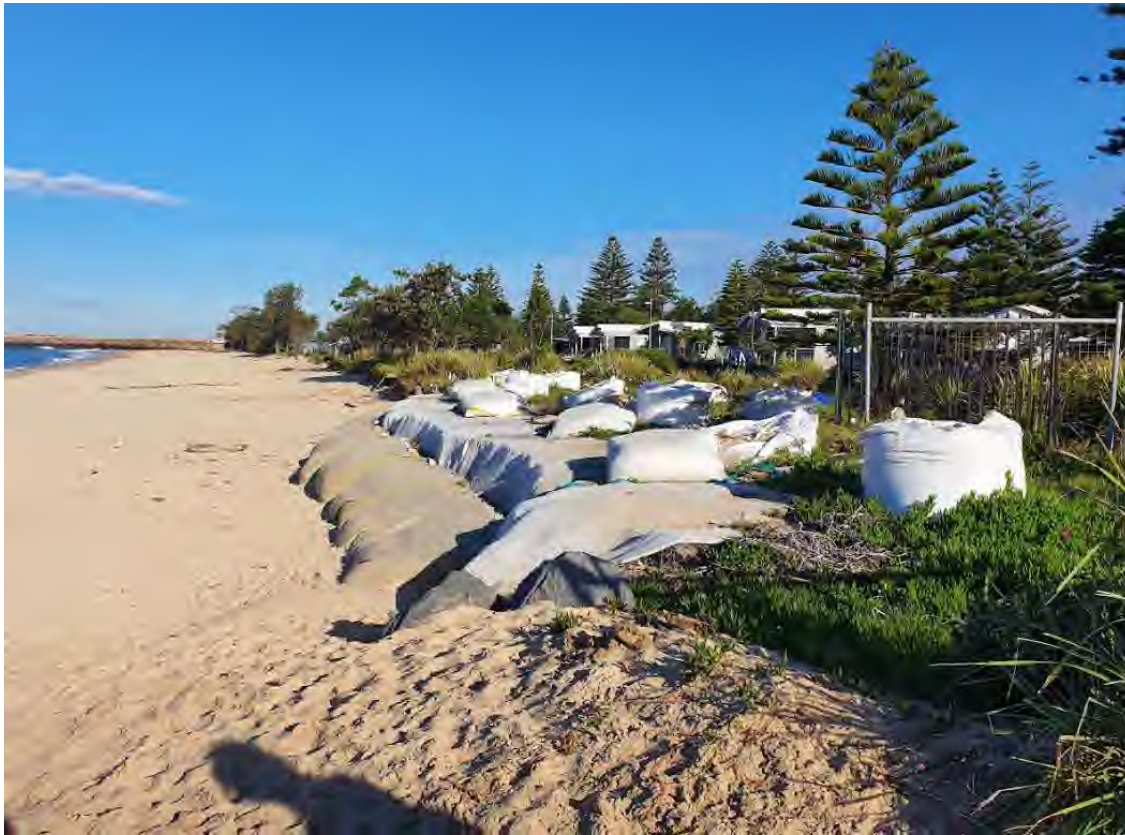
Figure 25: Facing south showing sandbags north of the holiday park.

Although the landscape retains value as a scenic coastal location, its amenity has been reduced in recent years due to significant coastal recession and the construction of coastal protection works. Areas once accessible for public recreation are now unsafe and no longer available for use, with some areas dominated by fencing and sandbags. The photos below show the coastal protection works within the study area and demonstrate the reduced amenity that is being experienced at Stockton due to coastal recession.

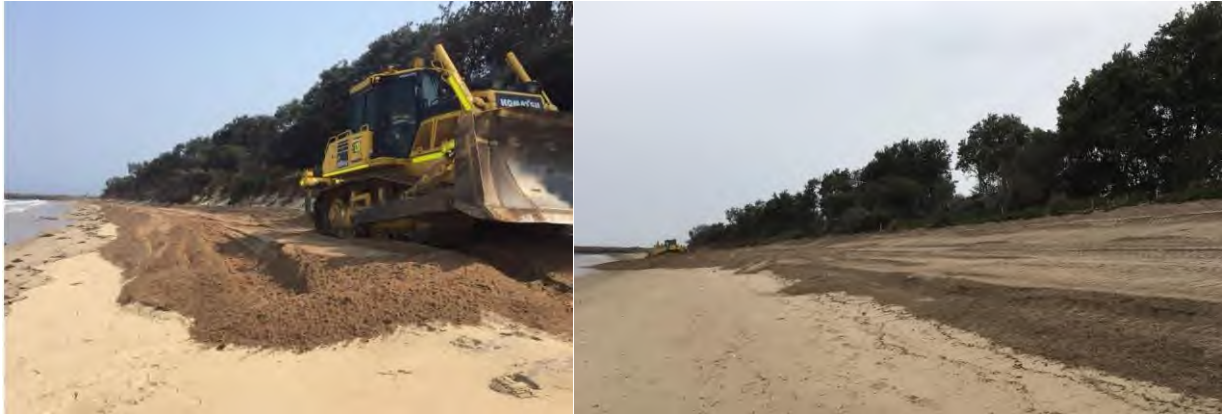
Figure 9: Photographs from the December 2019 pilot nourishment campaign (left) in progress and (right) upon completion (source: RHDHV, 2020).

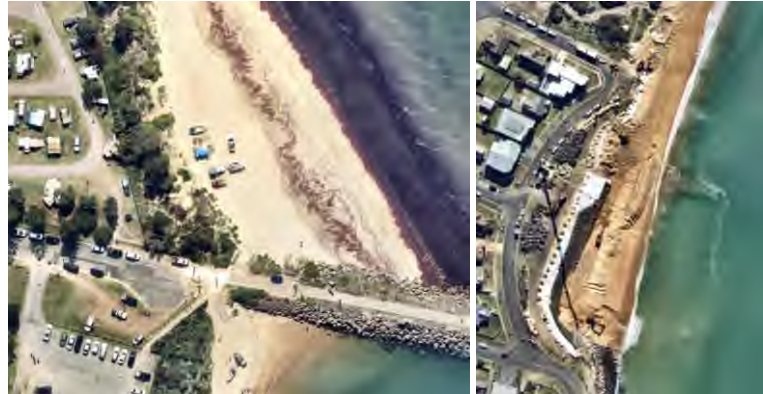
Physical	Plant and access	<p>Beach access for land-based machinery is possible at Pirate Point at the base of the northern breakwater as well at Griffith Avenue north of Mitchell Street seawall, as shown on below aerial images.</p>

Land-based infrastructure required for pumping ashore options (e.g., pipelines/ slurry booster pumps) have a visual impact (and noise for boosters) that require consideration. Pipework can be buried where beach/dune area is sufficient.

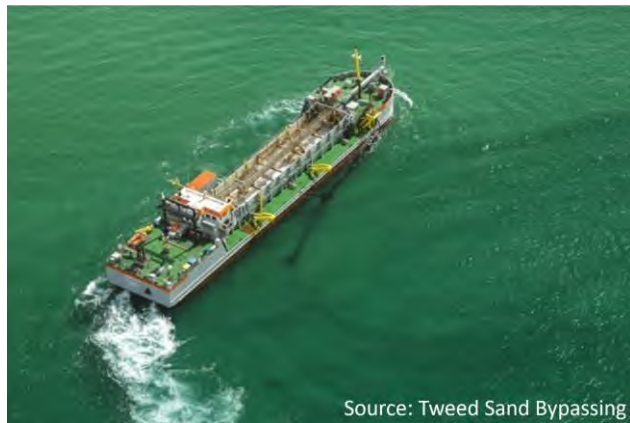
- suitable for dredging and transporting material (within hopper)
- suitable for placement via pipeline, bottom dumping or rainbowing
- requires water depth greater than >6-8m for dredging operation
- relatively high mobilisation cost (if suitable local dredge not available)
- relatively low unit rate for dredging/placement
- can operating in conjunction with other vessel traffic without overly affecting each other

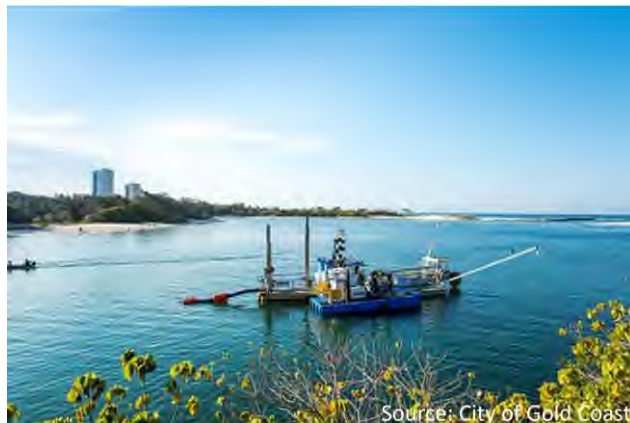
Cutter Suction Dredge (CSD)

- requires relatively sheltered location for operation
- requires the installation of a pipeline to transport and place material at destination (potentially across navigation channel)
- relatively low unit rate for dredging/placement
- is a stationary dredger and can cause delays to for vessel traffic when dredging in a shipping channel

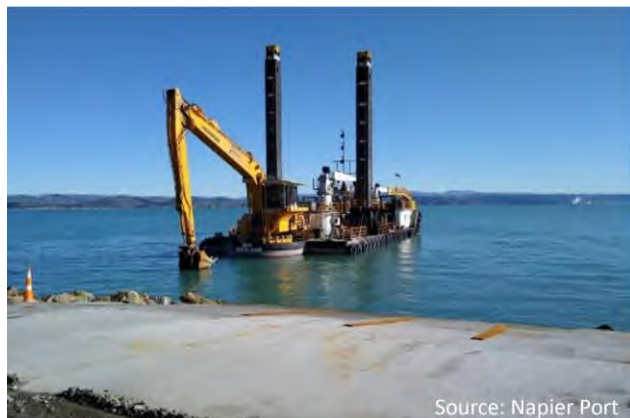
Backhoe Dredge (BHD)

- dredging depth is typically limited to 20 to 30m
- requires relatively sheltered location for operation
- typically requires support barges for transport of material
- relatively high unit rate for dredging/placement
- is a stationary dredger which can cause delays for vessel traffic when dredging in a shipping channel

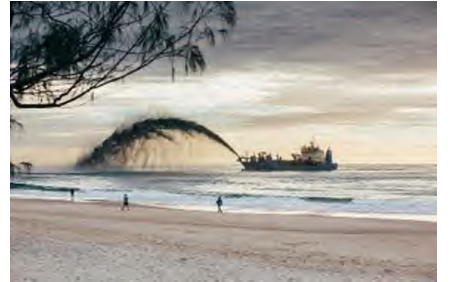
<p>Rainbowing to nourish the surf zone (see ‘A’ and ‘B’ in Figure 13)</p> <p>Some TSHD’s have ‘rainbow’ capabilities. This involves a sand slurry being jetted from the bow with the vessel positioned bow-in as close to the shore as possible. The objective is to widen the visible beach by moving the wave breaking zone seaward. The “losses” occur slowly and in a manner more consistent with a natural beach. For Stockton, a typical approach may:</p> <ul style="list-style-type: none"> • require TSHD’s to transport material to the site and rainbow • smaller TSHD’s with reduced draft rainbowing directly onto subaerial beach

<p>A medium sized TSHD rainbowing on the Gold Coast (source: City of Gold Coast).</p>

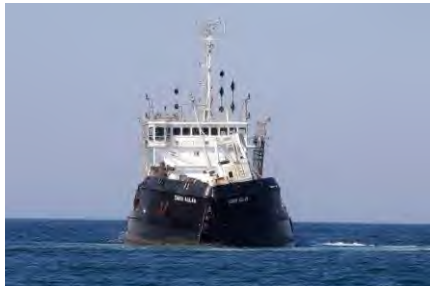
Placement option	Example
<ul style="list-style-type: none"> rainbowing to the surf zone provides some washing out of fines/ mixing with native sediment prior to arriving on the visible beach 	
<p>Bottom dumping to nourish the nearshore (see ‘A’ and ‘B’ in Figure 11)</p> <p>Bottom dumping of nourishment material is suitable in the outer surf zone and nearshore area depending on vessel draft. After the dredge (or barge) has filled its hopper, it sails to the sand placement area it either opens hopper doors located at the bottom of the vessel or splits its hull (split-hopper). Split hopper is generally preferred as it allows for shallower placements. Nearshore placement aims to emulate a natural storm bar formation. If a storm arrives soon after beach nourishment, wave breaking may be triggered and thereby help protect the coast. However, if no storm arrives, the waves will redistribute the sand onshore. For Stockton, a typical approach may consider:</p> <ul style="list-style-type: none"> the method provides cost-efficient placement and cycle times smaller TSHD with reduced drafts can place material in outer surf zone placed material would be ‘washed’ and efficiently sorted by the natural coastal processes with source material mixing with native material and likely to be virtually undetectable at the visible beach where this technique has been used in other NSW locations the beach response has been positive and there are additional recreational benefits if pattern placement is used

<p>Split hopper TSHD, the David Allan, placing material at Stockton Beach in August 2018 (RHDHV, 2020; photo: Peter Cousins).</p>

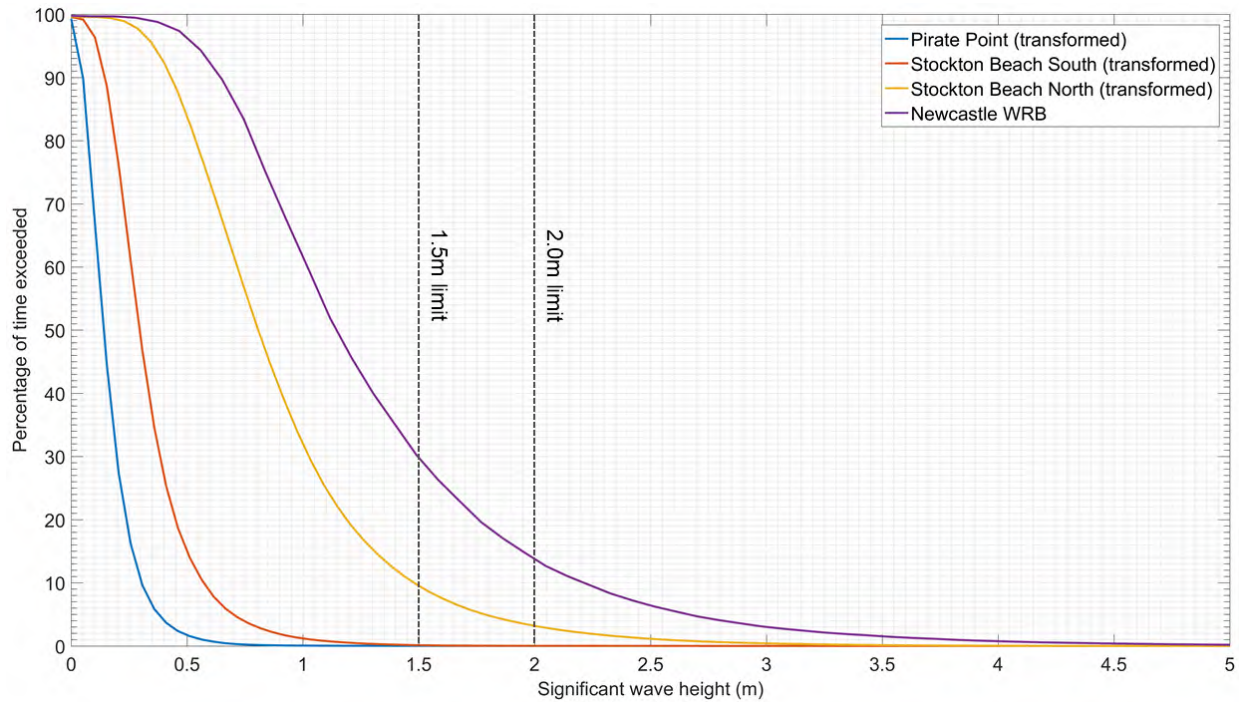
Figure 15: Wave height exceedance curves for Newcastle WRB and transformed inshore locations.

The downtime assessment completed is preliminary in nature. It is based on assumed limits and available site conditions. It does not consider all the factors that can influence workability.

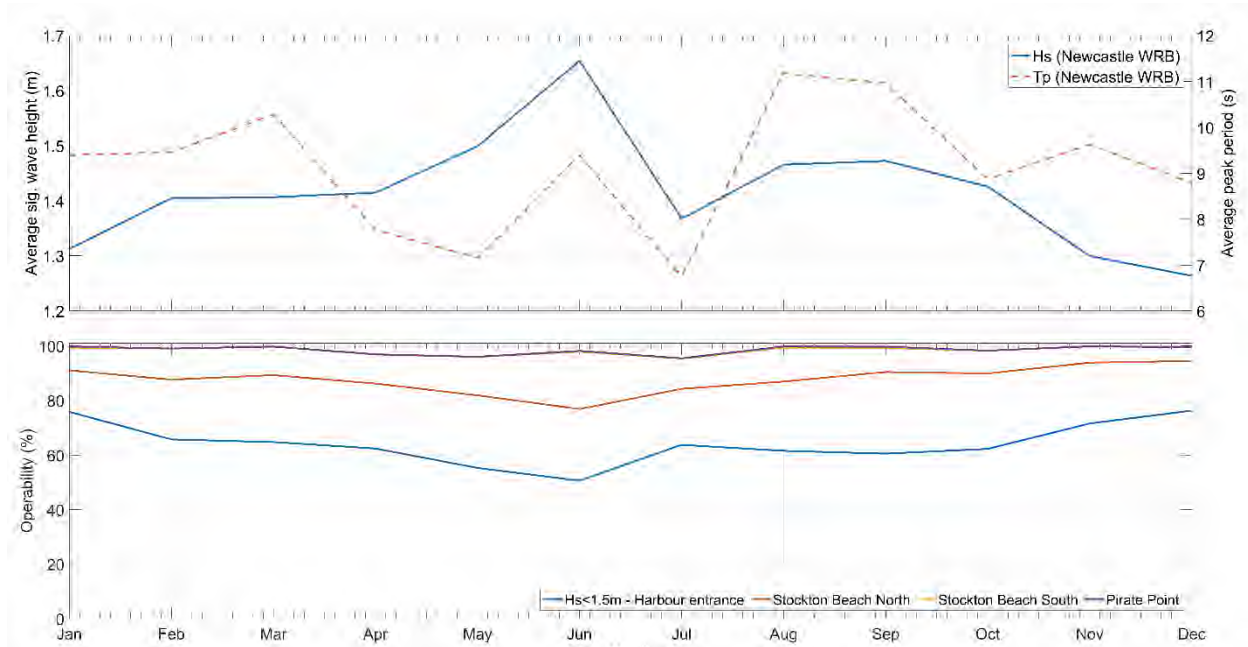
Figure 16: (top) Average monthly wave heights and periods derived from Newcastle WRB and (bottom) associated average operability at inshore locations (1.5m limiting wave height).

The period from November to January would be the most opportune period for executing the beach nourishment works, as it is less likely for the project to be interrupted by unworkable sea-state conditions.

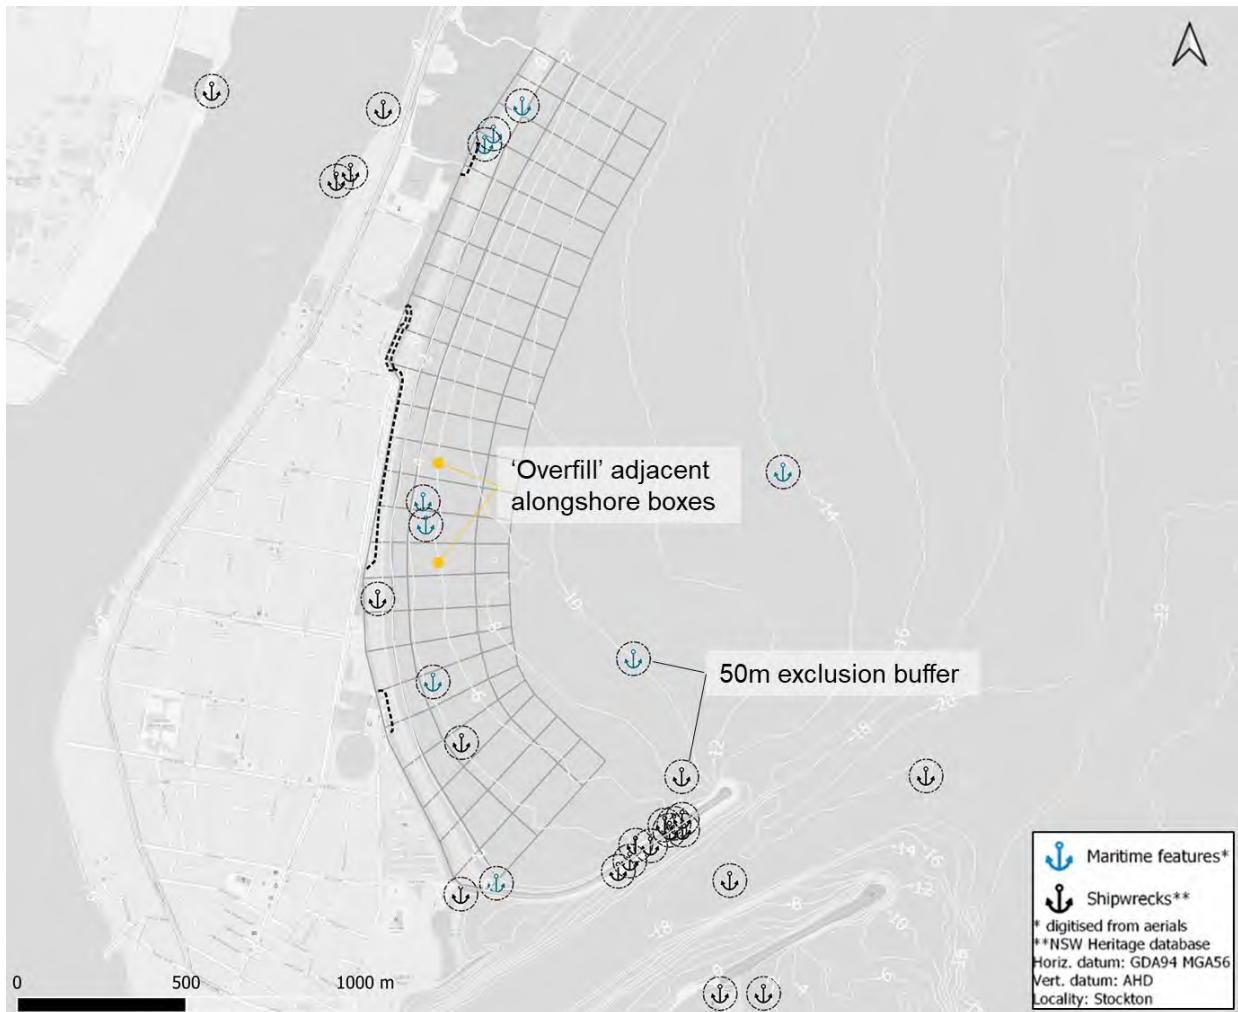
Figure 23: Pattern placement around shipwreck and maritime heritage item exclusion buffers (50m).

- 150% filling of two adjacent alongshore boxes, followed by
- 50% filling of the next two most adjacent boxes.

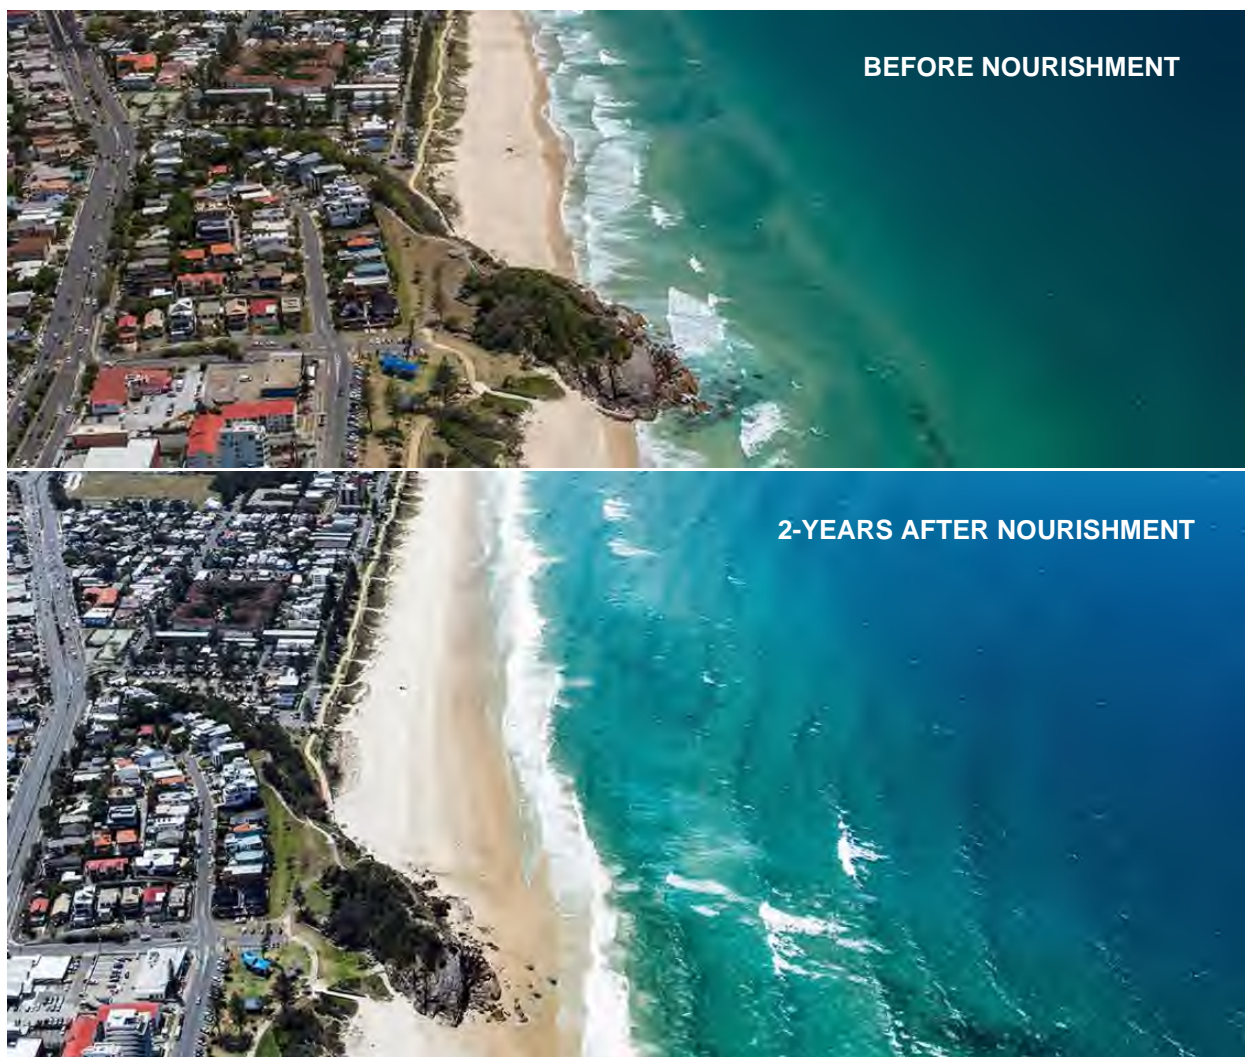
Figure 28: Photographs showing beach (top) immediately before Gold Coast mass nourishment on 17 February 2017 and (bottom) two years after mass nourishment on 14 October 2019 (source: City of Gold Coast).

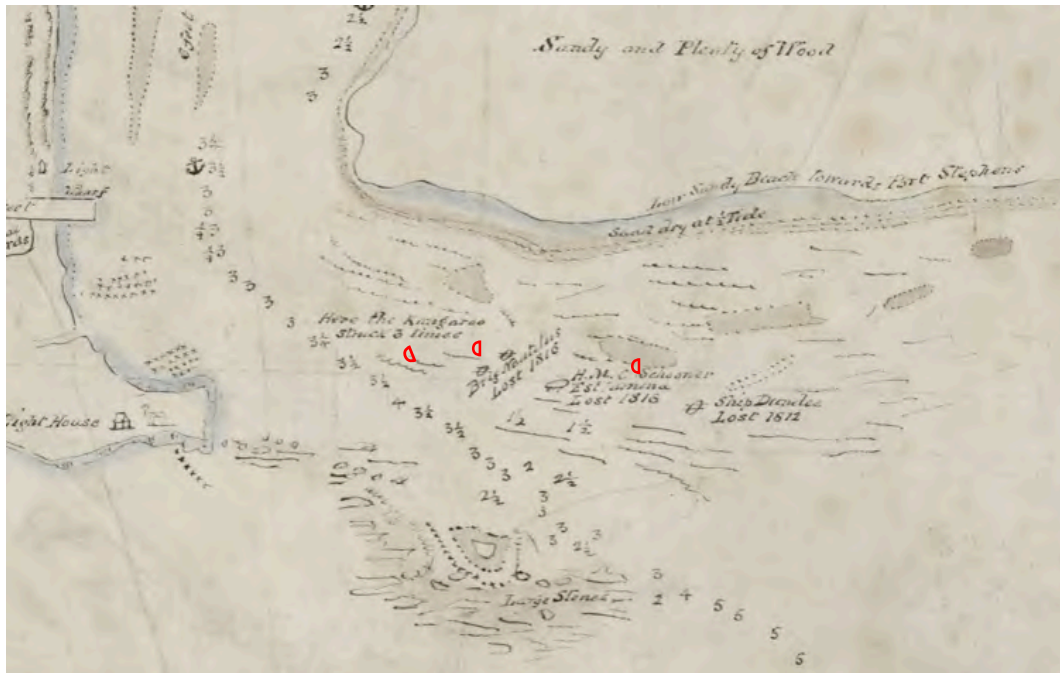
Figure 13: Hydrographic survey of the mouth of the Hunter River in March 1816, indicating the locations of three wrecks, the brig Nautilus (1816), the schooner Estramina (1816) and the ship Dundee (1812) (sic).⁴⁶

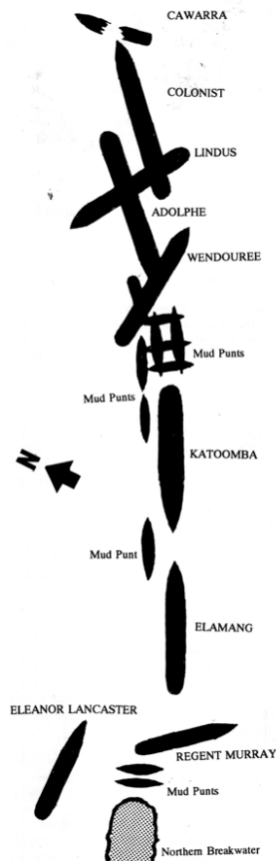
Figure 20: Diagram showing the approximate locations of wrecks incorporated into the Stockton Breakwater. Not to scale. Source: Ross and Pat Craig Collection, University of Newcastle (Australia).

to further solidify the breakwater (Figure 21). By 1905, a total of nine wrecks lay within or against the breakwater.

Stone for the breakwater was quarried at Platts Hill and brought to the site by punt, then via a tramway across Stockton Peninsula. The significant infrastructure project culminated in 1912, with the breakwater having a final length of 3,400 ft. A concrete top was laid in 1913.

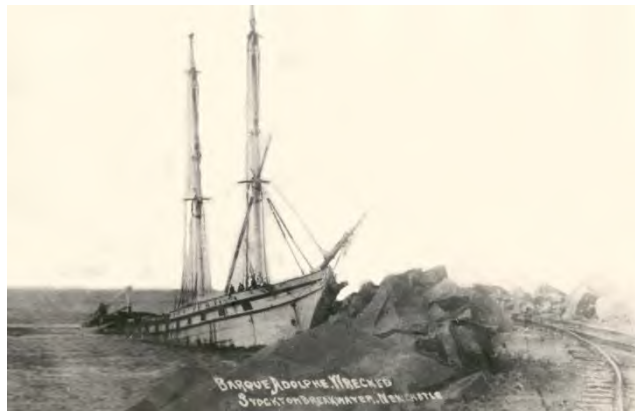
Figure 22: The Adolphe incorporated into the Stockton Breakwater. Date Unknown.⁶⁰

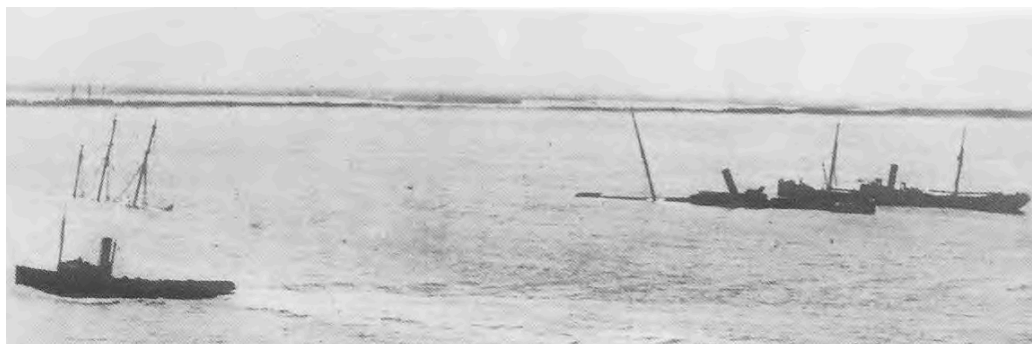
Figure 23: Stockton Breakwater wrecks, from left to right, Regent Murray, Wendouree and Lindus. Passing tug in the foreground. Date Unknown.⁶¹

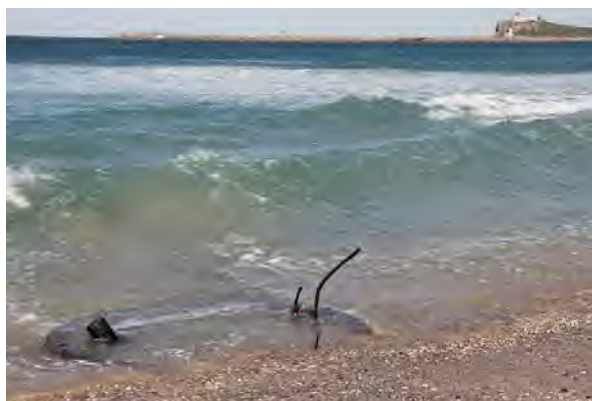
Figure 30: Stockton No. 3 Shaft exposed at 0.35m low tide in September 2017. The shaft has a diameter of approximately 3m. Remains of ladder can be seen on right. Photographer: Russell Rigby. Source: Hunter Living Histories.

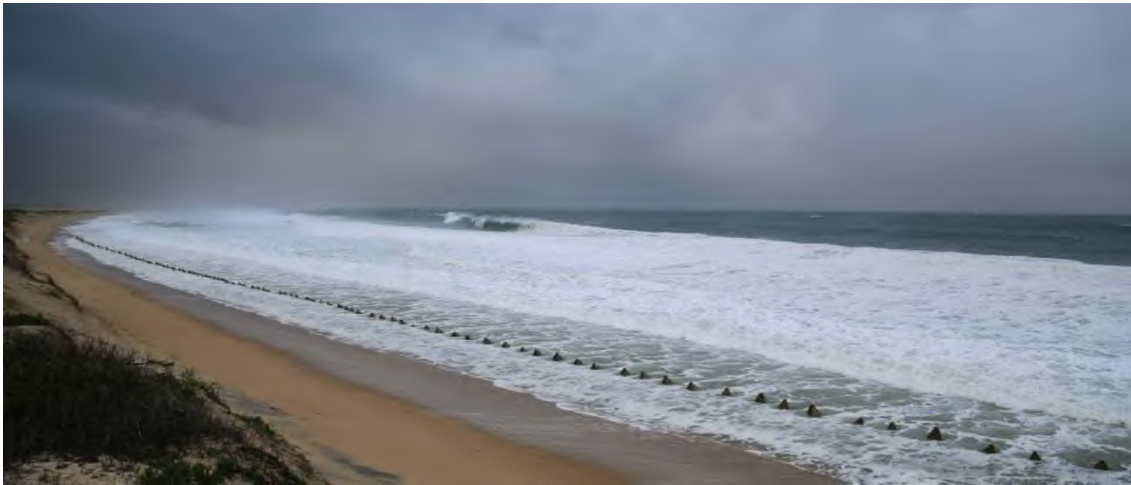
Figure 32: A photo taken of Stockton Beach in 2020 near Fort Wallace, showing a long line of anti-tank traps exposed after large swell. Photographer: Symon James. Source: Newcastle Herald.

In 2020, a long line of the traps, also known as tetrahedrons, could be seen along Stockton Beach following large swells (Figure 32). The anti-tank traps are made of concrete and feature sharp, protruding metal poles. In October 2020, Hunter Water removed 185 of

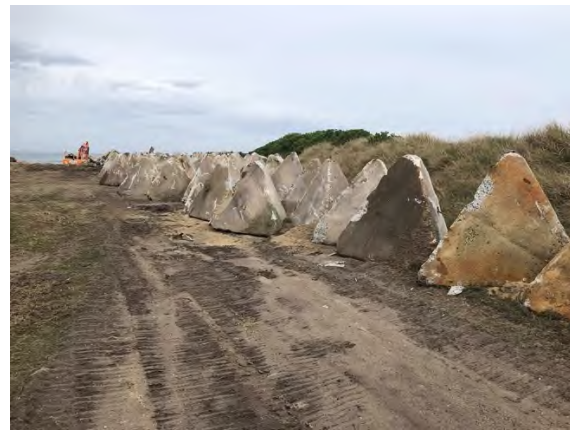
Figure 34: Concrete tank traps removed by Hunter Water. Image: Hunter Water.

approximately 200 tank traps that had become exposed due to safety reasons (Figure 33 and Figure 34).⁸³

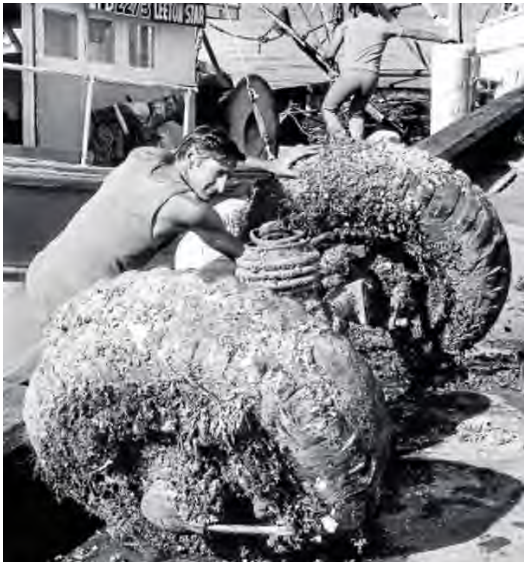
Figure 36: Driving wheel and tail-shaft of a DUKW found by fishermen trawling in Stockton Bight. Date unknown. Source: Port Stephens Historical Society Inc.

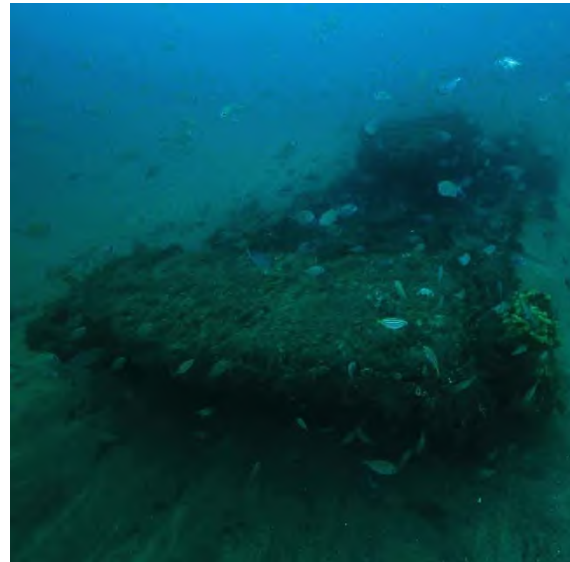
Figure 37: Wreck of LVT4A off Stockton Beach. Source: Grey Nurse Dive Charters Newcastle.

Another military-related maritime archaeological site is the wreck of an amphibious assault vehicle, located in approximately 30 m of water, at the mid-way point of Stockton Beach (Figure 37). In March 1954, a convoy of LVTs (Landing Vehicle Tracked) set out from Wave Trap Beach for a training exercise but encountered severe weather shortly after (Figure 35). Five LVT4As, one LVT4 and two DUKWs were lost, killing three personnel in what was a significant peacetime loss event.⁸⁴ While one LVT4A has been located on the seabed, the

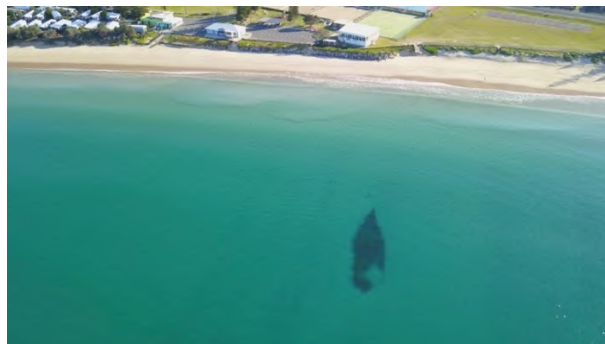
Figure 40: The possible wreck site of Berbice in front of the Stockton Surf Life Saving Club in February 2021.⁸⁸

A wreck site was exposed in 2018 and sits in approximately five metres of water off shore of the Surf Life Saving Club. Hunter Living Histories has attributed this site to the *Berbice*.⁸⁶ The NSW maritime database has a different location attributed to the *Berbice*. Both wreck locations are displayed in Figure 38.

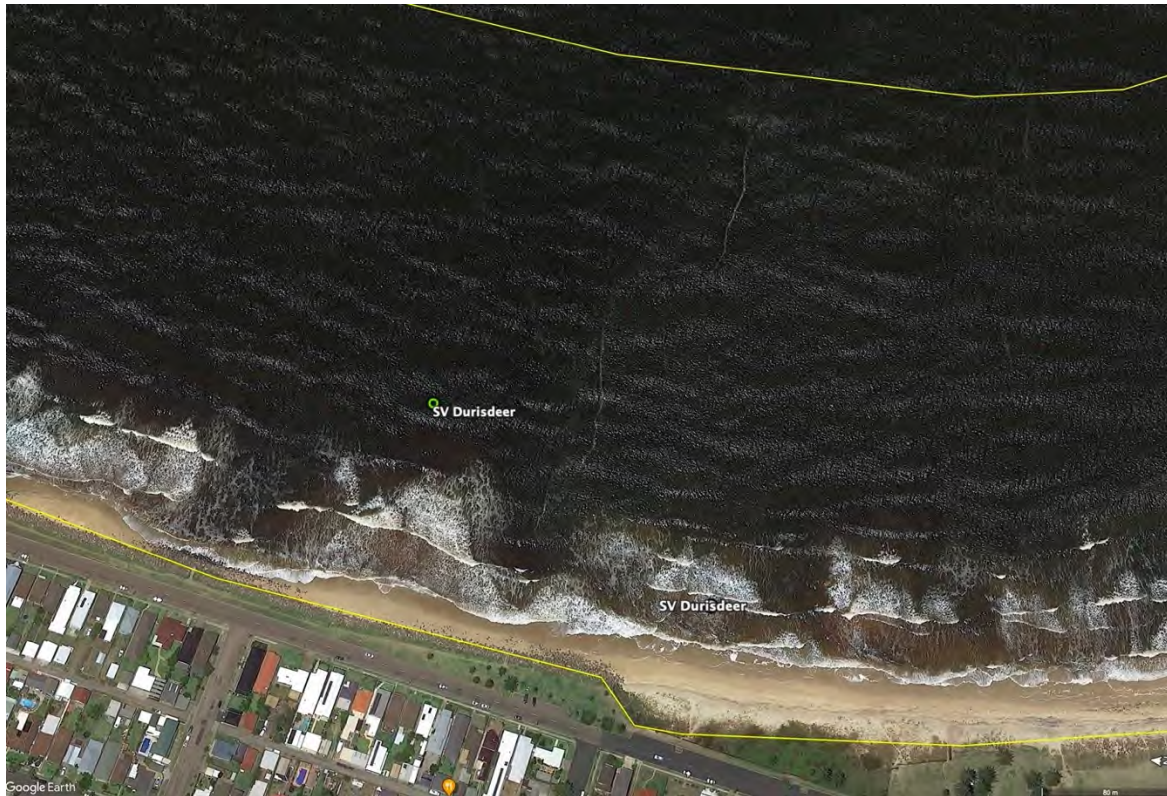
Figure 41: Location of shipwreck SV *Durisdeer*. Green mark location provided by BlueCoast and white mark taken from NSW Maritime Database. Sand placement area in yellow outline.

There is a wreck site attributed to SV *Durisdeer* lying in approximately 5 m of water, resting on its port side just off Stockton Beach.⁸⁹ The NSW maritime database has a different location attributed to the SV *Durisdeer*. Both wreck locations are displayed in Figure 41.

While shifting sands can affect how much of the wreck is visible, its large iron masts are a prominent feature, pointing out to sea.

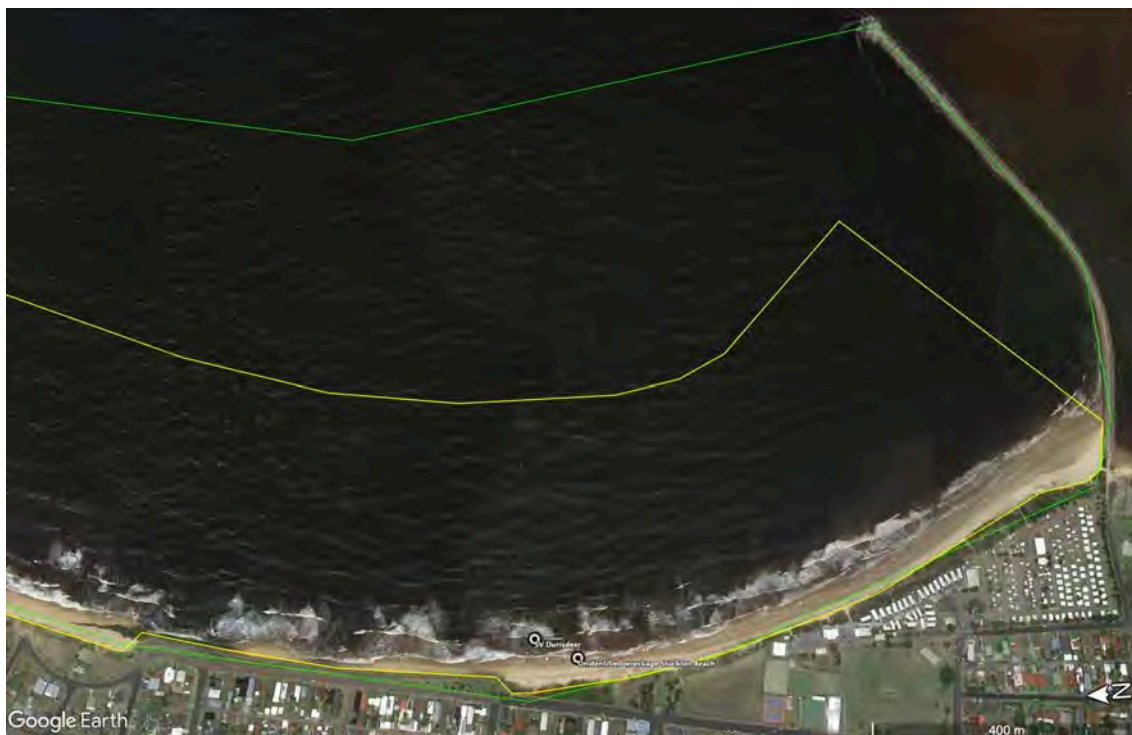
Figure 44: Location of unidentified wreckage in relation to the wreck of SV Durisdeer. Sand placement area in yellow outline, study area in green. Locations from NSW Maritime Database.

A piece of wreckage was located in the intertidal zone close by to the wreck site location in the NSW Maritime Database attributed to *Durisdeer* in 2013 (Figure 44). It consisted of an approximately 3 m length of timber with regularly spaced clench bolts. The NSW maritime database does not specify the current location of the item ie whether this wreckage is still *in situ* or was removed.

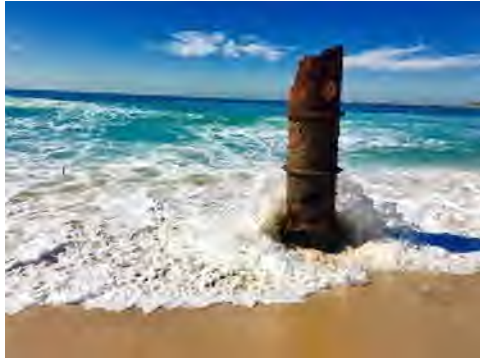
Figure 46: Potential Stockton Colliery ventilation pipe which has since washed away.⁹²

The pipe consisted of three bolted sections (approximately 750 mm diameter) with a square base. The pipe was previously completely buried in the sand dune but has now collapsed after it was left freestanding in the intertidal zone (Figure 46).⁹¹
