City of Newcastle

Stockton Beach Nourishment

Review of Environmental Factors for sand placement

Report No: P22218_StocktonNourishmentEA_R3.00

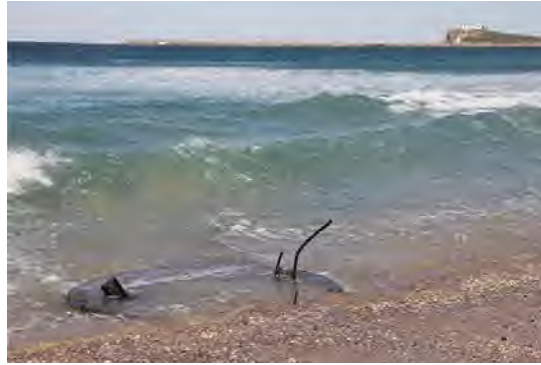
Figure 47: Potential Stockton Colliery shaft.⁹³

The remaining shaft is approximately 3 m in diameter and features a metal protrusion which appears to be an iron ladder (Figure 47).

The No. 3 Shaft would be a good representative example of its class, however its condition is unknown due to its position within the seabed. A better understanding of the shaft's condition and intactness is needed before determining whether the No. 3 Shaft would meet this criterion.

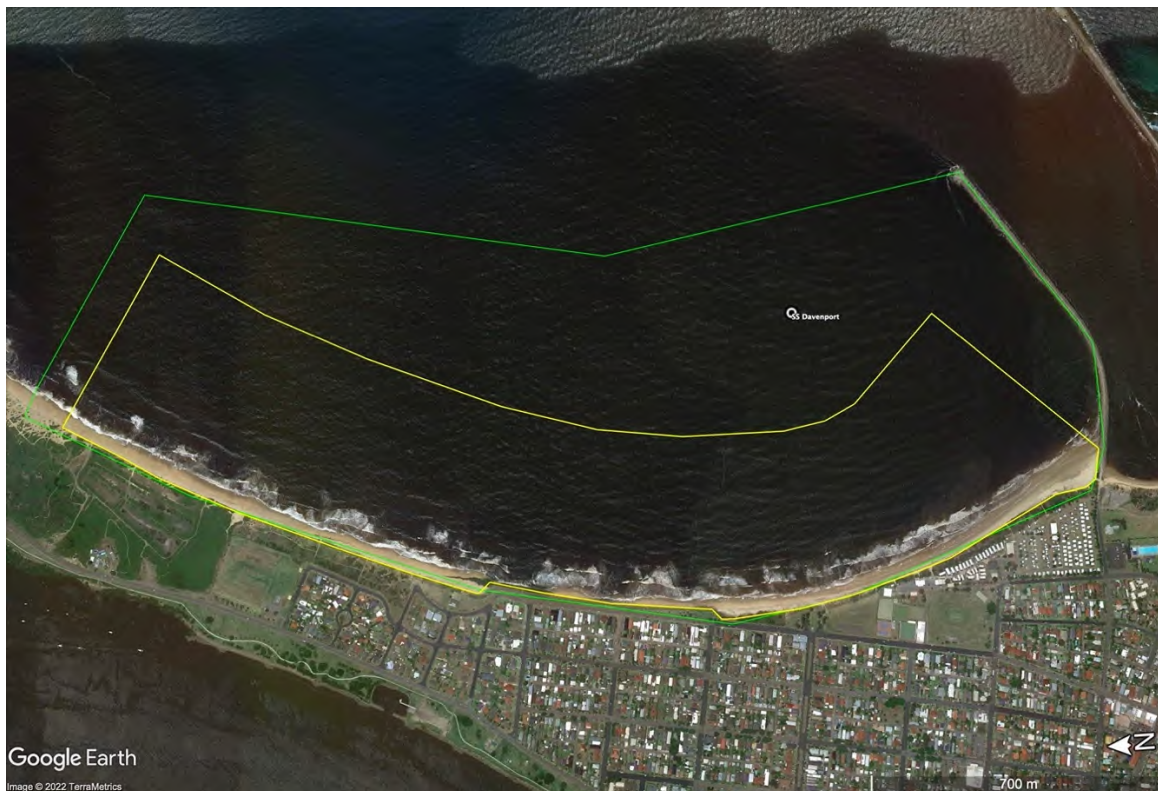
Figure 48: Location of shipwreck SS Davenport. Study area in green outline. Sand Placement area is in yellow.

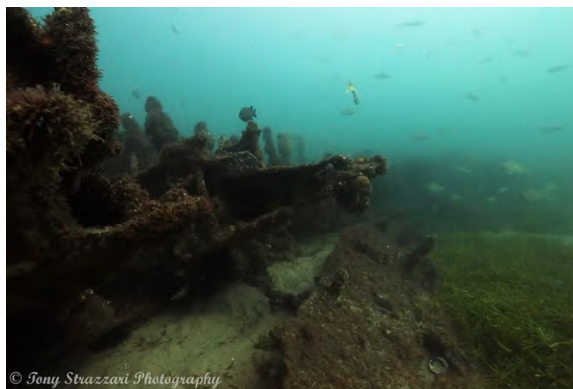
Figure 49: SS Davenport wreck site. Image courtesy of Grey Nurse Dive Charters.

The wreck of *SS Davenport* is spread over a wide area and was heavily damaged by fire before it sank. While the boilers and winches can be identified, it is unlikely that the wreck remains will yield information contributing to this criterion.

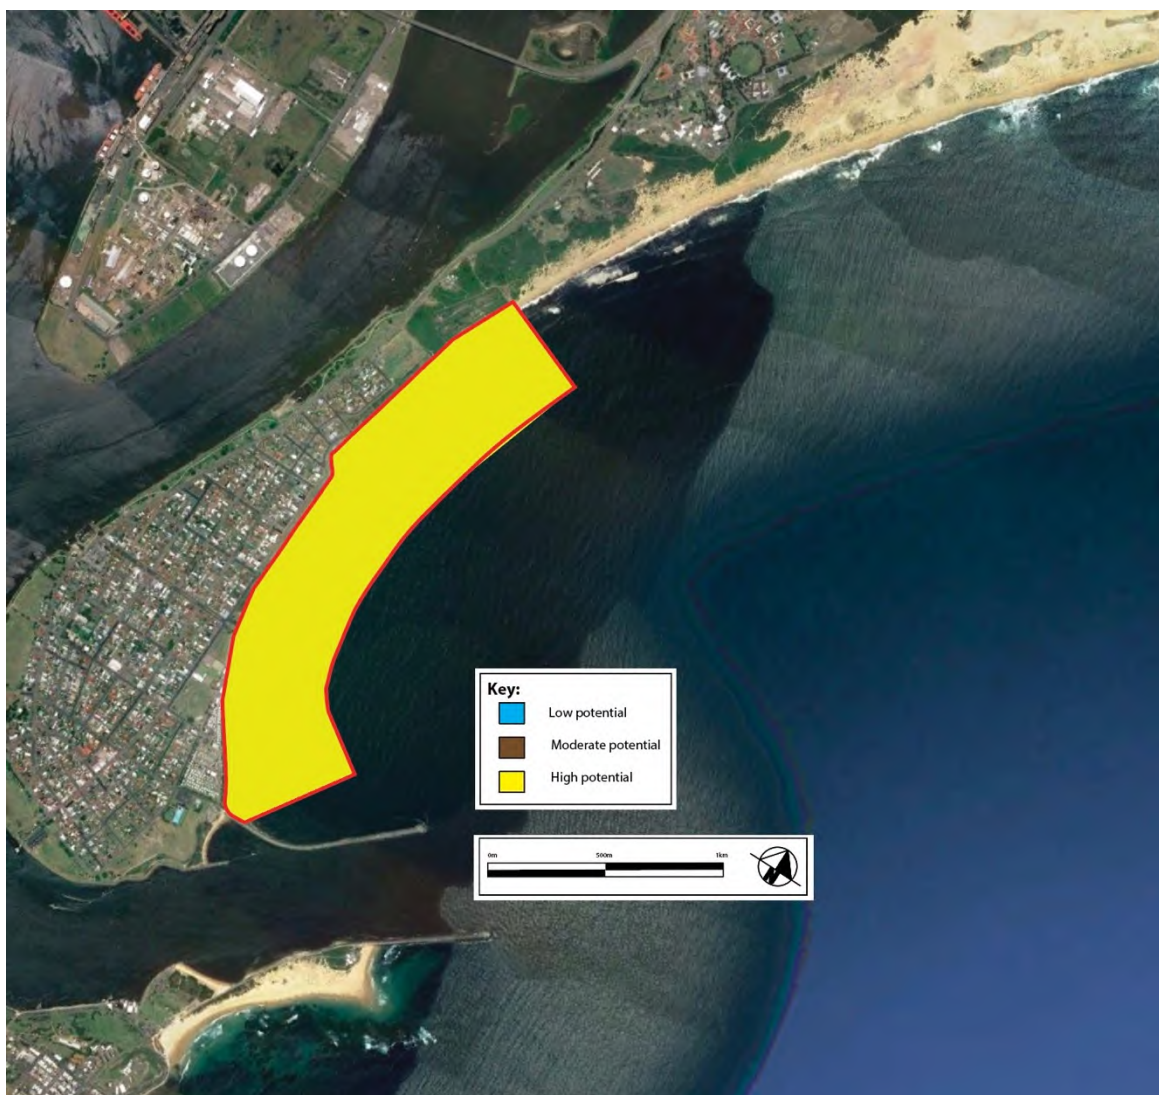
Figure 53: Archaeological potential within the sand placement area.

Based on the findings of archival research using maps, databases and primary sources such as newspapers, the following table and map outline the archaeological potential within the sand placement area (Table 5 and Figure 53).

The entire sand placement area has been assessed as being of high archaeological potential due to the location of the Oyster Bank and the historical records indicating a significant amount of shipwrecks not found within the area.

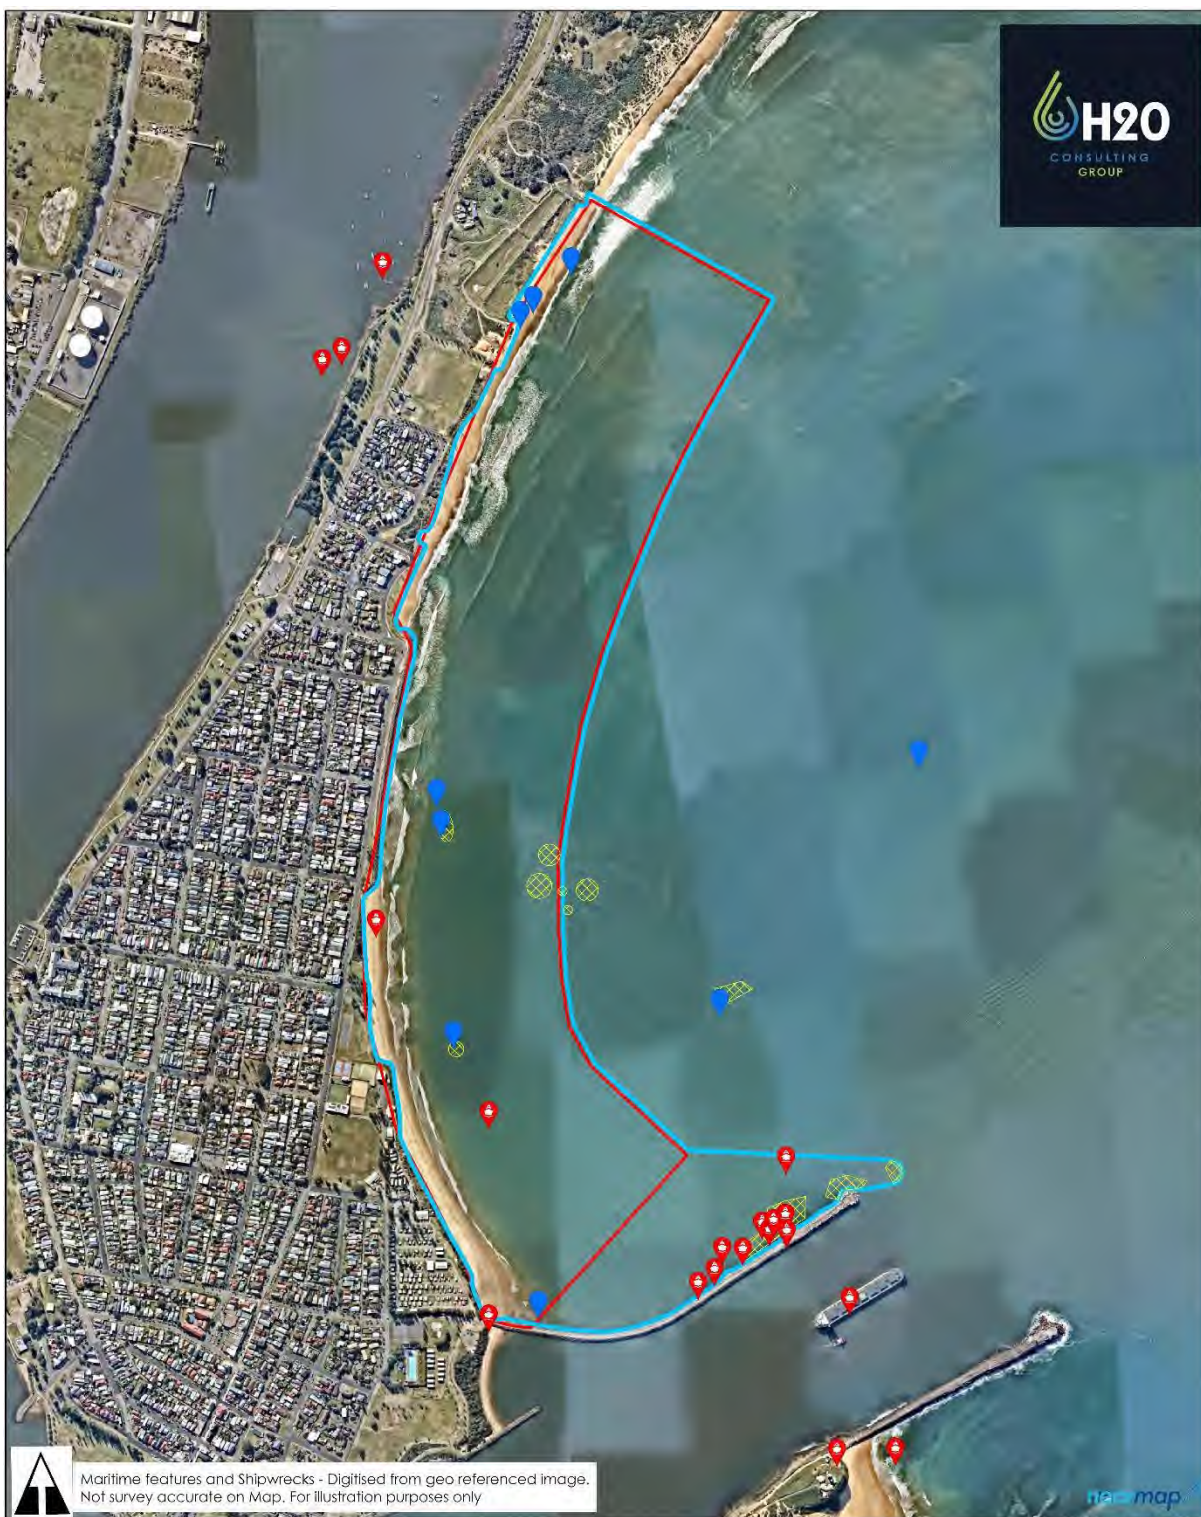
Figure 4: Habitat map of the Study Area, showing no seagrass within the proposed nourishment area.

Hard substrata subtidal habitat is limited within the Study Area and predominantly artificial as a result of the breakwater and adjacent shipwrecks (Plate 4) which are outside the Project Area (Figure 4). However, seabed mapping and aerial imagery indicate that some small outcrops of substrate occur within the Project Area (Figure 4), which are likely maritime archaeological sites and shipwrecks. Aerial imagery indicates that these structures may be periodically covered by sand, indicating that sand movement resulting in smothering and erosion, is likely a regular process in these areas (Figure 5). In turn, this is expected to result in reduced marine growth and provision of only short-term refuge habitat for marine species that utilise hard substrata benthic habitats in the locality.

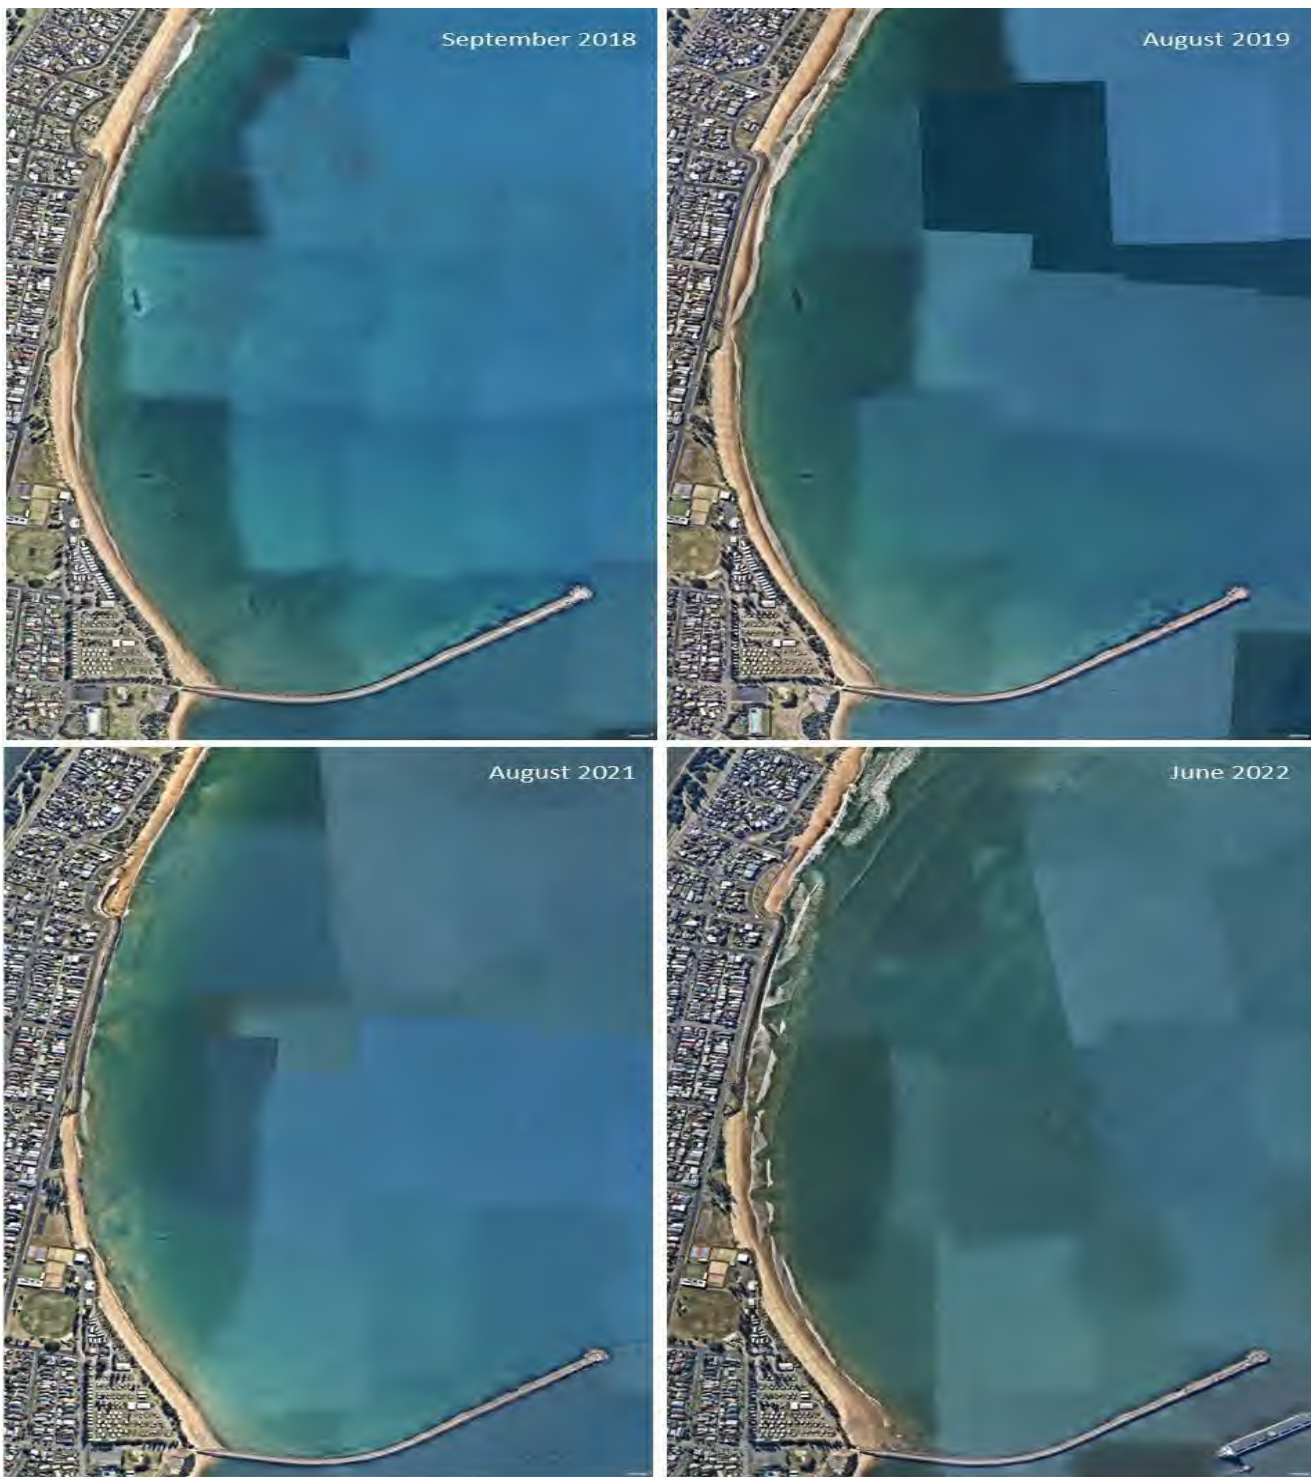
Figure 5: Nearmap imagery timeseries for the Study Area occurring between 2018 and 2022.

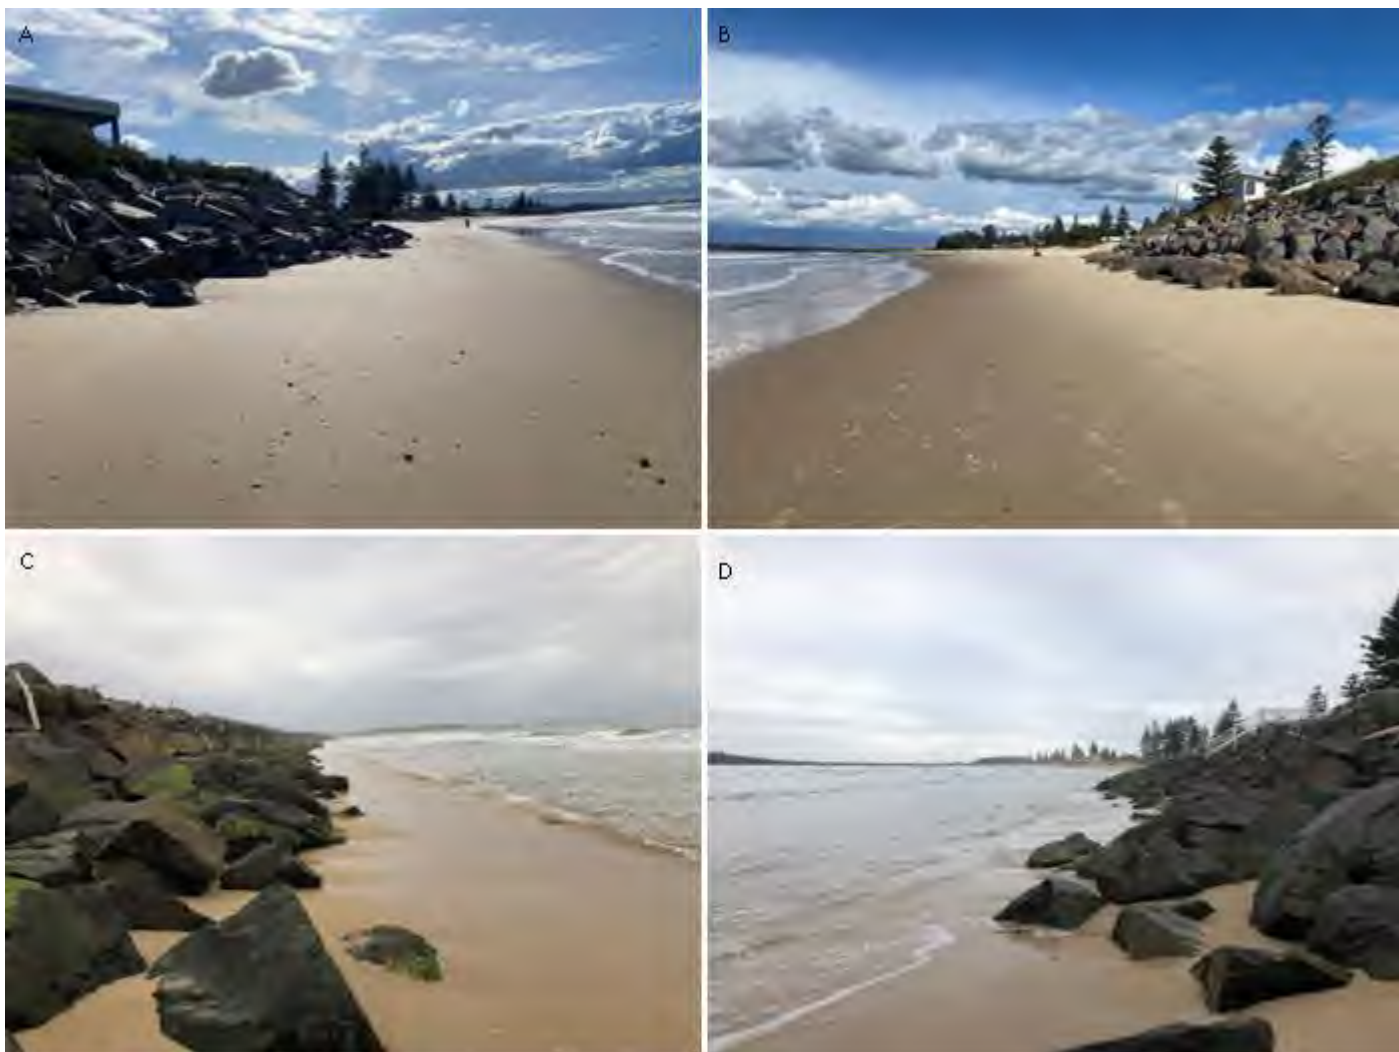
Plate 2: Sandy intertidal habits within the Study Area

- A: Open sections of the southern end of Stockton Beach looking north.
- B: Open sections of the southern end of Stockton Beach looking south.
- C: Beach at low tide below the Mitchell Street Seawall looking north
- D: Beach at low tide below the Mitchell Street Seawall looking south
