# Newcastle Coastal Zone Hazards Study

## *Final Report*

Prepared For: City of Newcastle

Prepared By: BMT WBM Pty Ltd (Member of the BMT group of companies)

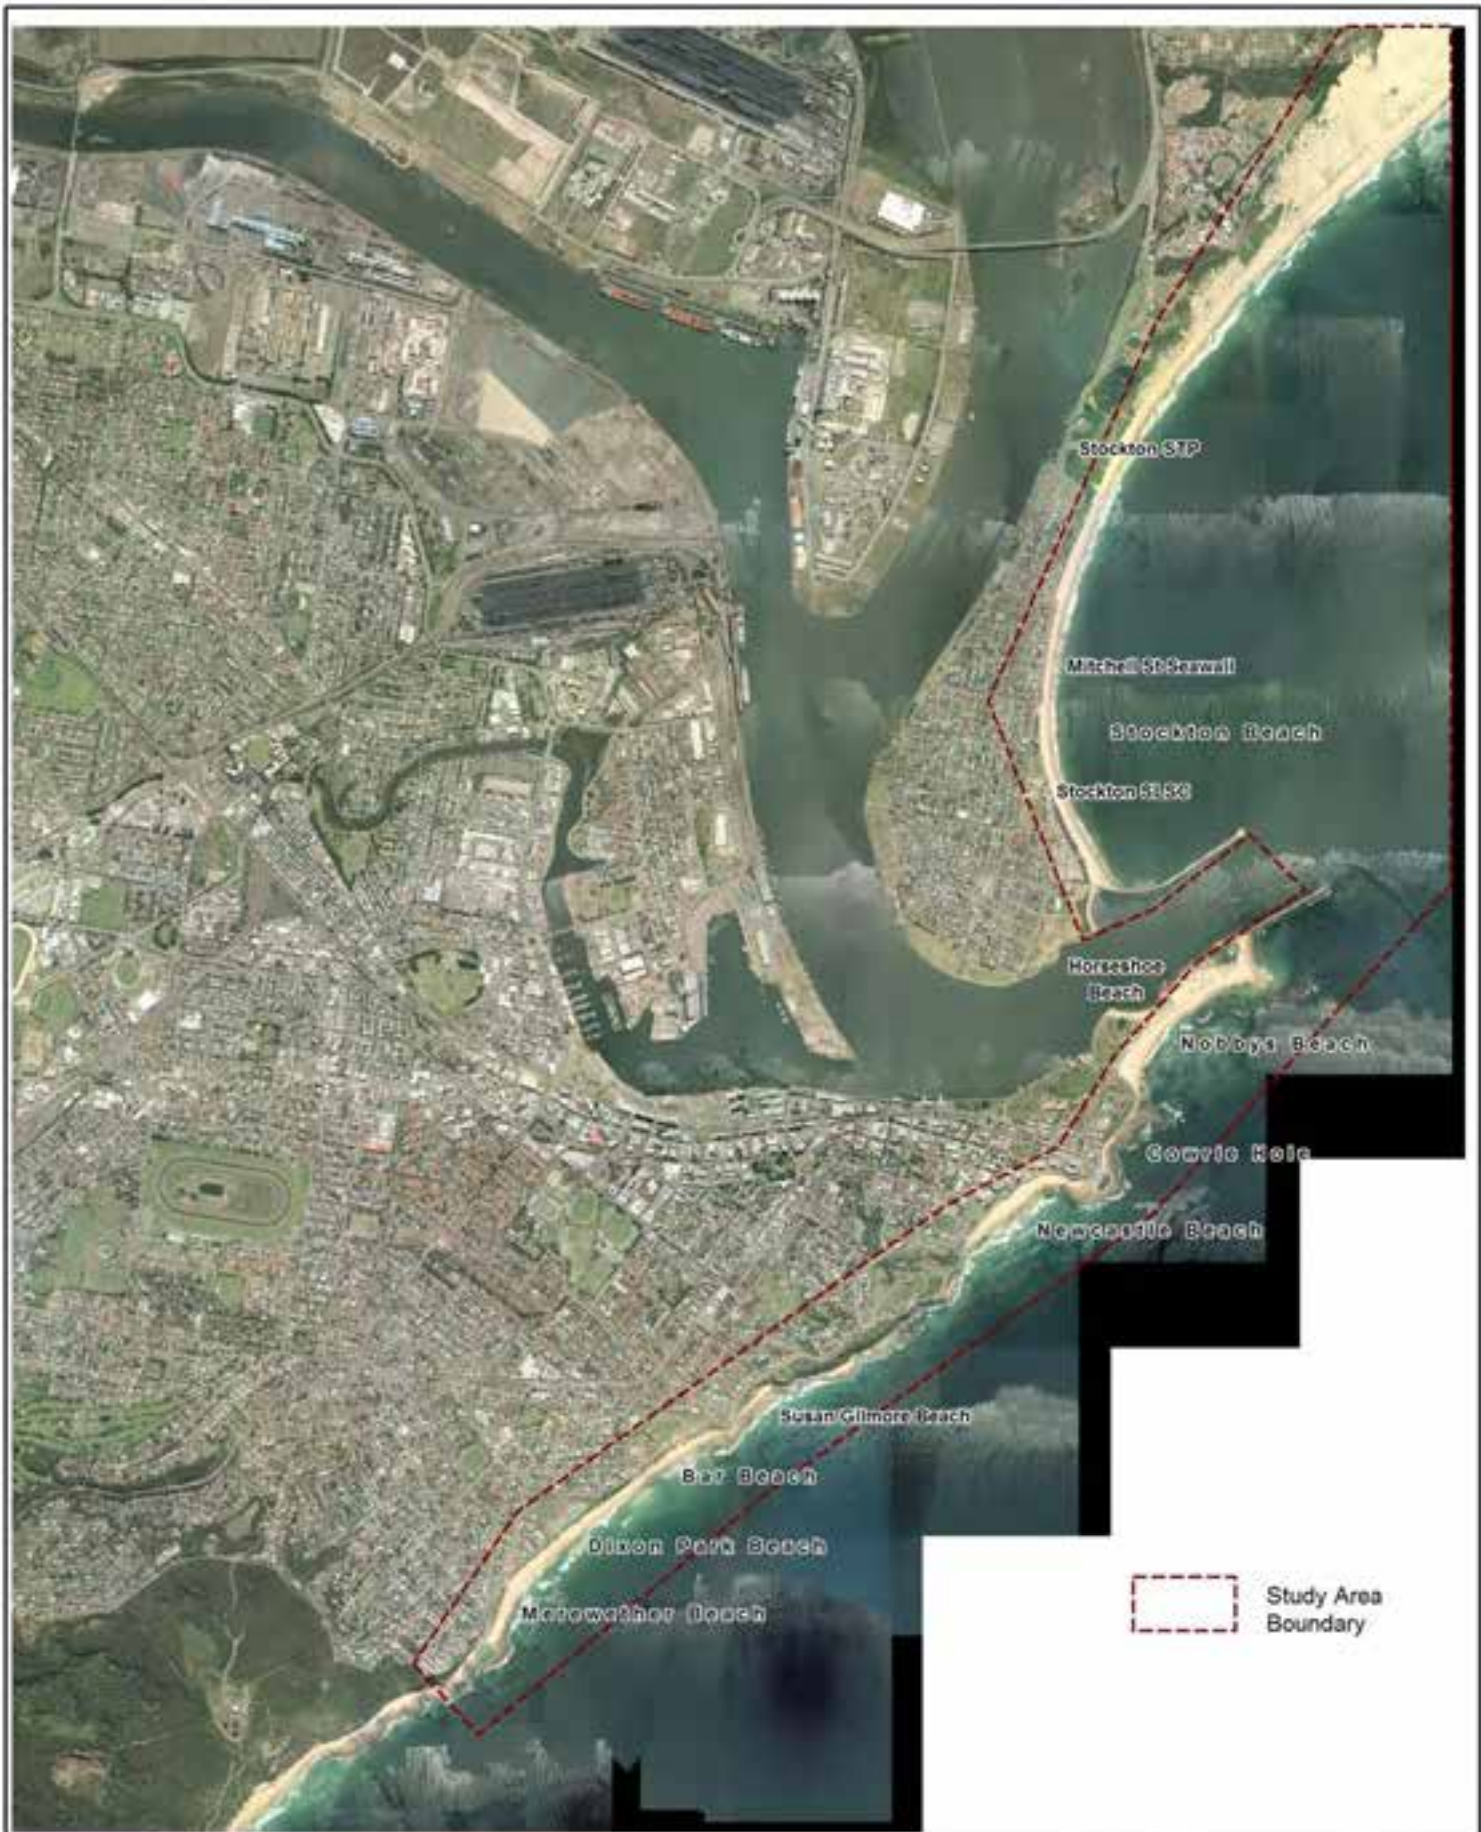
Figure:  
**1-1**

Title:  
**Study Area - Newcastle Coastline**

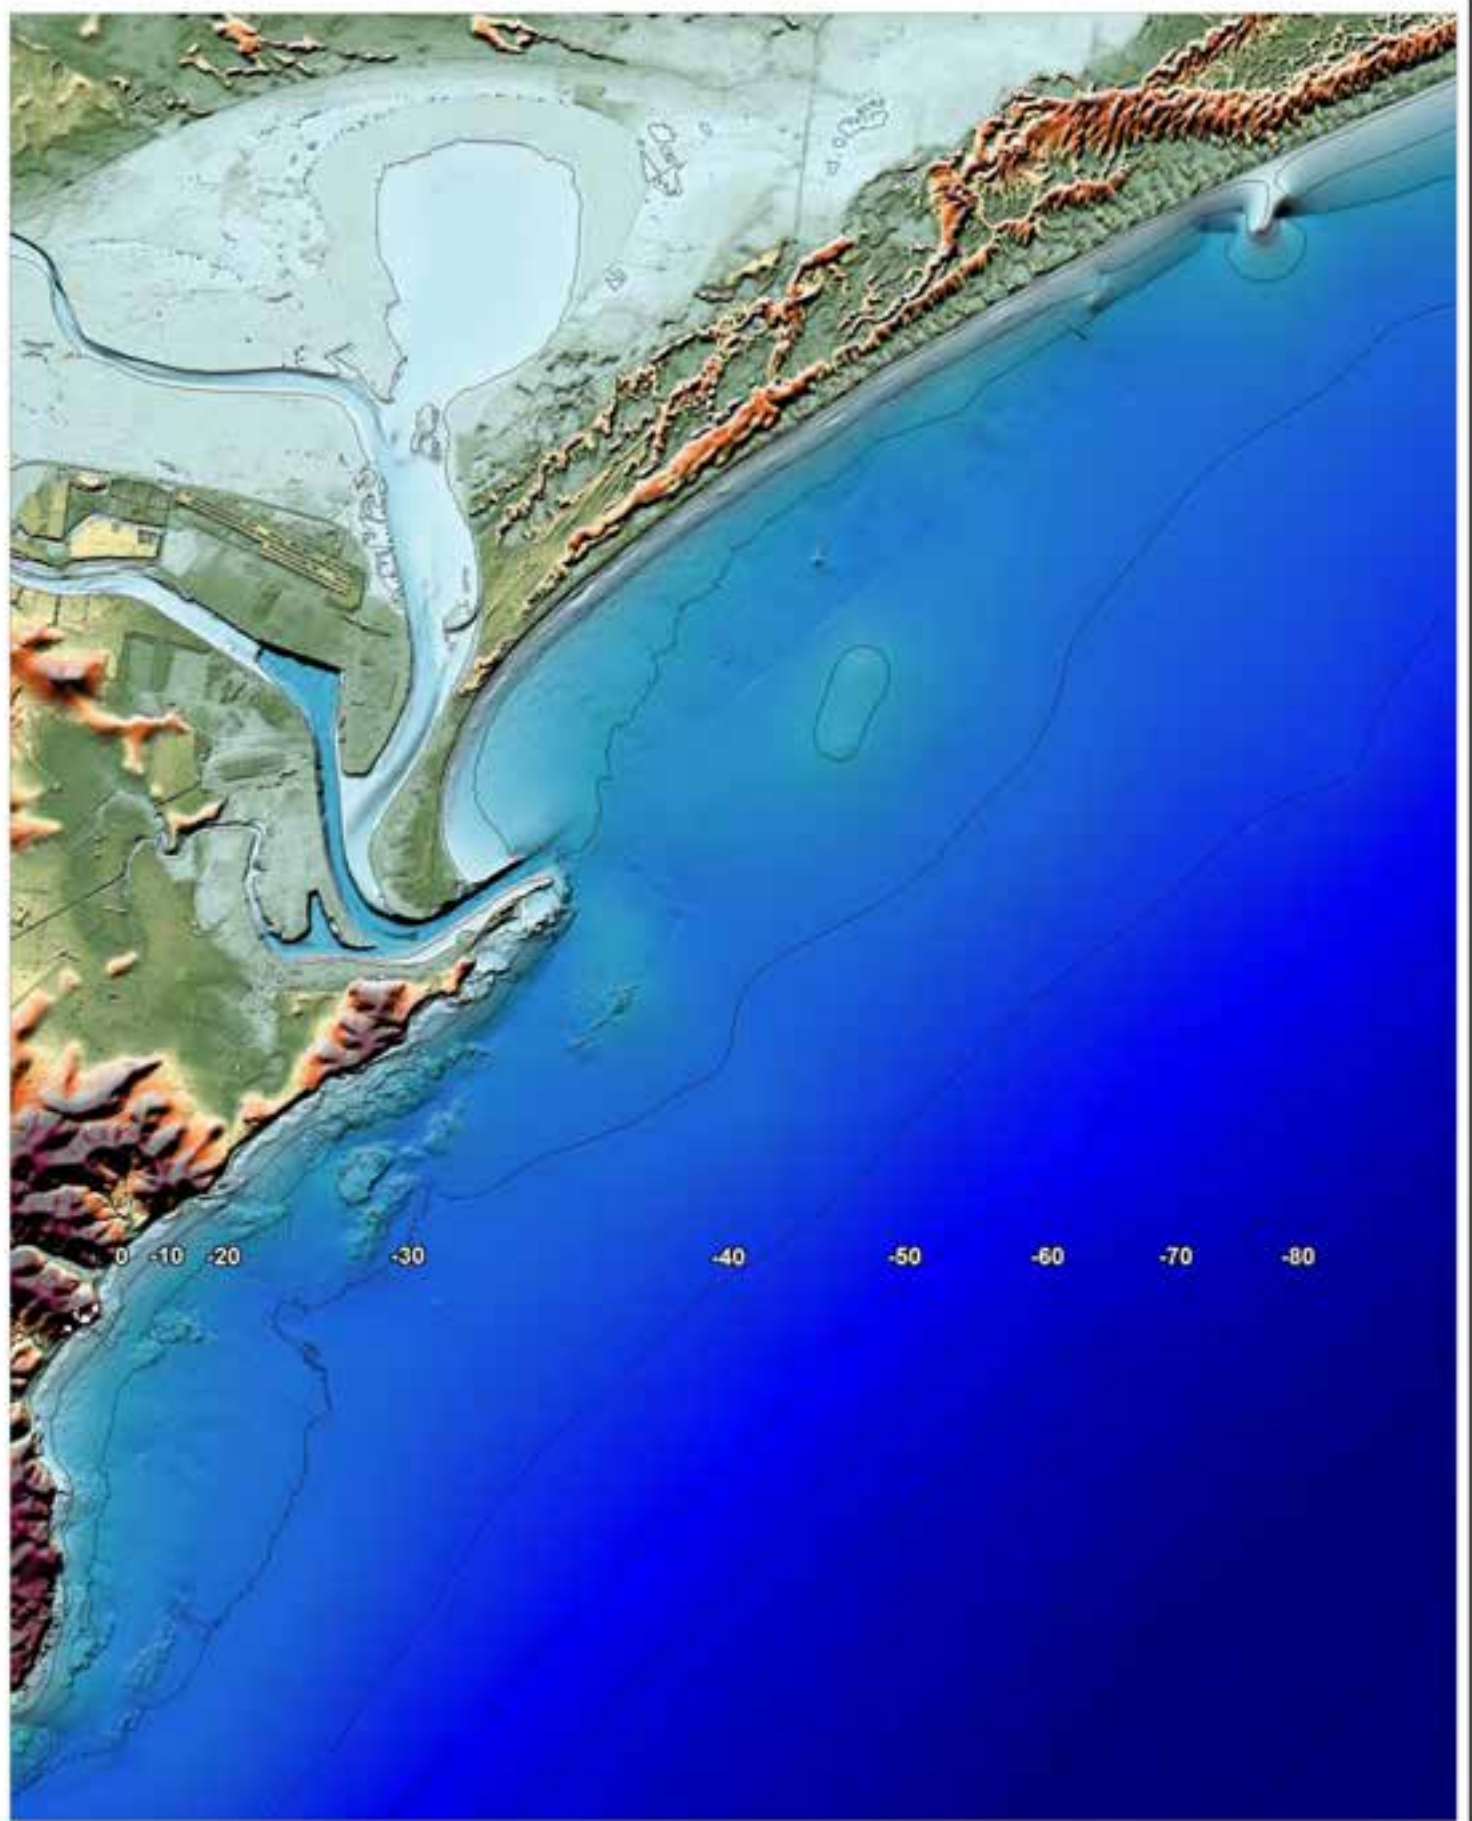
Figure:  
**2-1**

Title:  
**Digital Elevation Model - Newcastle Coast and Bathymetry**

The Newcastle nearshore zone is dominated by rock reef, which is clearly visible in aerial photographs. The 2008 marine LIDAR data also indicates the region between the 20 to 30 m contour to be dominated by rock reef. This suggests that sand reserves are relatively depleted through this zone. Roy (2001) noted south of the Hunter River that the steep rocky nature of the shelf suggests there is a relatively limited supply of shelf sand, with coastal barriers typically stationary or receding over geological timescales (thousands of years). Cross shore sediment transport may be constricted by the presence of these reefs under lower wave conditions. Longshore sediment movements will occur across the surface of the reefs.

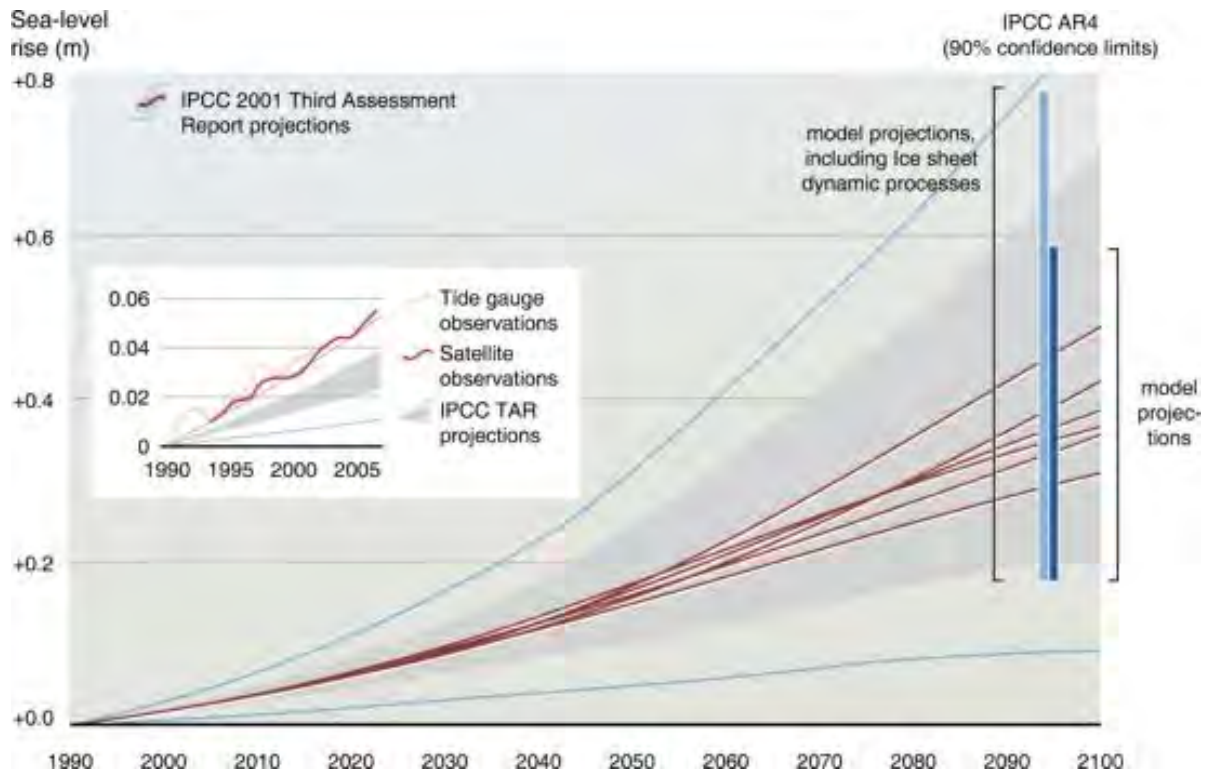
\*UNEP/GRID-Arendal (2012) explain for this figure: "the projected range of global averaged sea-level rise from the IPCC 2001 Assessment Report for the period 1990 to 2100 is shown by the lines and shading [grey]. The updated AR4 IPCC [2007] projections made are shown by the bars plotted at 2095, the dark blue bar is the range of model projections (90% confidence limits) and the light blue bar has the upper range extended to allow for the potential but poorly quantified additional contribution from a dynamic response of the Greenland and Antarctic ice sheets to global warming".

**Figure 2-4 Projected and Measured Sea Level Rise to 2100 (source: UNEP/GRID-Arendal\*, 2012)**

Figure 2-4 provides a summary of the global measurements and projections for sea level rise since 1990. The rate sea level rise measured over the last century was 1.7 mm/year (Church et al., 2010). The rate of global sea level rise since 1992 to date is around  $3.1 \pm 0.4$  mm/year (CSIRO/ARECRC, 2012).

Figure 2-4 shows that global sea level rise measurements are tracking with the highest sea level rise projections (i.e. 90th percentile projection plus poorly defined ice-sheet contribution). Similarly, the HCCREMS projections are very similar to the NSW Government policy levels. This indicates that the upper range levels used to derive the former NSW sea level rise policy benchmarks are likely to occur by 2100 and provide the best estimate projection for this coastal hazard assessment.

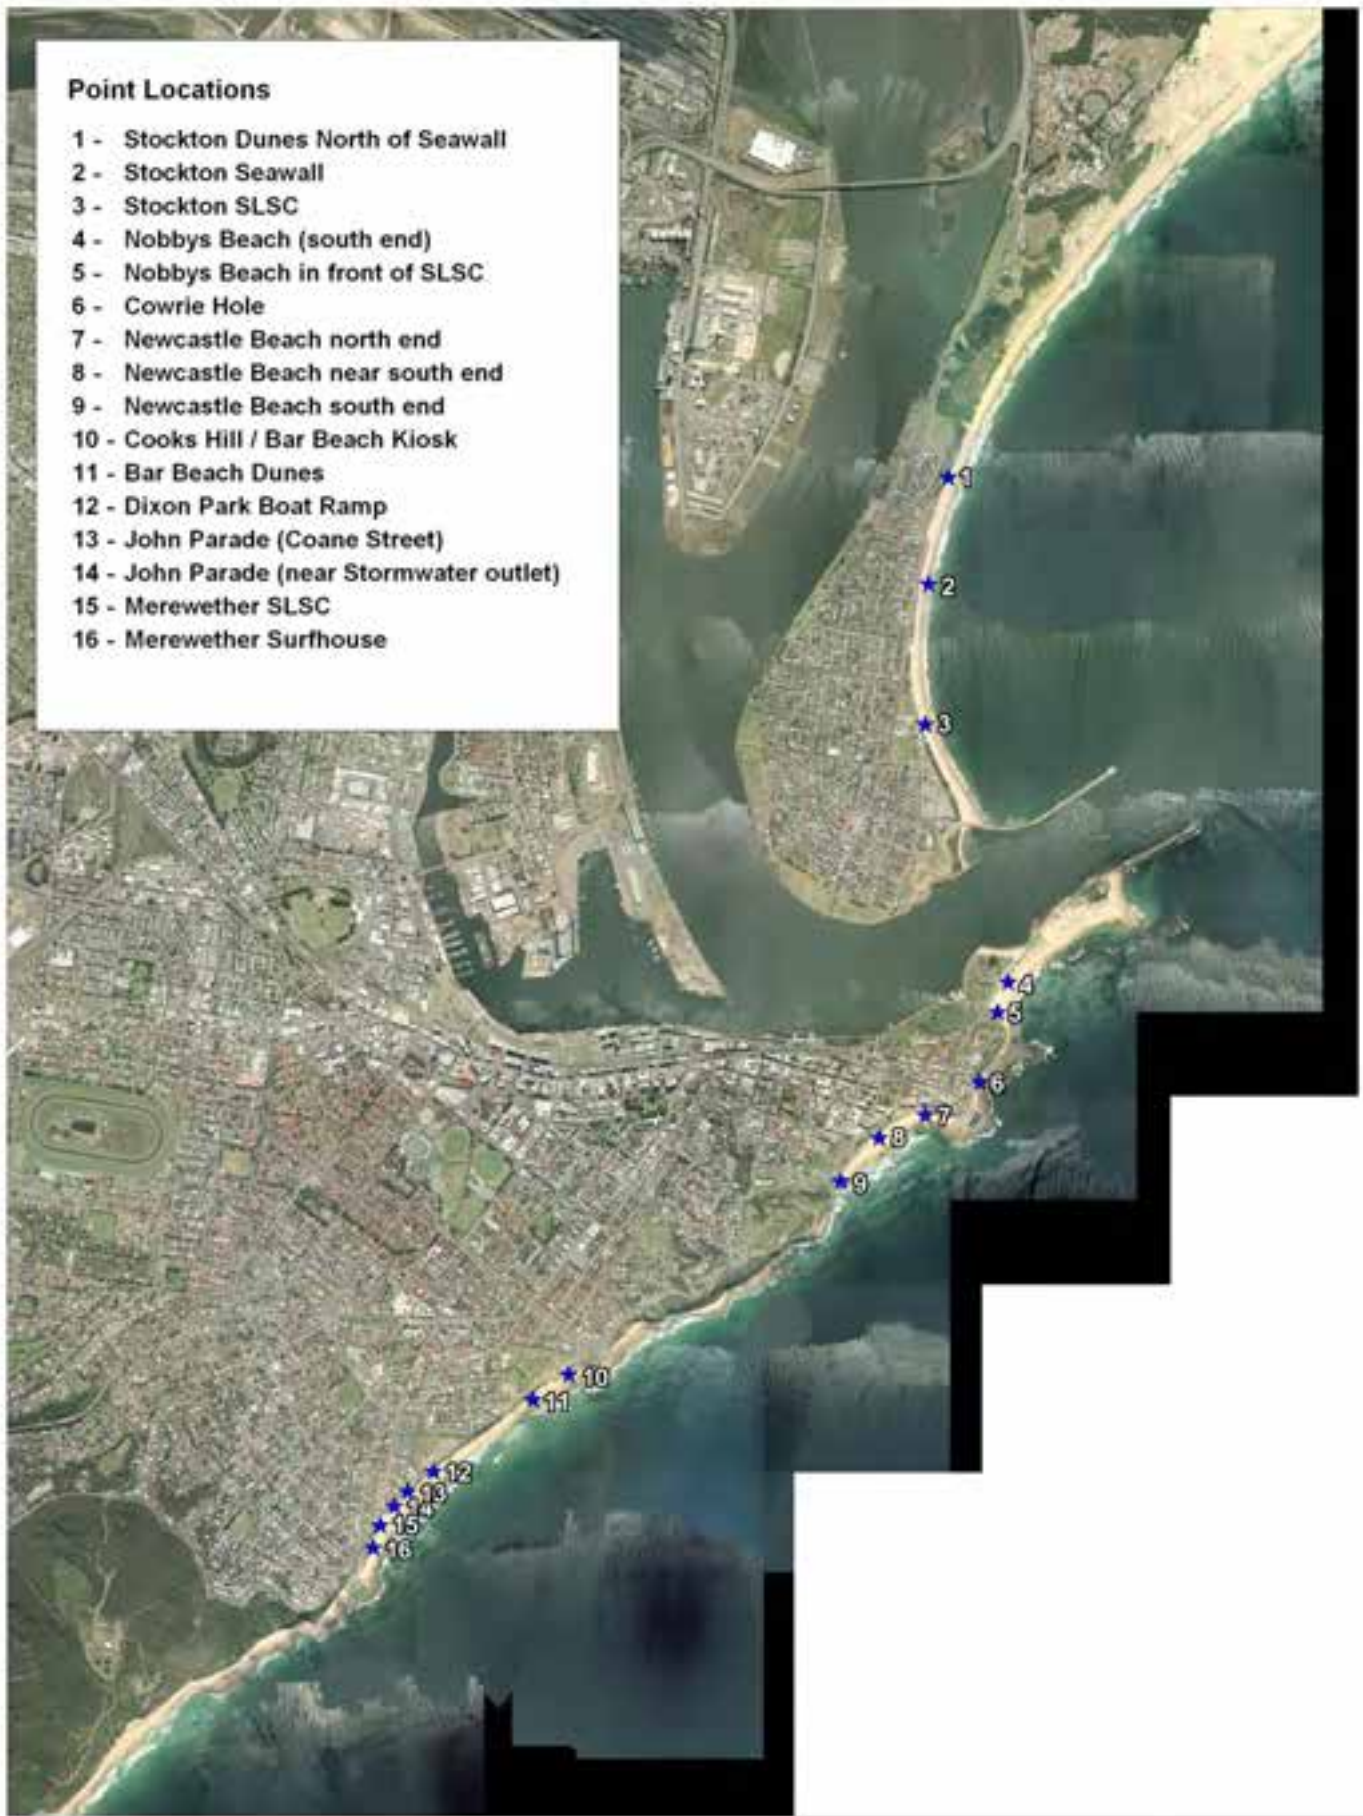
Drawing:  
**3-10**

- 1 - Stockton Dunes North of Seawall
- 2 - Stockton Seawall
- 3 - Stockton SLSC
- 4 - Nobbys Beach (south end)
- 5 - Nobbys Beach in front of SLSC
- 6 - Cowrie Hole
- 7 - Newcastle Beach north end
- 8 - Newcastle Beach near south end
- 9 - Newcastle Beach south end
- 10 - Cooks Hill / Bar Beach Kiosk
- 11 - Bar Beach Dunes
- 12 - Dixon Park Boat Ramp
- 13 - John Parade (Coane Street)
- 14 - John Parade (near Stormwater outlet)
- 15 - Merewether SLSC
- 16 - Merewether Surfhouse

Title:  
**Locations for Run-up and Overtopping Analyses**

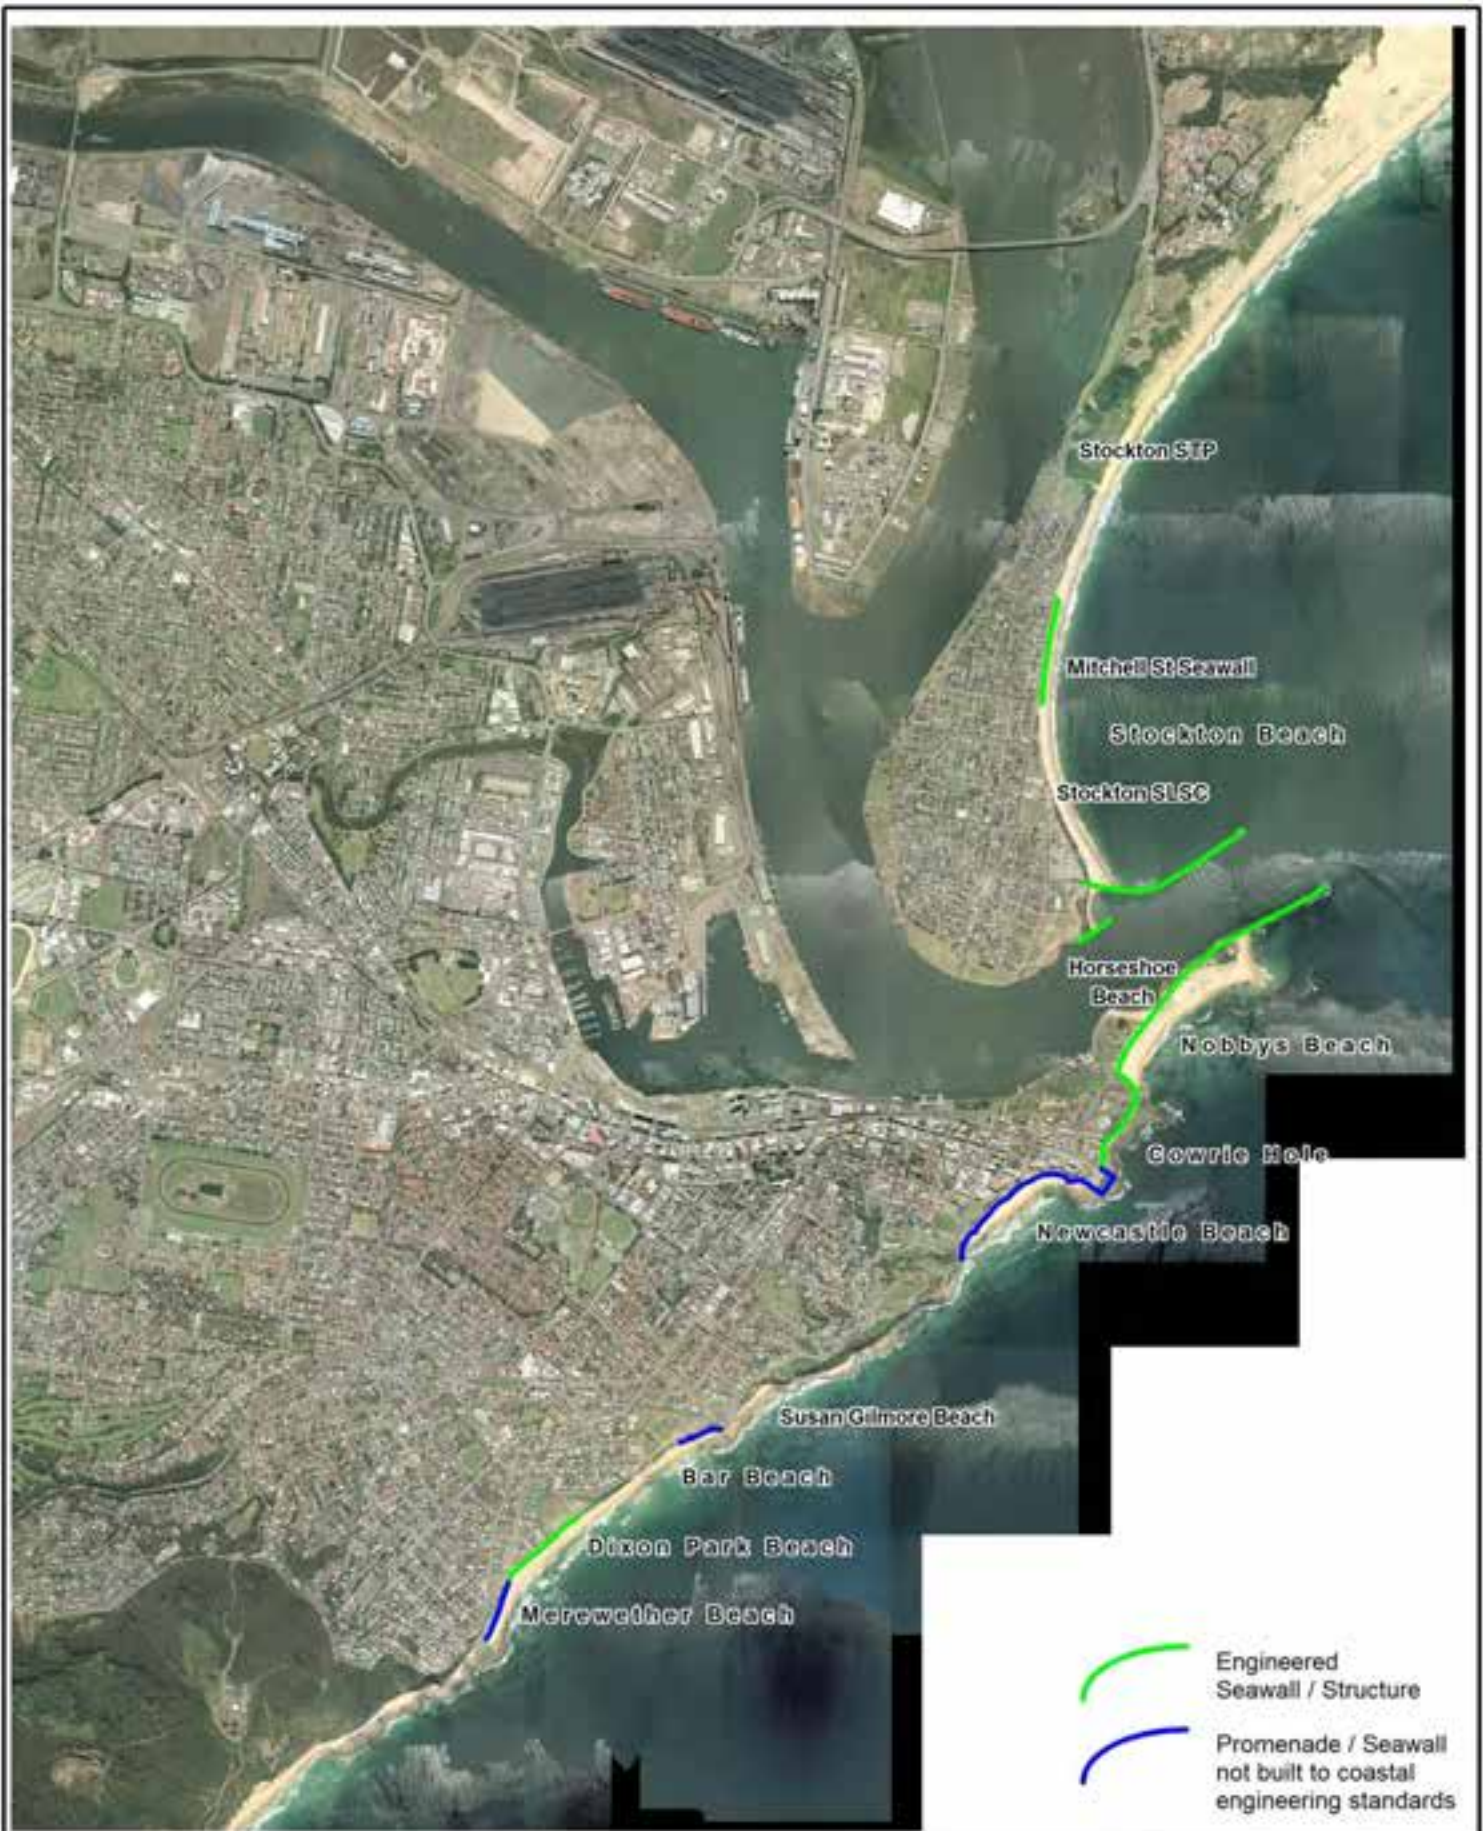
Figure:  
**3-11**

Title:  
**Location and Type of Seawalls in Newcastle LGA**

The existing walls at Newcastle's beaches are of varying construction and age (Figure 3-11). They include:

- Vertical seawalls constructed of stone or concrete (generally older structures dating from 1800s to 1960s, or repairs to these structures);
- Sloping rock armoured revetments (1970s and 1980s); and
- Sloping revetments of geotextile sand filled containers (1996 to present).

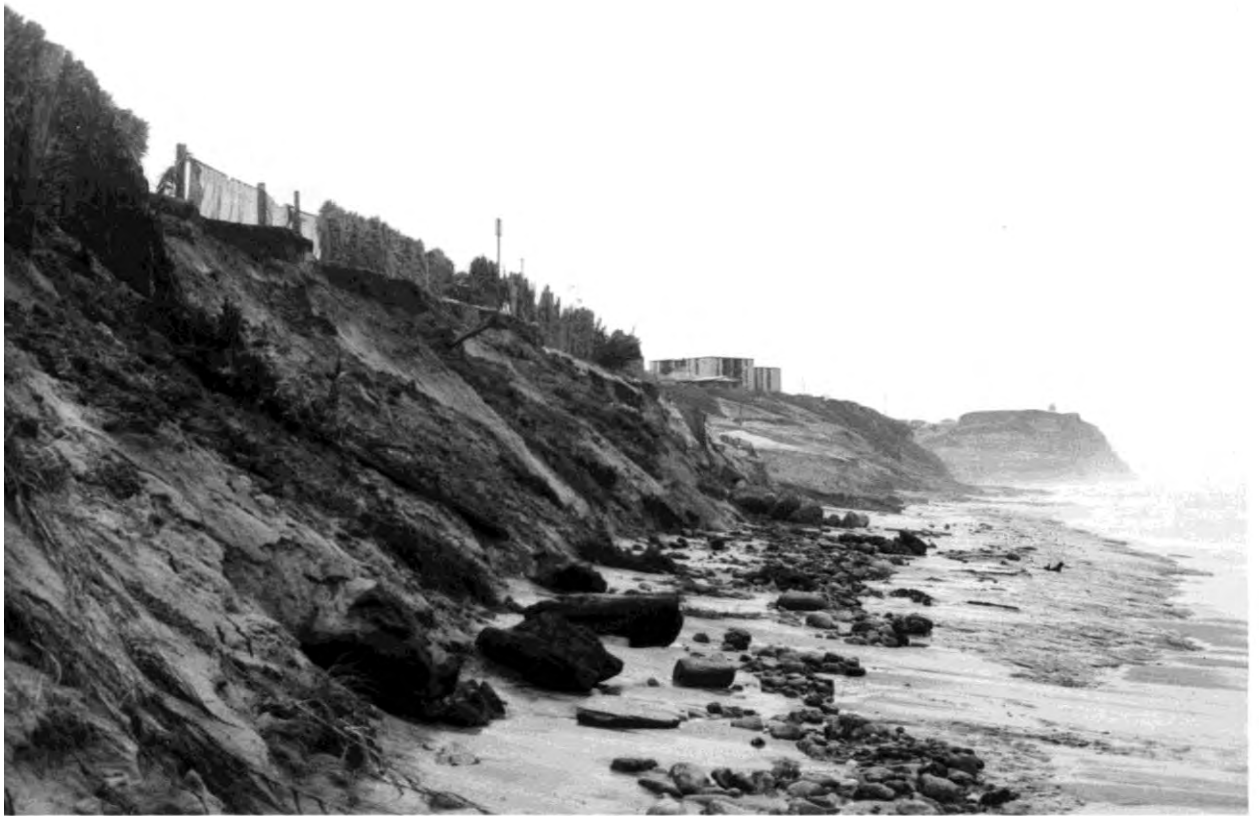
**Figure 4-1 Merewether to Dixon Park Beach Erosion Following Severe Storms circa 1974**

If a beach is backed by a seawall or natural rocky outcrops, such as the southern beaches in Newcastle, the storm demand may exceed the volume of sand available thereby effectively removing all the sand from the upper beach profile. There is evidence of such events at Newcastle, such as during 1974 (refer Figure 4-1 to Figure 4-4, Chapter 4).

Photographic evidence (Figure 4-1) suggests that the area of John Parade at Merewether comprises deep dune sands, with little to no bedrock constraint. The roadway of John Parade is effectively constructed along the crest of what would previously have been the frontal dune. Residential development lies immediately behind John Parade. Likewise, the car park at Dixon Park is also situated on top of the frontal dune. However, at Dixon Park, residential properties are set behind parkland adjacent to the beach. Following severe erosion in the 1970s, a rock seawall was constructed along the beach between Merewether Surf Club and Dixon Park (approximately to the base of the Cliff) in 1976/77. The Dixon Park Surf Life Saving Club House is constructed on high ground some 60m back from the beach face.

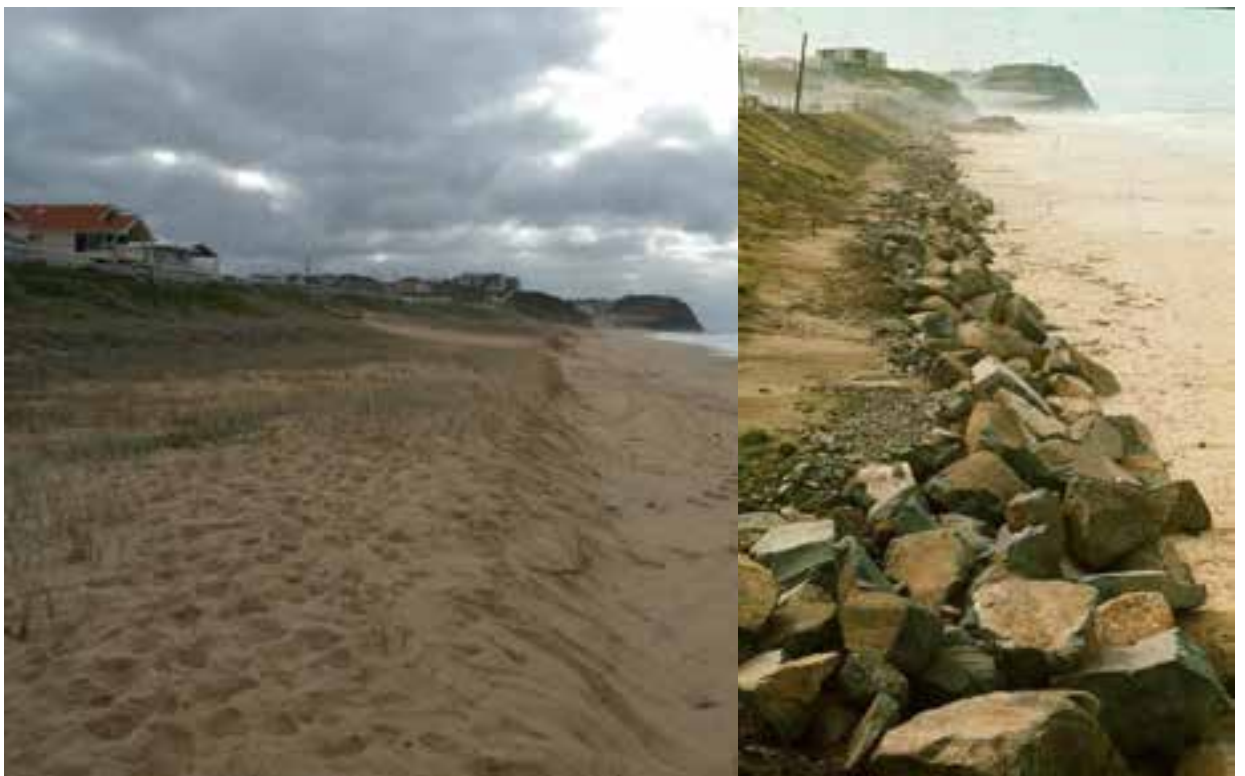
**Figure 4-2 Merewether to Dixon Park (2011) – Well developed dunes now overlay seawall (right)**

Dune vegetation was established after 1988, and dune works have progressed to the present (particularly to replace non-native weeds such as bitou bush with native, low lying species). At the current time, a well developed, typically vegetated frontal and incipient dune exists along the entire beach unit, and has completely covered the rock seawall between Dixon Park and Merewether (Figure 4-2).

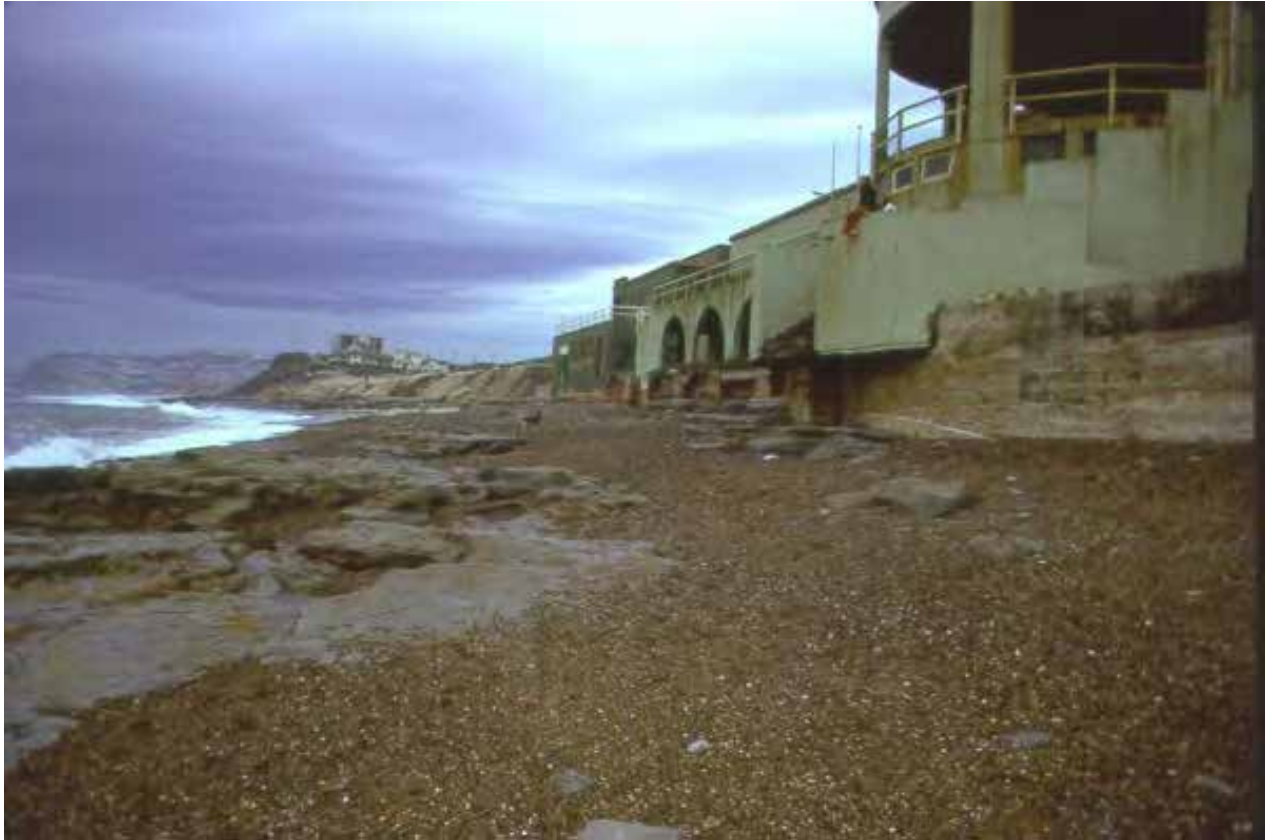
**Figure 4-3 Bar Beach (centre) Erosion Extents Following Severe Storms circa 1974**

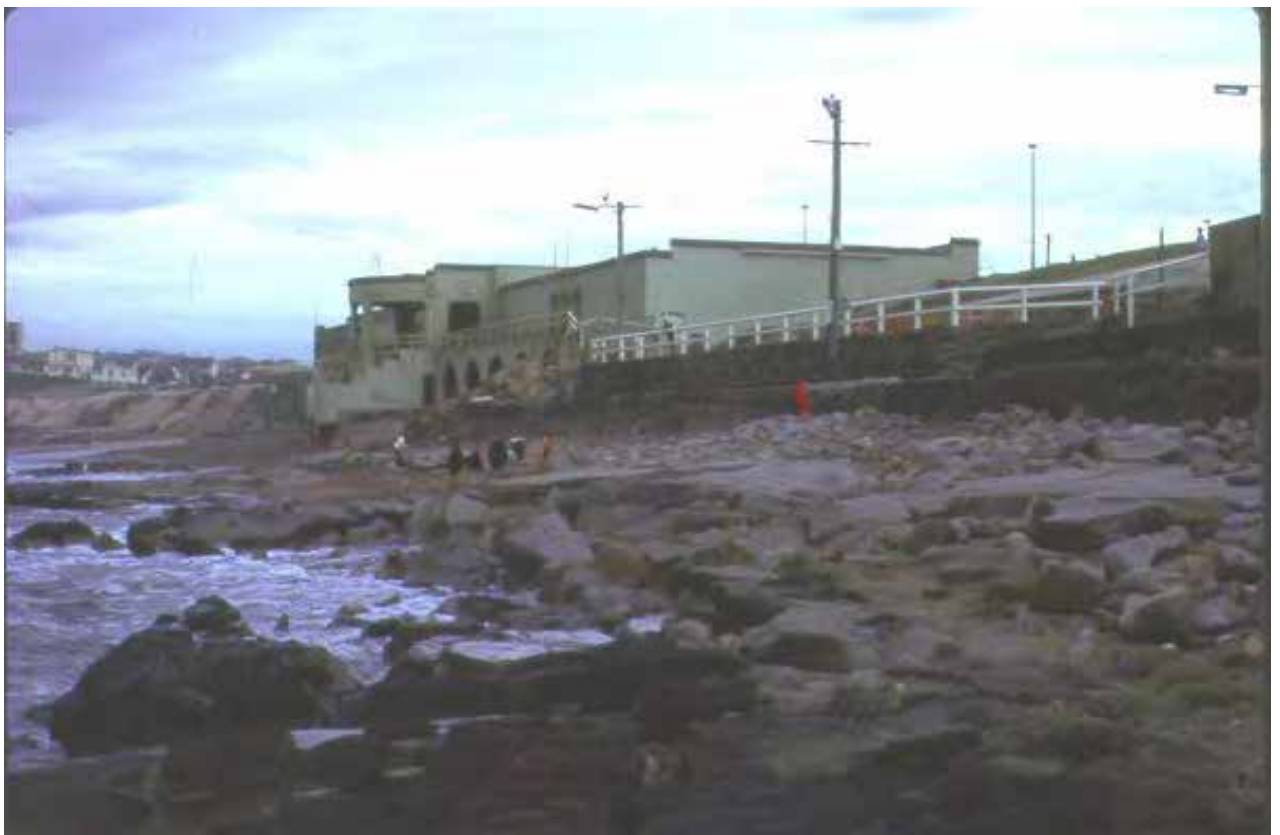
**Figure 4-4 Bar Beach (north) Erosion Extents Following Severe Storms circa 1974**

Historical photographs of the southern beaches of Newcastle following the 1974 storms provide an excellent graphical portrayal of the potential extent of erosion. The beaches were eroded back to the bedrock level at Newcastle and the northern end of Bar Beach to Cooks Hill SLSC (refer to Figure 4-11 and Figure 4-4 of Chapter 4). The potential landward extent of erosion in 1974 appears to have been limited to the roadway of John Parade and Scenic Drive at Bar Beach. These areas have limited bedrock extent and the back beach area is dune sand. In 1979, a seawall was constructed along

At the northern end of the beach unit (Bar Beach), the Cooks Hill Surf Life Saving Club and associated pavilions, promenades and seawalls have been constructed at the base of the hill immediately adjacent to the beach. While there is certainly reef and bedrock across the entire surf zone between the Cliff and Bar Beach, the beach above this is likely to be dunal sands with bedrock at depth, and thus erodible (Figure 4-3) Bedrock below Cooks Hill Surf Club and the northern end of the beach has been uncovered by erosion in the past (Figure 4-4), and is a constraint to potential storm erosion.

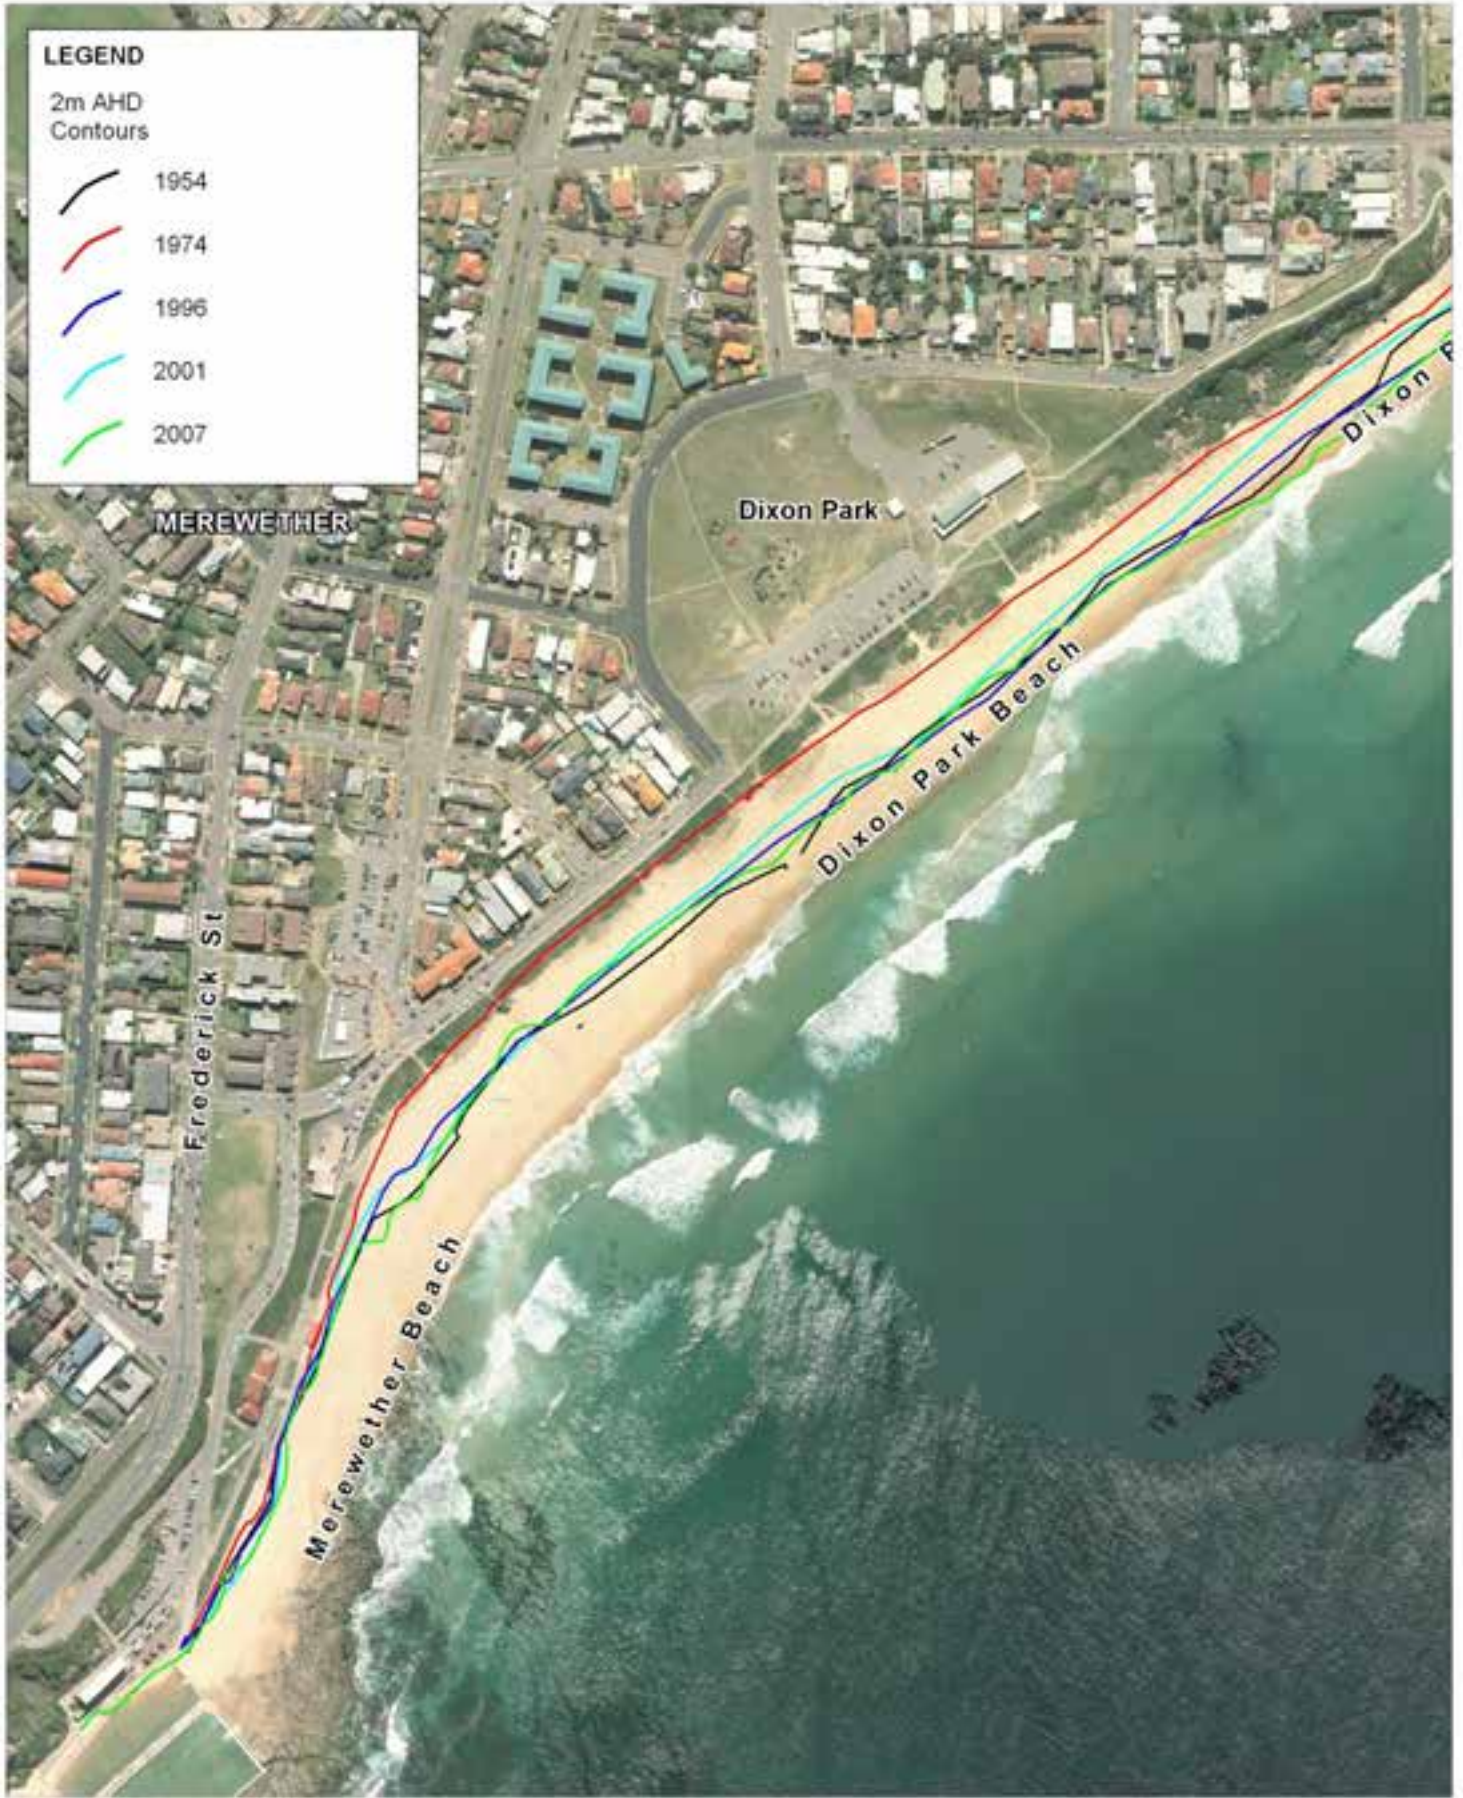
Drawing:  
**4-5**

-   1954
-   1974
-   1996
-   2001
-   2007

Title:  
**Position of the 2 m AHD Contour Over Time,  
Merewether to Dixon Park Beach**

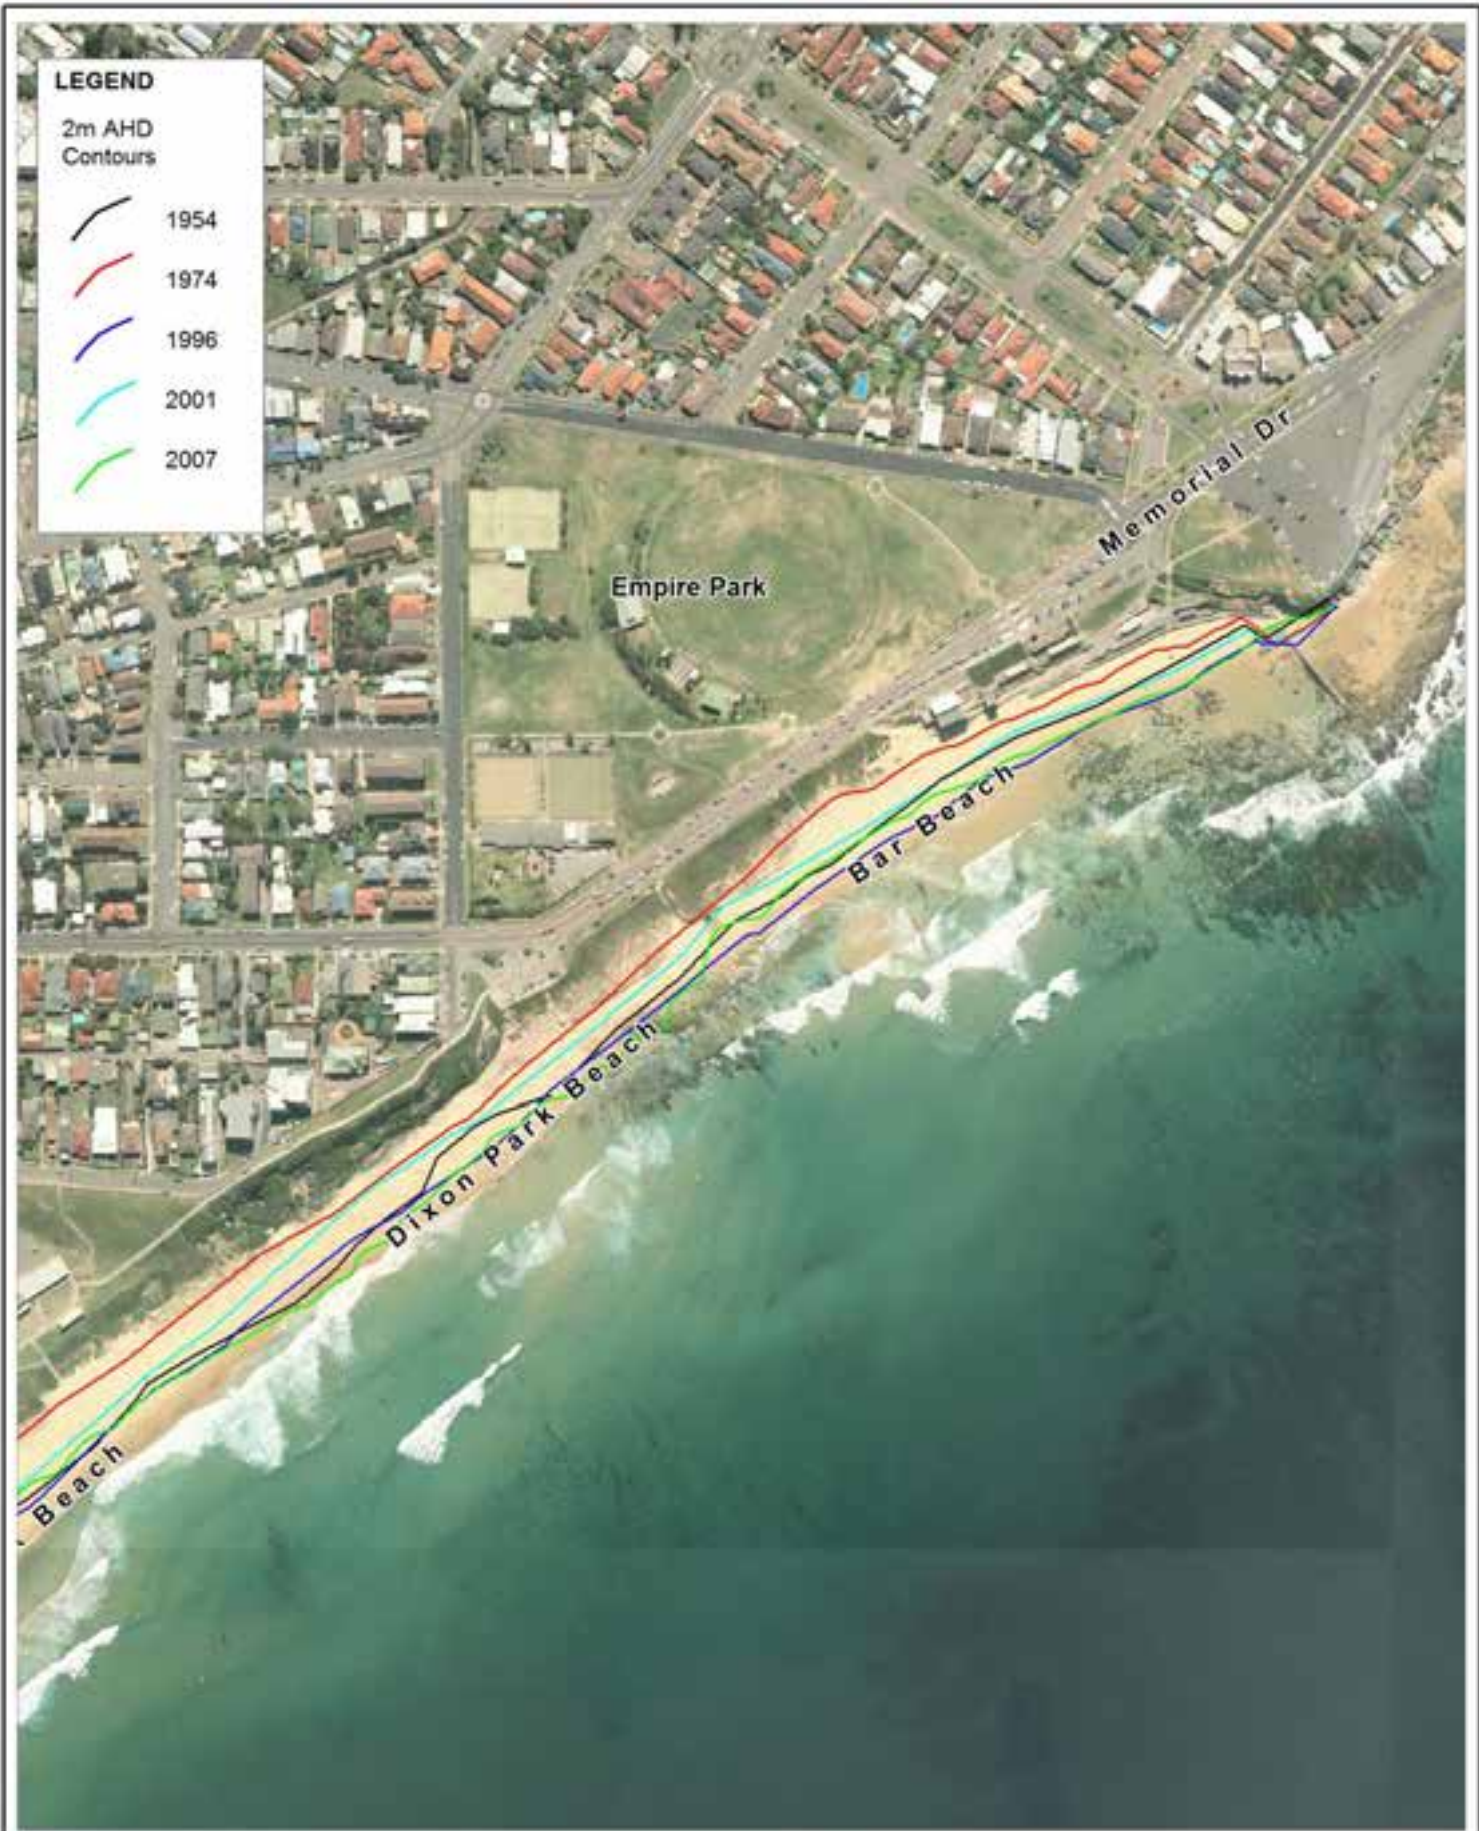
Title:  
**Position of the 2 m AHD Contour Over Time,  
 Dixon Park to Bar Beach**
