# Newcastle Coastal Zone Hazards Study

## *Final Report*

Prepared For: City of Newcastle

Prepared By: BMT WBM Pty Ltd (Member of the BMT group of companies)

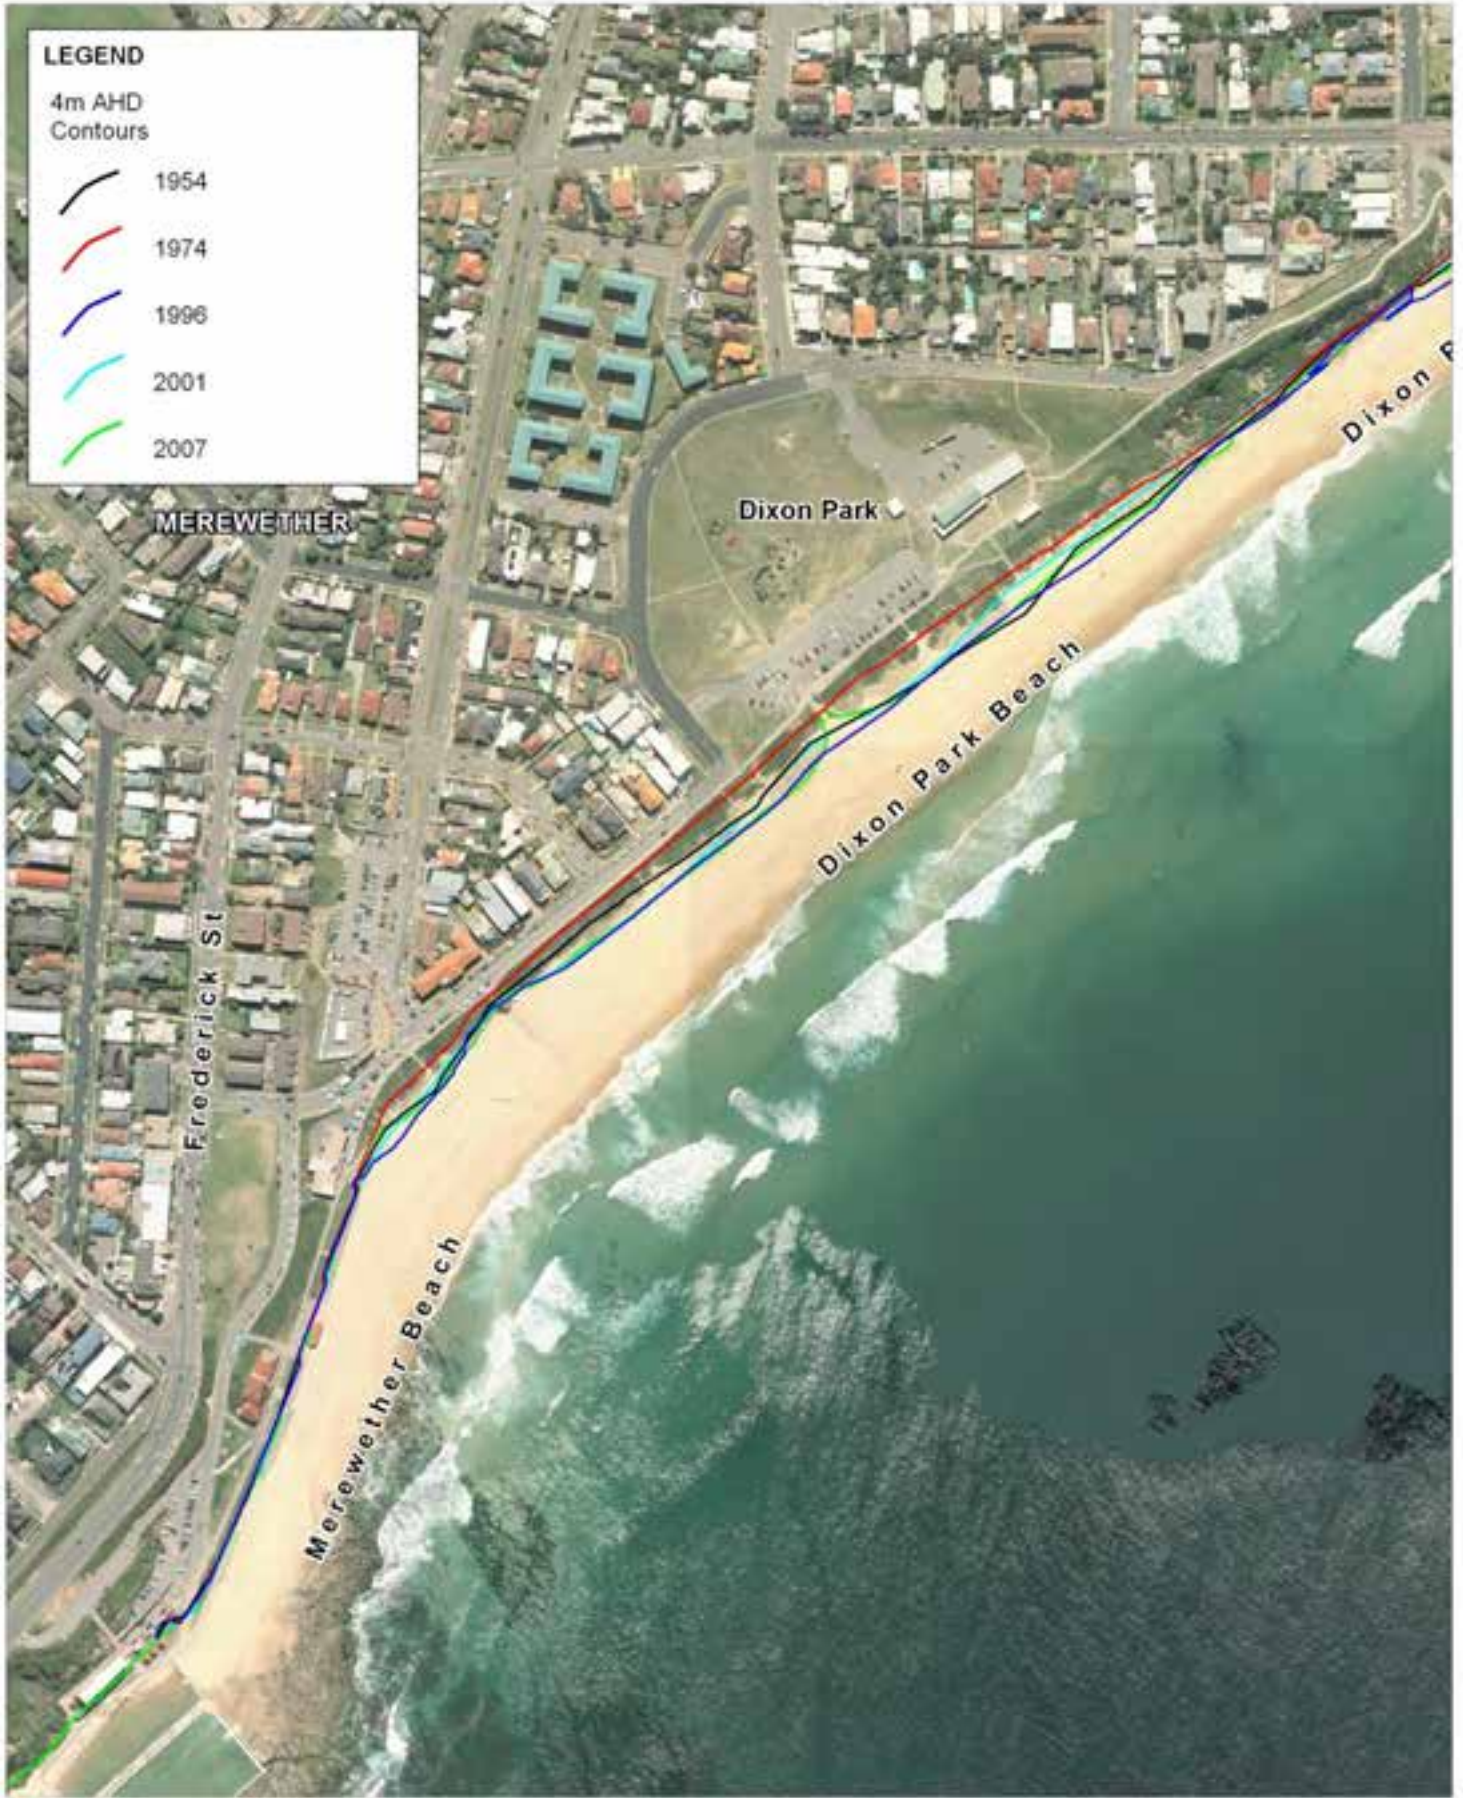
Drawing:  
**4-7**

4m AHD  
Contours

-   1954
-   1974
-   1996
-   2001
-   2007

Title:  
**Position of the 4 m AHD Contour Over Time,  
Merewether to Dixon Park Beach**

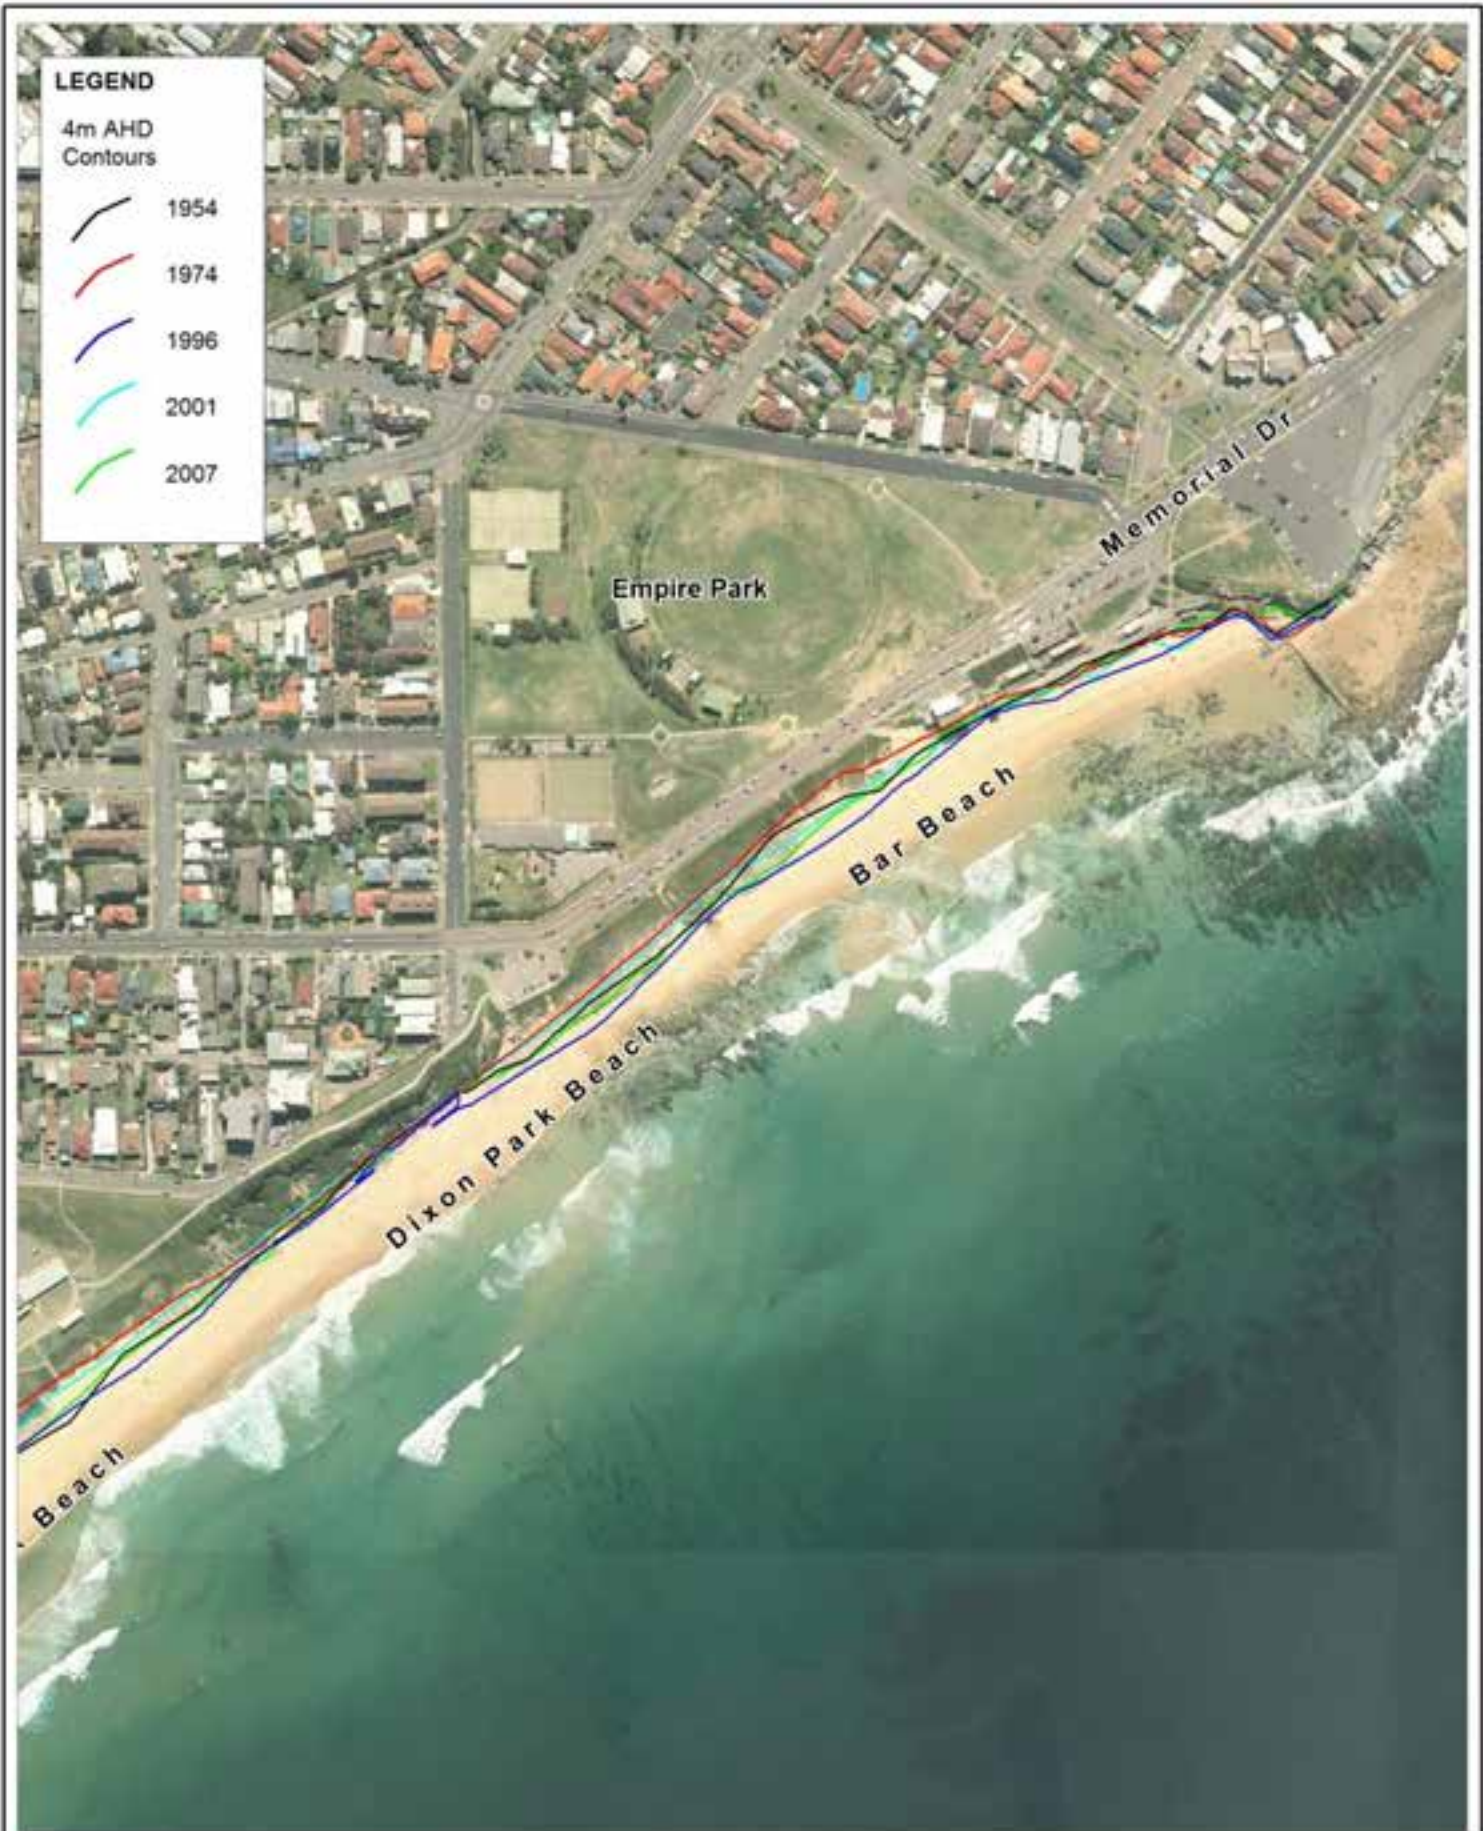
Drawing:  
**4-8**

Title:  
**Position of the 4 m AHD Contour Over Time,  
 Dixon Park to Bar Beach**

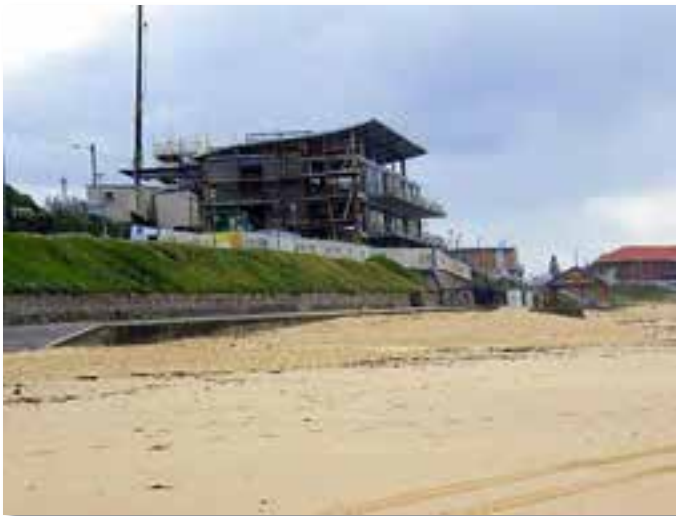
**Plate 2.1** New Surf House at Merewether under construction. A mixture of high level and low level walls are constructed on the lower beach. The front pathway appears to follow the alignment of the old railway. Sections of the retaining structures, paving and fittings are in poor condition. **Photo:** Coastal Environment 30/04/2011

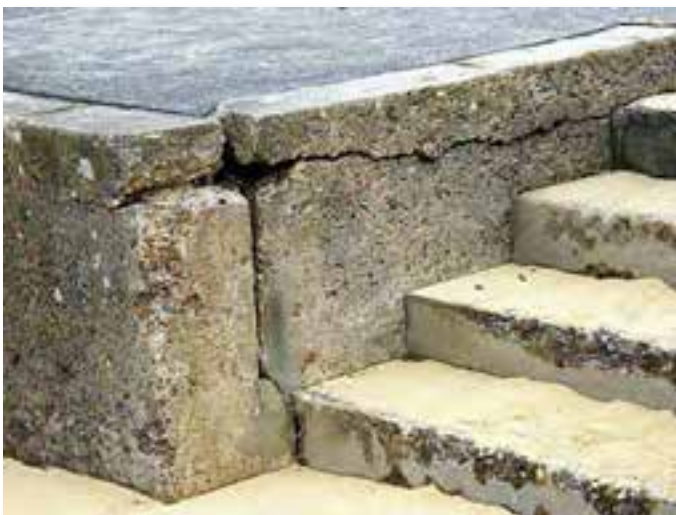
**Plate 2.2.** Stairs leading from the walkway to the beach. Construction details are not known. The front seawall of vertical concrete construction is exposed to wave action and has rotated seaward at the top with cracking extending through the structure. **Photo Source:** Coastal Environment 30/04/2011

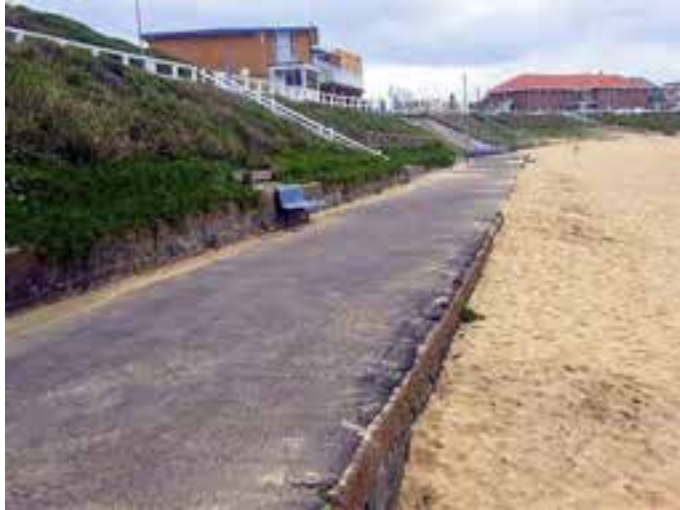
**Plate 2.3** Walkway between Surf House and the SLSC, following the route of the old colliery railway line. There is a low vertical wall on the seaward side of unknown construction which is regularly overtopped by storm waves at present. This section of the beach appears to be shallowly underlain by bedrock. **Photo:** Coastal Environment 30/04/2011

While the condition of the existing seawall and paving is serviceable, there is little available documentation showing the construction of the seawall components and their suitability to withstand substantial wave erosion. Some visible element of the structures are degraded (plates 2.3, 2.4) and in need of maintenance or replacement.

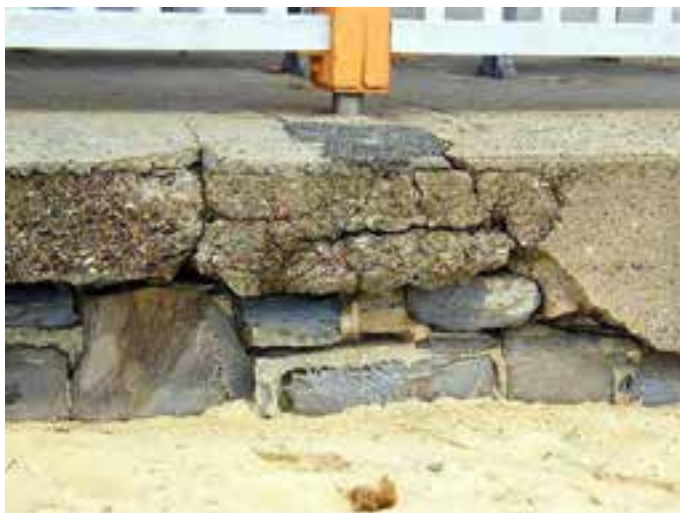
**Plate 2.4.** Low retaining /seawall seaward of the shelter sheds. The original wall is of stone blocks with mortar that is eroding. Concrete paving has been poured over this and is cracking. Much of this structure is in poor condition and could be further damaged under wave action. **Photo:** Coastal Environment 30/04/2011

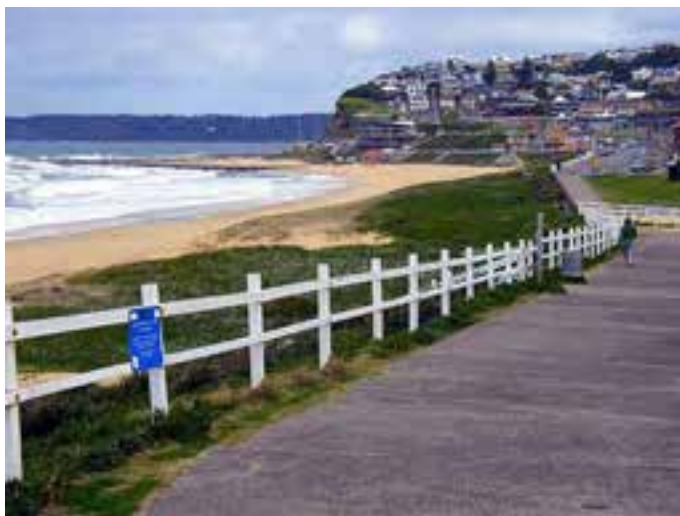
**Plate 2.5.** A sloping rock armoured revetment extends from the boat ramp at Merewether SLSC to the northern extent of the Dixon Park SLSC. This wall, constructed in the 1970s is buried beneath the existing dune. **Photo:** Coastal Environment 30/04/2011

From the boat ramp north of the Merewether SLSC to the northern side of the Dixon Park SLSC, there is a substantial rock armoured revetment, which is currently covered with dune sand and dune vegetation. CoN files (50/00509/00000/15) show the structure was built in two sections. The first section was constructed by CoN from the Merewether SLSC ramp to the intersection of Berner Street and John Parade. This was completed in 1975/76. The second section extended the wall from this intersection to the north side of the Dixon Park SLSC where it abuts a natural rock outcrop. This section was completed under a state Government Beach Improvement Program grant and completed in 1976. Both sections of wall are now buried under the vegetated dune face and no longer visible. The wall does not extend to the crest of the embankment and occasional rocks are visible along the crest. A separate concave concrete deflector wall is constructed along John Parade at ground level. This was placed to control windblown sand movement from the beach, which was a problem for back beach footpaths, roadway and development prior to dune revegetation works following the construction. Sections of this deflector fence have been recently replaced (1999) with flat fibre cement sheeting.

The revetment face is at a slope of 1V to 2H with a crest level at approximately 5m AHD and a toe level at approximately -1m AHD. The revetment face comprises two layers of primary armour (2 tonne to 5 tonne) with two layers of secondary armour and a gravel filter over the sand slope. Where existing dumped rock protection existed this has been integrated into the wall. There is no work as executed drawings for the seawall as constructed. However, the design drawings on CoN files show the wall to be comparable with current design practice. The structure and height of the wall should be assessed and surveyed when it is next exposed.

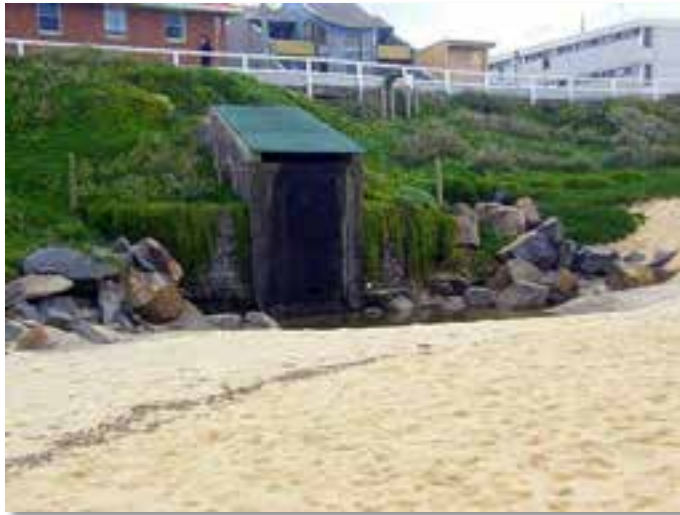
**Plate 2.6.** Stormwater outlet north of Watkins Street. Rock has been placed to protect the outlet structure which intersects the buried seawall

Overtopping modelling was undertaken at three locations between the Dixon Park SLSC and Merewether (Site 12, 13, 14, Figure 3-10). Site 12 is at the Dixon Park boat ramp at the southern end of the car park, approximately 125 m south of the SLSC. Site 13 is on John Parade near Coane Street. Site 14 is near the stormwater outlet north of Watkins Street (Plate 2.6).

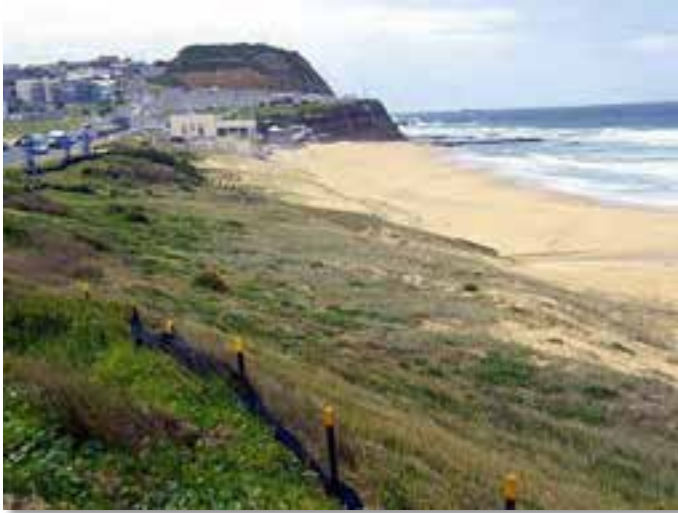
**Plate 2.7.** North of Dixon Park SLSC there is no seawall protecting the back beach north to the Cooks Hill SLSC at Bar Beach. **Photo:** Coastal Environment 30/04/2011.

backed by an elevated bluff area along Kilgour Avenue to the car park at the end of Memorial Drive and then a natural, vegetated dune system along Memorial Drive to Bar Beach (Plate 2.7). The area is underlain by bedrock with rock outcrops evident in the surf at isolated locations. Bar beach is facing south east and exposed to the predominant swell direction.

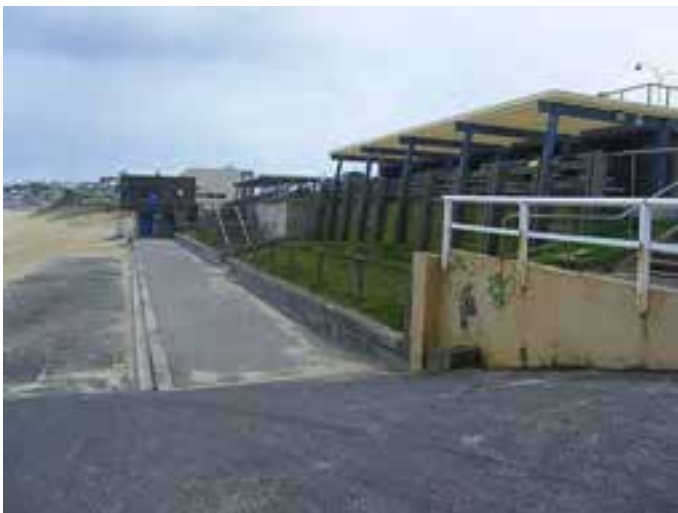
**Plate 2.8.** View north along the Bar Beach foreshore. The low level promenade is at the left. The lifeguard tower is in the background and the Cooks Hill Surf Club beyond. **Photo:** Coastal Environment 30/04/2011.

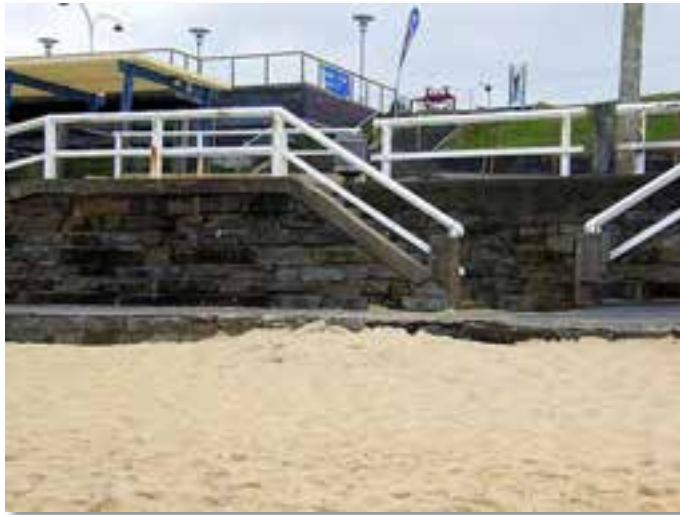
**Plate 2.9.** There are a variety of retaining structures along Bar Beach, of unknown construction. The walls behind the promenade and up the slope to the road above are unlikely to be designed for any sort of wave loadings. **Photo:** Coastal Environment 30/04/2011.

The protection structures include the seawall, paving and retaining walls up the slope behind the buildings and to the headland carpark. These walls are of early construction and appear, in the main, to be stone block walls with little or no mortar remaining. They have been intersected by access works and drainage with repairs and patched at many locations. The stormwater drainage is intermingled with the protection walls and there also appears to be redundant pipe outlets still in place. Many sections of the seawalls appear to be in poor condition, some sections at the end of their useful design life and in need of repair/replacement (Plate 2.9).

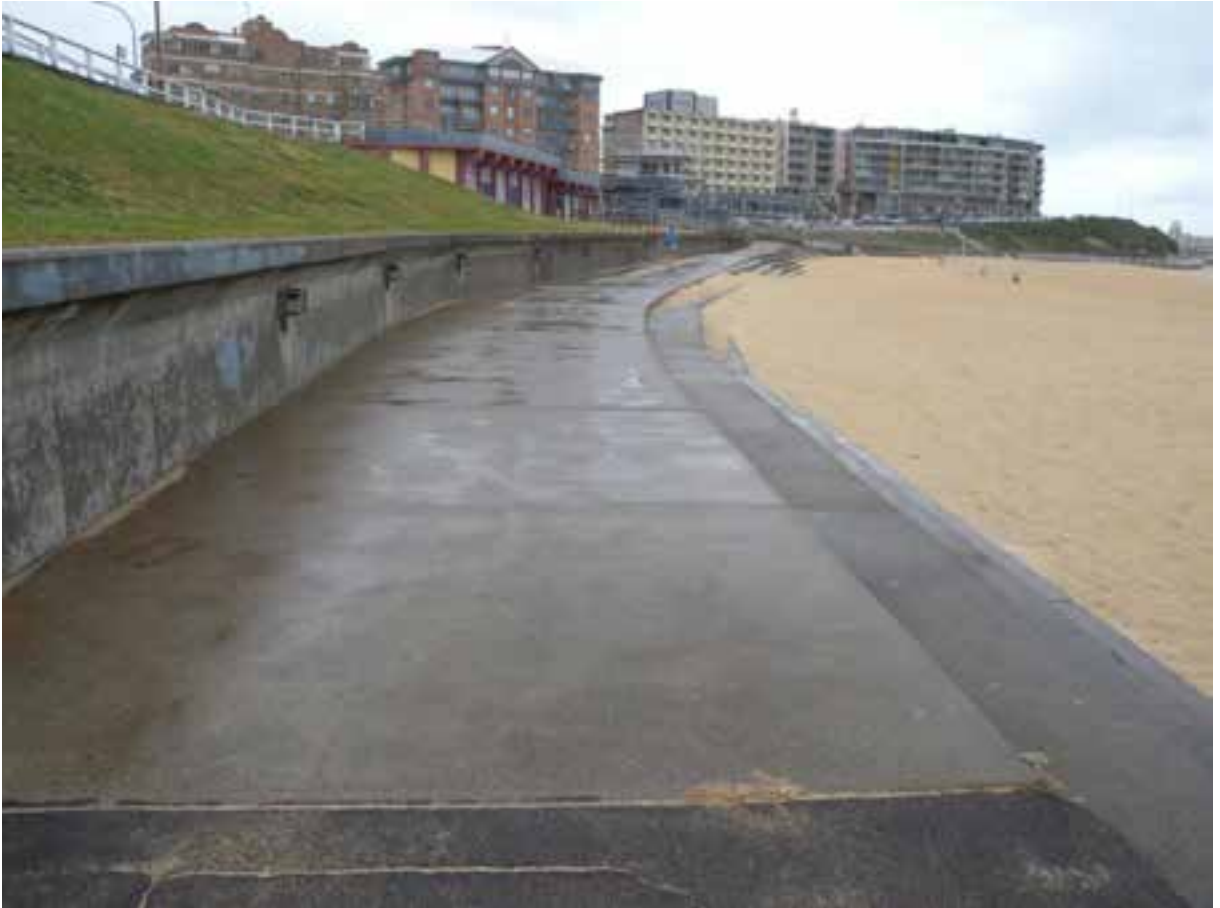
**Figure 4-9 Newcastle Beach (2011) - Promenades and Walls Back the Entire Beach**

The beach has effectively no dune system with seawalls, pavilions, Newcastle Beach surf club, a skate park and promenades constructed along the entire back beach area (Figure 4-9). At the southern end, the beach is backed by a steep cliff. Shortland Esplanade has been constructed at the base of this cliff adjacent to the beach. It is now closed to vehicular traffic and substantial stability works have been undertaken to mitigate rock falls. The roadway is open to pedestrian and cycle traffic. Discussion of the geotechnical stability of this roadway has been provided by RCA Australia (2011).

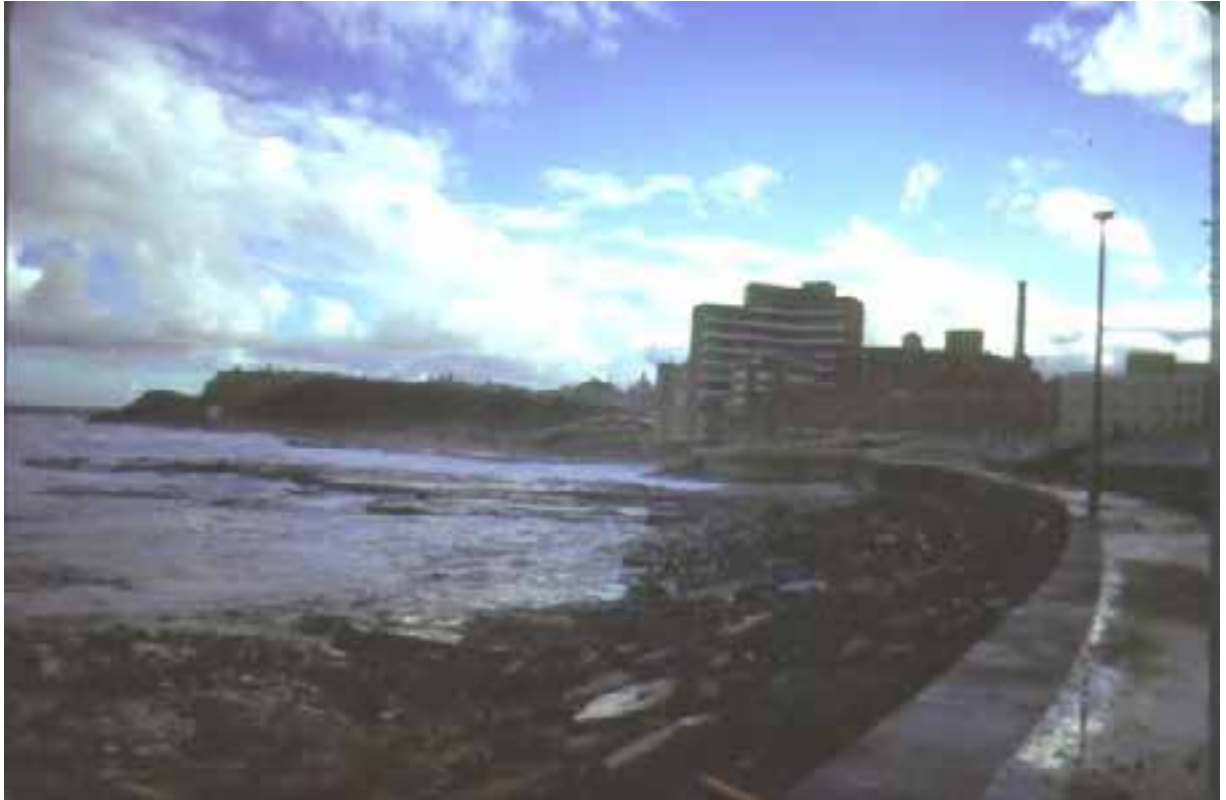
**Figure 4-10 South Newcastle Beach Erosion Extents Following Severe Storms circa 1974**

Newcastle Beach presently has a relatively wide expanse of sand. However, during storms in the past (e.g. 1974), effectively all of this sand has been removed exposing underlying bedrock and causing damage to promenades and other structures. This is demonstrated clearly in Figure 4-10 and Figure 4-11.

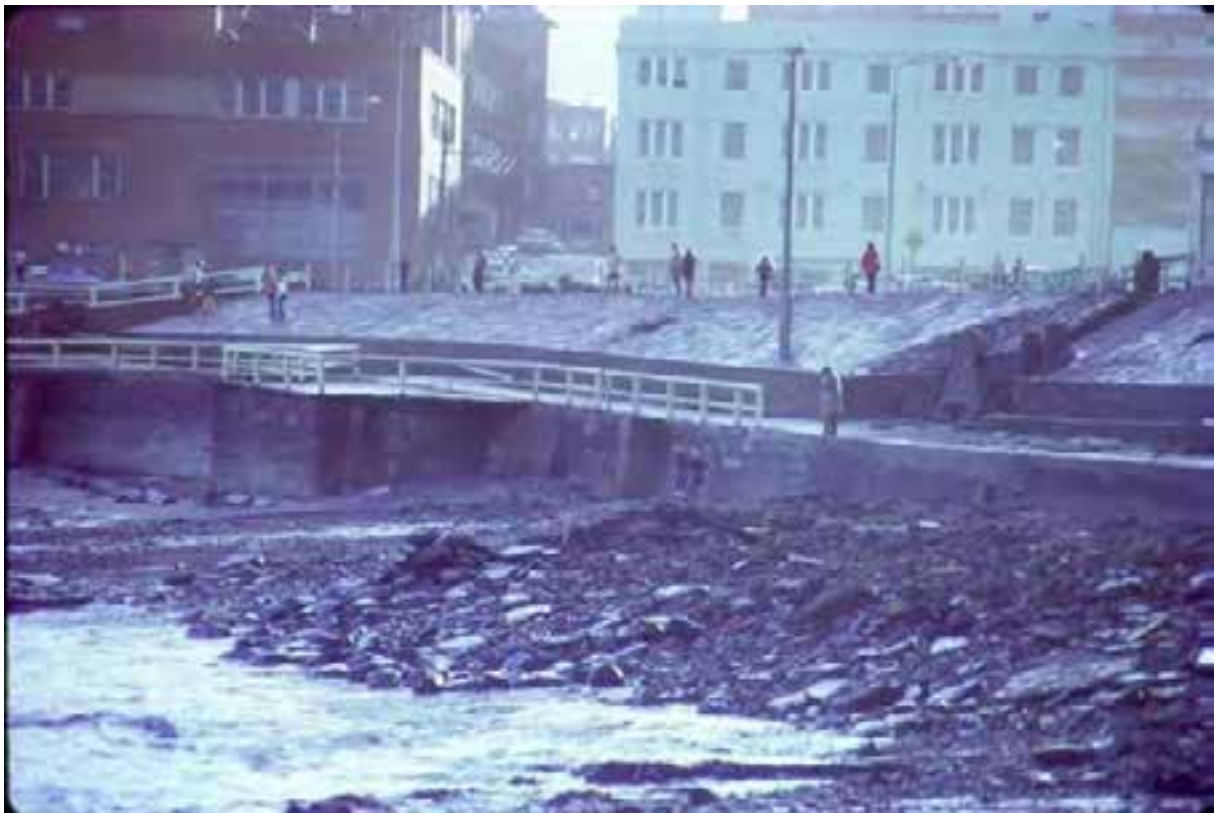
**Figure 4-11 Newcastle Beach Erosion Extents Following Severe Storms circa 1974**

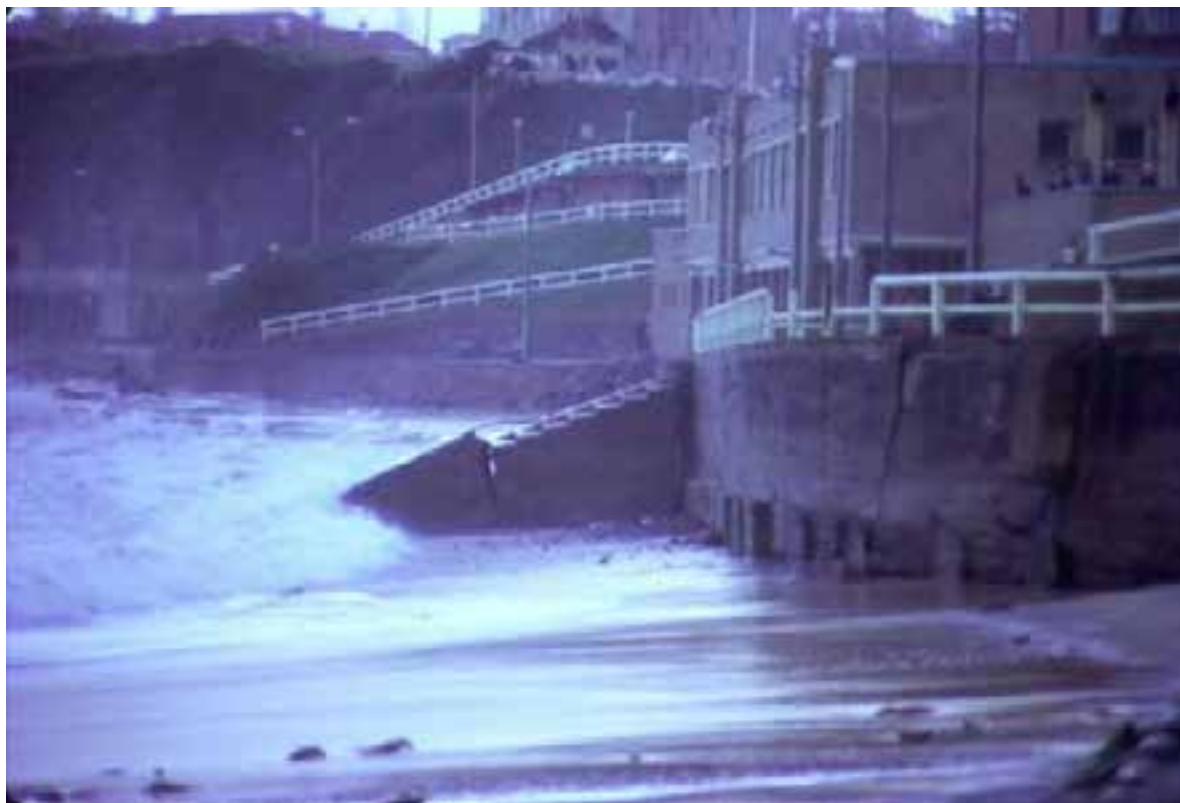
**Figure 4-14 Wave Uprush onto Promenades and Former Surf Club, Newcastle circa 1974**

The Newcastle Beach Surf Life Savings Club was replaced after the 1970s storms, however, it is still a low lying structure that could be expected to experience wave impacts during elevated ocean levels and storm conditions. Figure 4-14 demonstrates wave uprush during an erosion event of the 1970s.

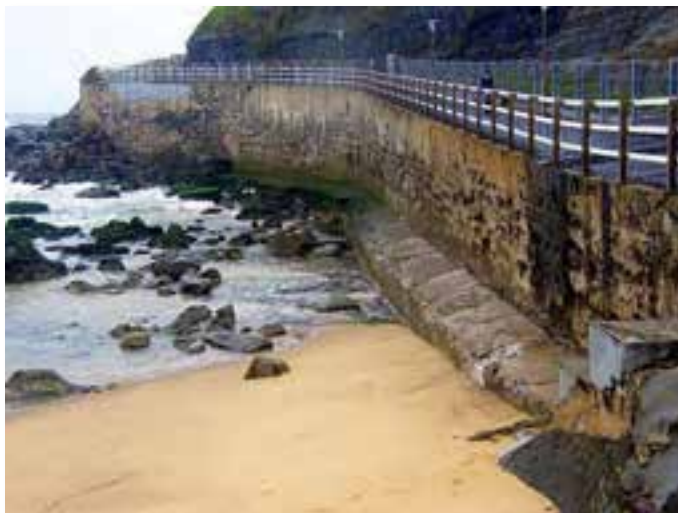
**Plate 2.10.** South Newcastle beach, old vertical rendered stone revetment protects the now closed section of Shortland Esplanade immediately behind the beach.  
**Photo:** Coastal Environment 30/04/2011.

Overtopping calculations were undertaken at four sea wall sections along Newcastle Beach and the Cowrie Hole to the north of the baths (Sites 6, 7, 8 and 9, Figure 3-10). Site 6 is landward of the Cowrie Hole and adjacent to the residential development on the western side of Shortland Esplanade (Plate 2.14). Site 7 is towards the northern end of Newcastle Beach, between the Canoe Pool and dressing sheds (Plate 2.13). Site 8 is around the centre of the beach at the bottom of Church Street. Site 9 is at the southern end of the beach adjacent to the closed section of Shortland Esplanade below Ordnance Street (Plate 2.10).

These overtopping volumes will more than double by 2050 and will increase by a factor of 4 to 8 along the central (Plate 2.12) and northern sections (Plate 2.13) by 2100. At the southern end where the crest level is lowest (Plate 2.10) the oceans storm level will be only a half metre below the promenade level by 2100. Storm waves will break across the promenade, possibly impacting the newly stabilised bluff slope 10m to 15m landward of the seawall crest. By 2100, the promenade will be unusable on many high tides and the extensive overtopping during storms may damage the seawall, paving and facilities on the promenade.

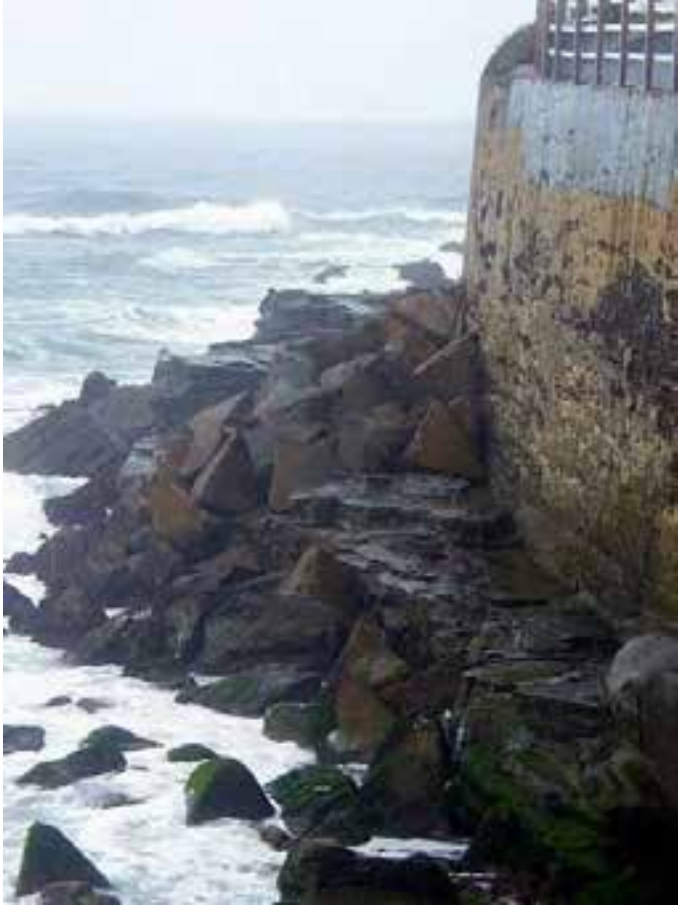
**Plate 2.11** Parts of the seawall (at least) are constructed on the rock shelf. Reclaimed tank traps have been placed at the base of the wall on the underlying rock at this most exposed location. The stone block construction can be inferred through the render, (similar to plate 2.15). Repairs to the upper section of the wall are clearly visible.

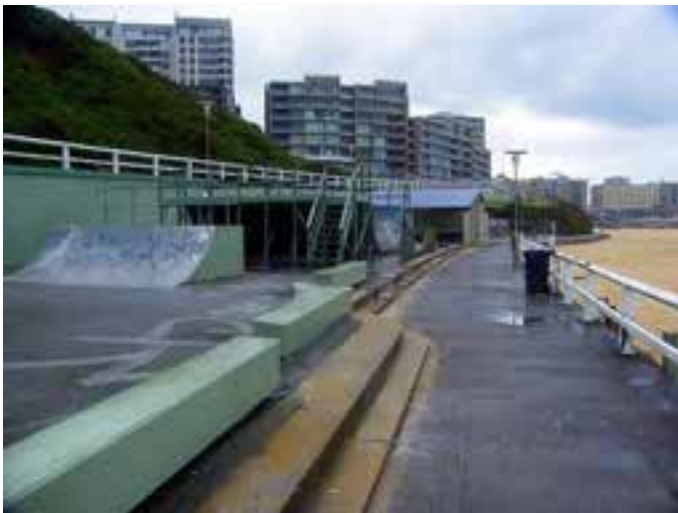
**Plate 2.12.** A low level promenade runs around the foreshore from south end of Newcastle Beach to the Canoe Pool. A vertical seawall faces the promenade with low crest level. Structures and retaining walls are located landward of this seawall, at the base of the slope up to Shortland Esplanade above.

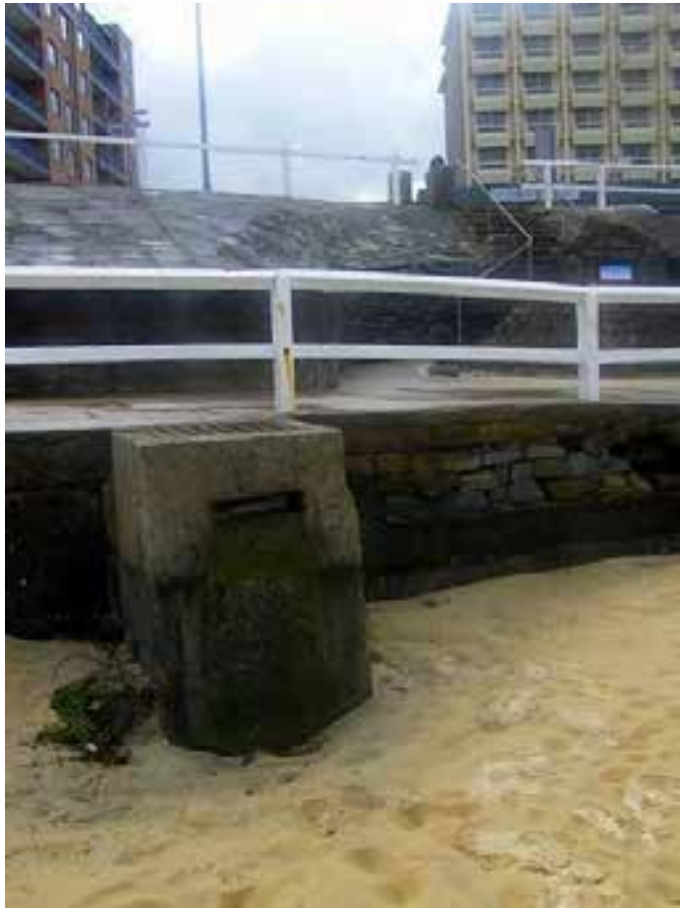
**Plate 2.13.** At Newcastle Beach there are a range of protection structures at a low level separating the walkways, change sheds and paved areas from the sandy beach. These are of variable quality and largely undocumented construct. Stormwater services are intertwined with the protection works. **Photo:** Coastal Environment 30/04/2011.

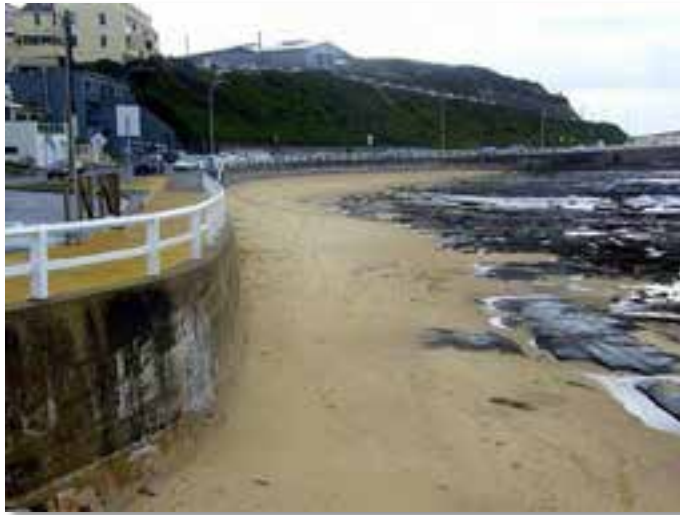
**Plate 2.14.** North of Newcastle baths, the old near vertical seawall continues along the shoreline to Nobbys Head. Again this seawall appears to be constructed on the rock shelf along Shortland Esplanade. Construction and foundation details are unknown.  
**Photo:** Coastal Environment 30/04/2011.

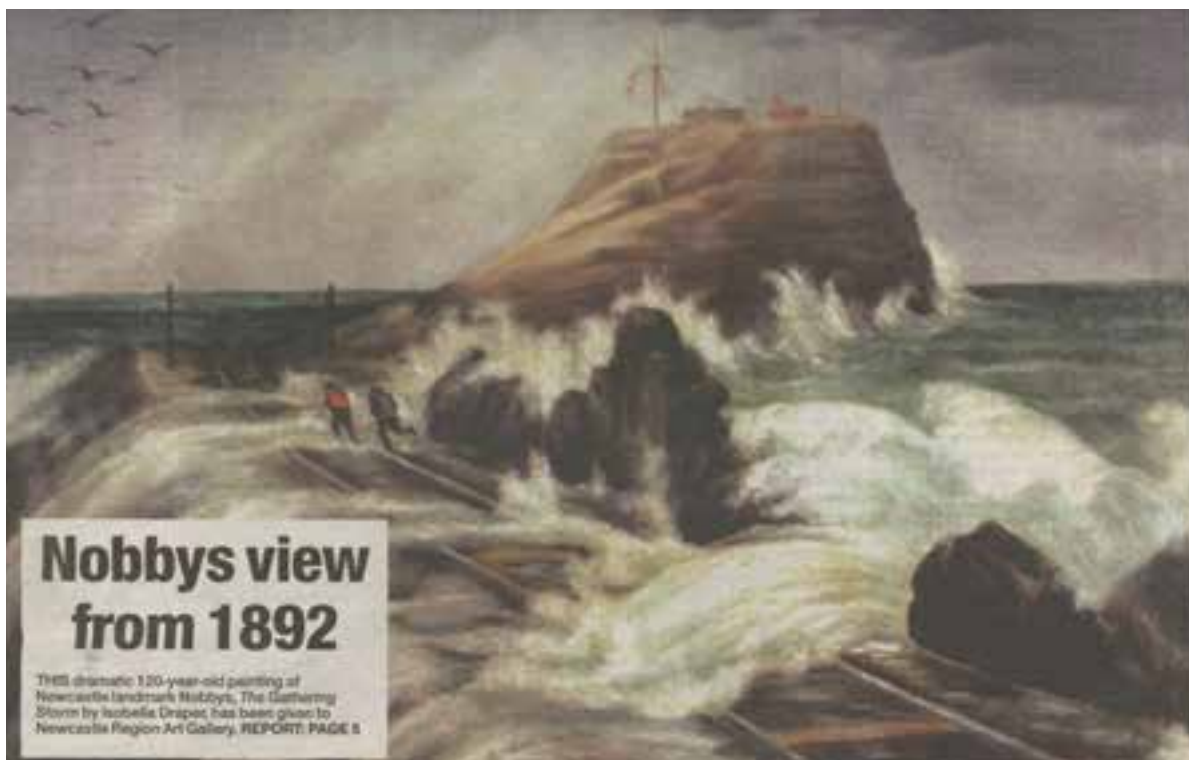
**Figure 4-15 Historical Painting of Nobbys Beach following Construction of Macquarie Pier (Newcastle Herald, 29 Sep 2010)**

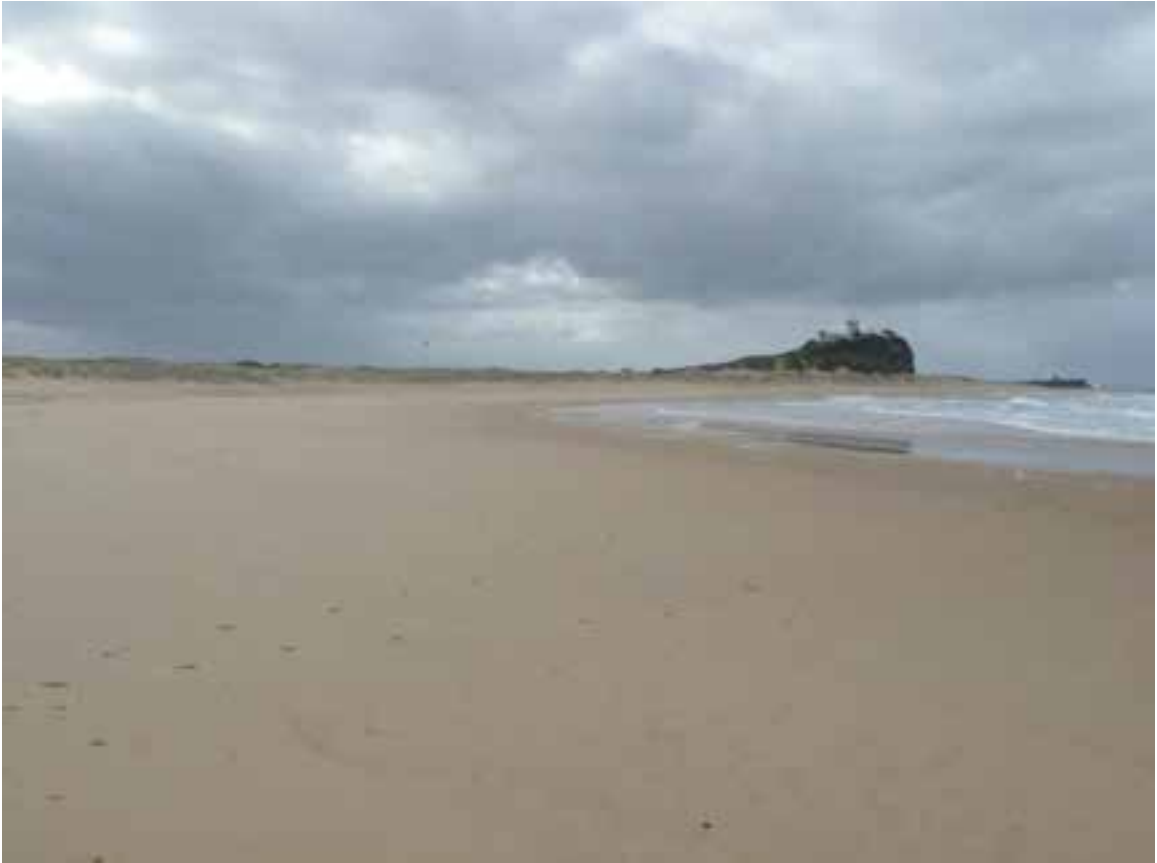
**Figure 4-16 Nobbys Beach at Present (2011)**

Nobbys Beach is essentially formed from the accretion of littoral drift sediment against the southern breakwater. The construction of the Hunter River entrance breakwaters commenced with a land bridge out to Nobbys Island completed in 1846, then the extension of the southern breakwater from Nobbys Island was completed in 1896. Historical paintings of Nobbys (Figure 4-15) at the time of the breakwater construction clearly illustrate waves breaking up onto the breakwater. The southern breakwater has interrupted the net northerly littoral drift, effectively capturing it against the breakwater to form Nobbys Beach (Figure 4-16).

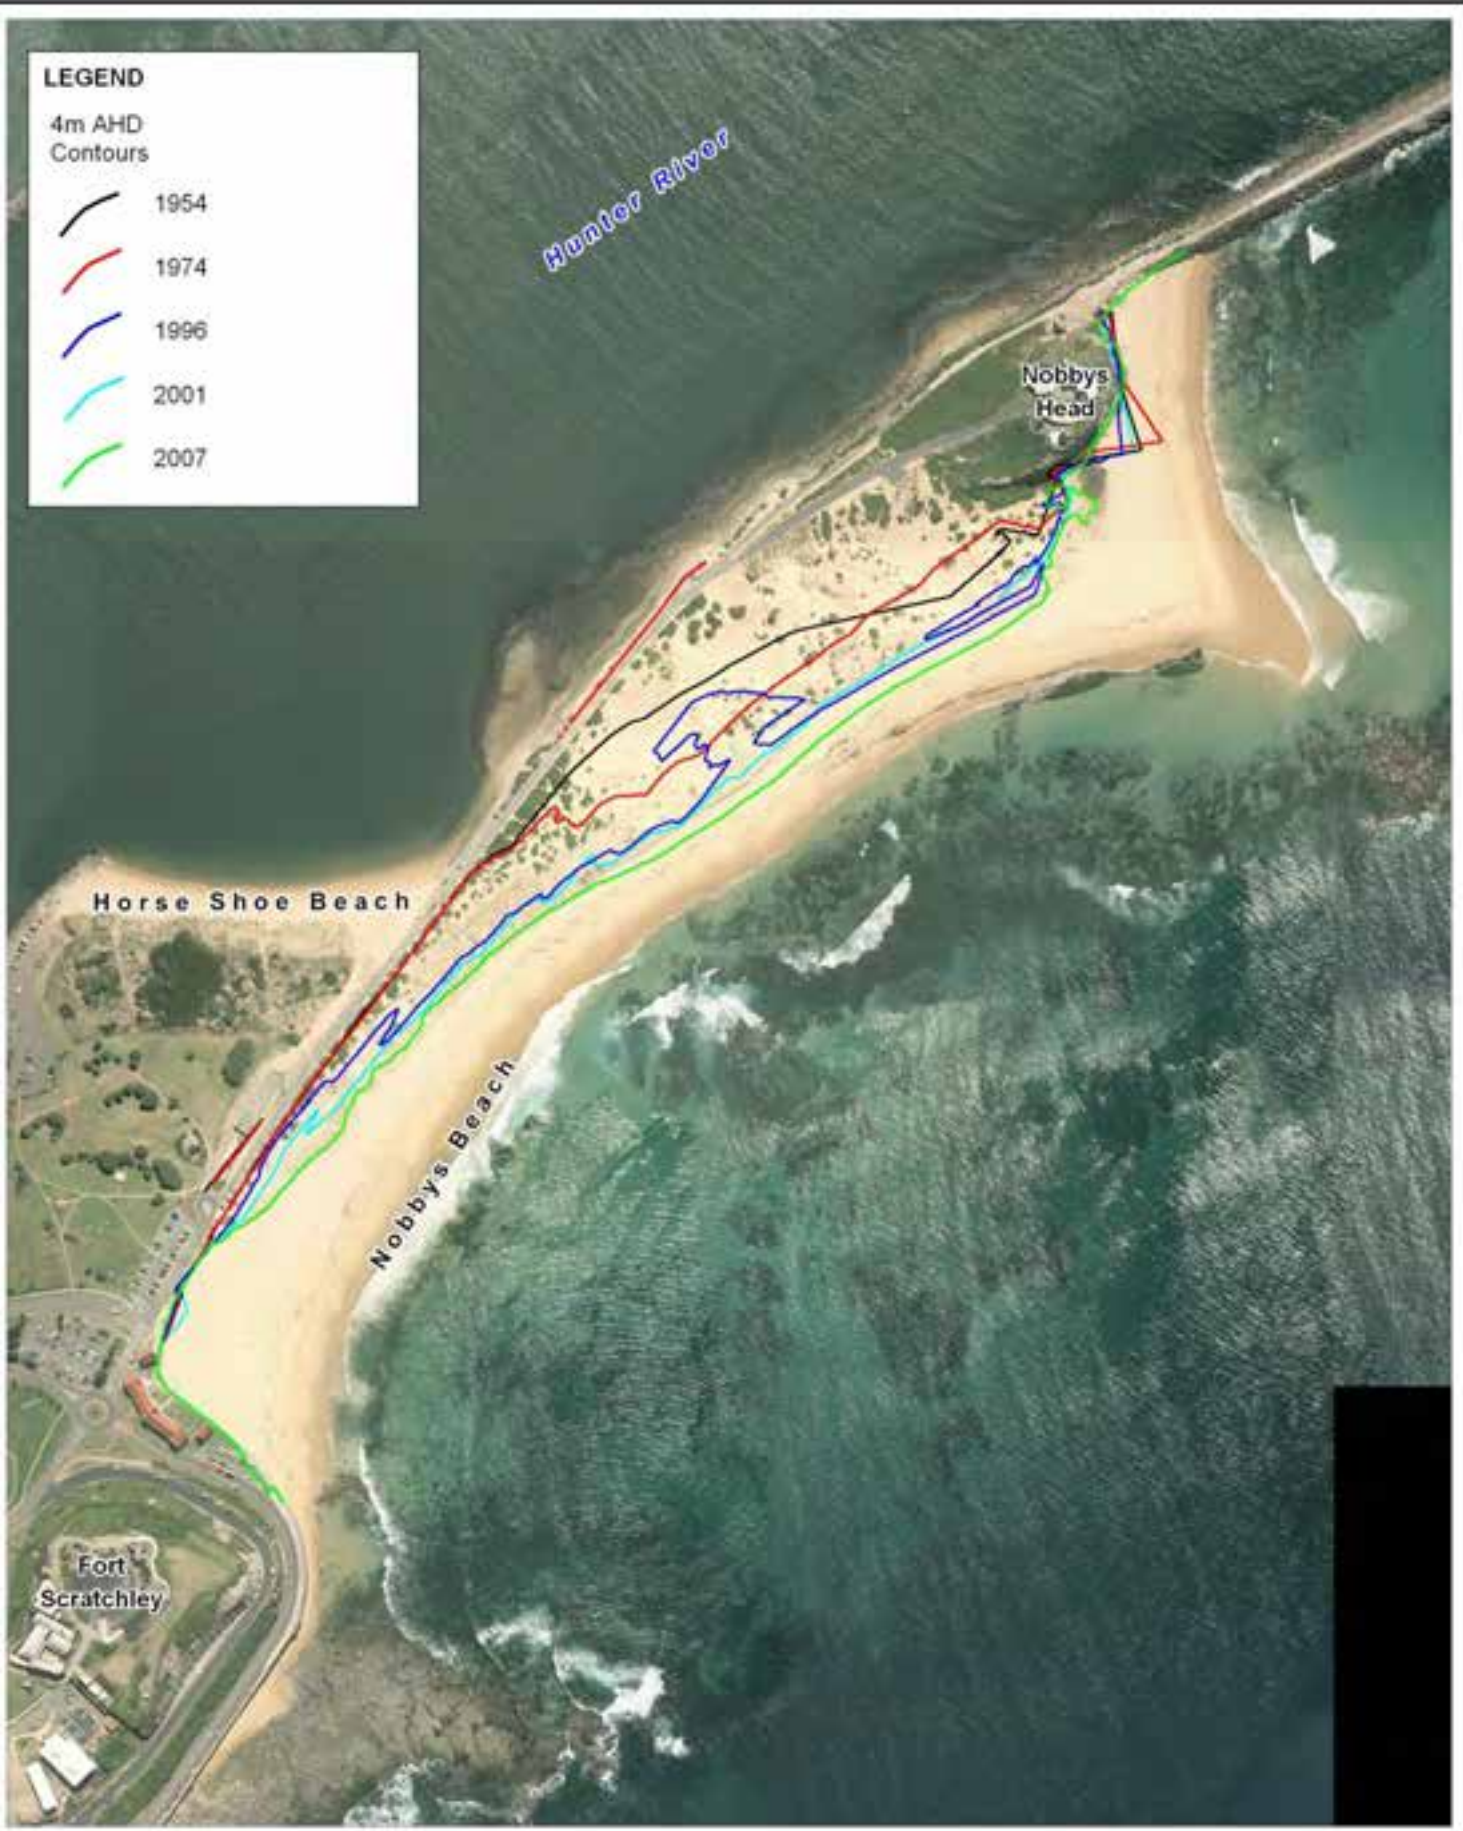
Drawing: <b>4-19</b>	Rev: <b>A</b>
-------------------------	------------------

Title:  
**Position of the 4 m AHD Contour Over Time,  
Nobbys Beach**

The photogrammetric data for Nobbys Beach demonstrates accretion of sand in the past, which has slowed and stabilised to the present position. For example, in the photogrammetric cross section in Figure 4-17, the formation of incipient dunes which have then been transported through wind landward to form a dune, then the formation of incipient dunes again is clearly evident, illustrating the processes through which the beach and dune system has formed. Contour plots for the 2 m and 4 m AHD position show a similar pattern of growth which has slowed to present, in Figure 4-18 and Figure 4-19.
