# Newcastle Coastal Zone Hazards Study

## *Final Report*

Prepared For: City of Newcastle

Prepared By: BMT WBM Pty Ltd (Member of the BMT group of companies)

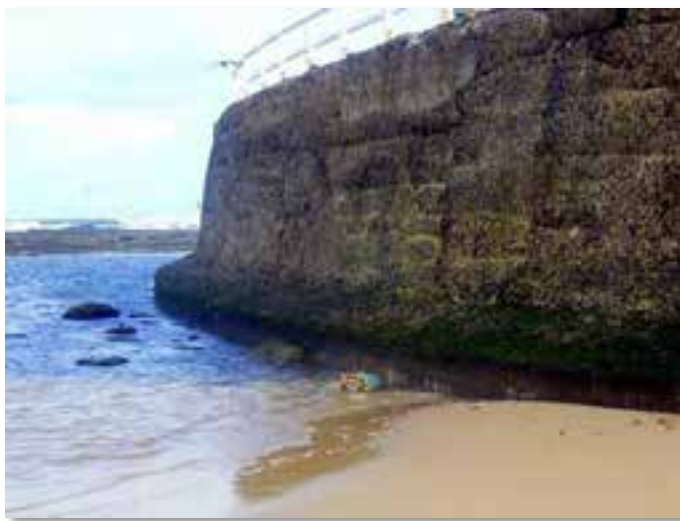
**Plate 2.15.** Exposed section of the seawall at the south end of Nobbys Beach suggests a construction of stone blocks, possibly with a later addition of render. A substantial toe section can be seen and appears to be founded on the rock shelf. **Photo:** Coastal Environment 30/04/2011.

**Plate 2.11** Parts of the seawall (at least) are constructed on the rock shelf. Reclaimed tank traps have been placed at the base of the wall on the underlying rock at this most exposed location. The stone block construction can be inferred through the render, (similar to plate 2.15). Repairs to the upper section of the wall are clearly visible.

At the eastern end of Nobbys SLSC (Site 5), the beach is oriented to the north east and sheltered from the predominant swell, but exposed to the east and north east. The seawall is a vertical concrete wall of unknown construction. There is an accumulation of sand in front of the wall and the lower sections and toe are not visible. To the east there is rock exposed in the surf zone, adjacent to the continuing vertical seawall connected with Shortland Esplanade (Plate 2.16 and 2.15 to the south).

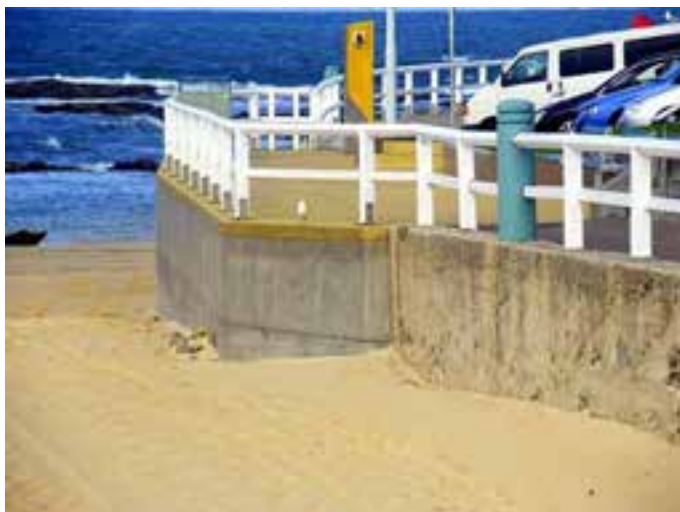
**Plate 2.16.** South of the SLSC and shelter shed, the roadway has been widened and a section of reinforced concrete seawall constructed. **Photo:** Coastal Environment 30/04/2011.

The crest level of the vertical seawall at Site 5 is 4.0 m AHD (estimated from 2007 LiDAR survey) and the level of the toe is not known. The overtopping assessment shows the potential for increasing overtopping rates to the east as the exposure of the wall increases. At this location (Plate 2.16) overtopping at present for peak storm conditions is 107.8 l/s/m which is unacceptable for pedestrian traffic and of concern for motor vehicles. Indeed, this section of wall (such as shown in Plate 2.15) is already known to overtop at high tide. This overtopping rate will continue to increase, doubling by 2050 and increasing by a factor of 8 to 2100. By that time the overtopping is estimated at 846 l/s/m and may result in damage to the paving behind the seawall and possibly to the seawall itself.

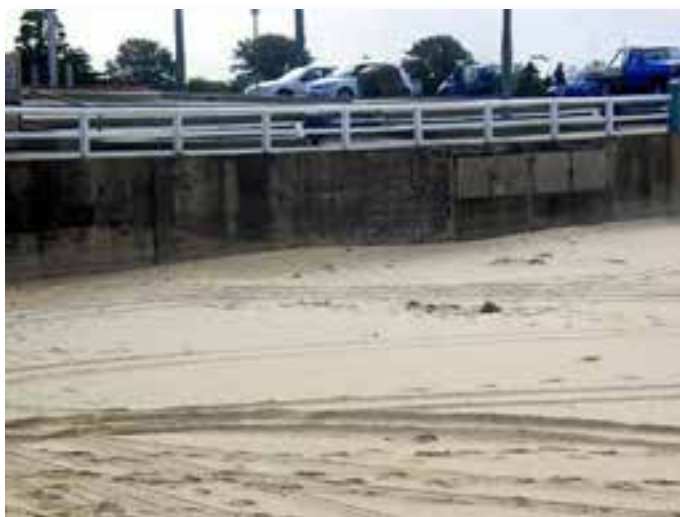
**Plate 2.17.** Along the northern section of Nobbys Beach there is a vertical seawall adjacent to the carpark. Construction details are unknown. The whole of Nobbys Beach to the north is backed by the early 19th century construction of Macquarie Pier joining Nobbys Head to the mainland. **Photo:** Coastal Environment 30/04/2011.

At the southern end of Nobbys Beach (Site 4), the beach is facing south-east and exposed to the predominant swell direction. The back beach is protected by a vertical, concrete finished wall of unknown construction (Plate 2.17). There is a buildup of sand to the north in front of the wall and the lower part of the wall and toe are not visible. Further north the wall disappears beneath the sand

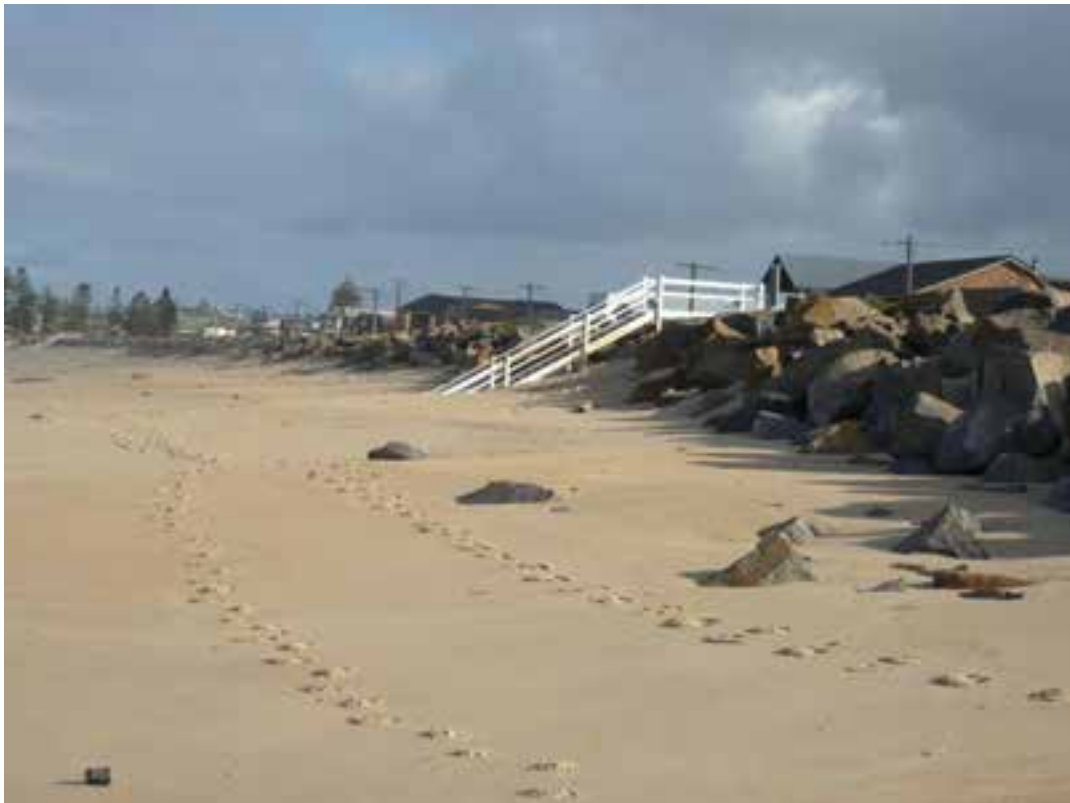
Figure 4-20 Stockton Beach (June 2011) With Sand Accreted Onto Mitchell St Seawall

At the present time, Stockton Beach is in a relatively accreted state, following suitable wave climate conditions. For example, in Figure 4-20 a wide berm and accretion onto Mitchell Street seawall is

The Mitchell Street seawall was constructed in 1989 and extends along 550 metres of the Stockton beach frontage between Pembroke Street in the south and Stone Street in the north (as shown in Figure 4-20 and Figure 4-22). Information on the wall design is recorded in the Newcastle City CoN files (50/00502/00000/13). The wall was constructed to a design prepared by the NSW Public Works Department. It comprises two layers of primary armour stone (3.2 tonne to 5.3 tonne) at a slope of 1V to 1.5H, and two layers of secondary armour with a geotextile filter underlayer. The crest of the

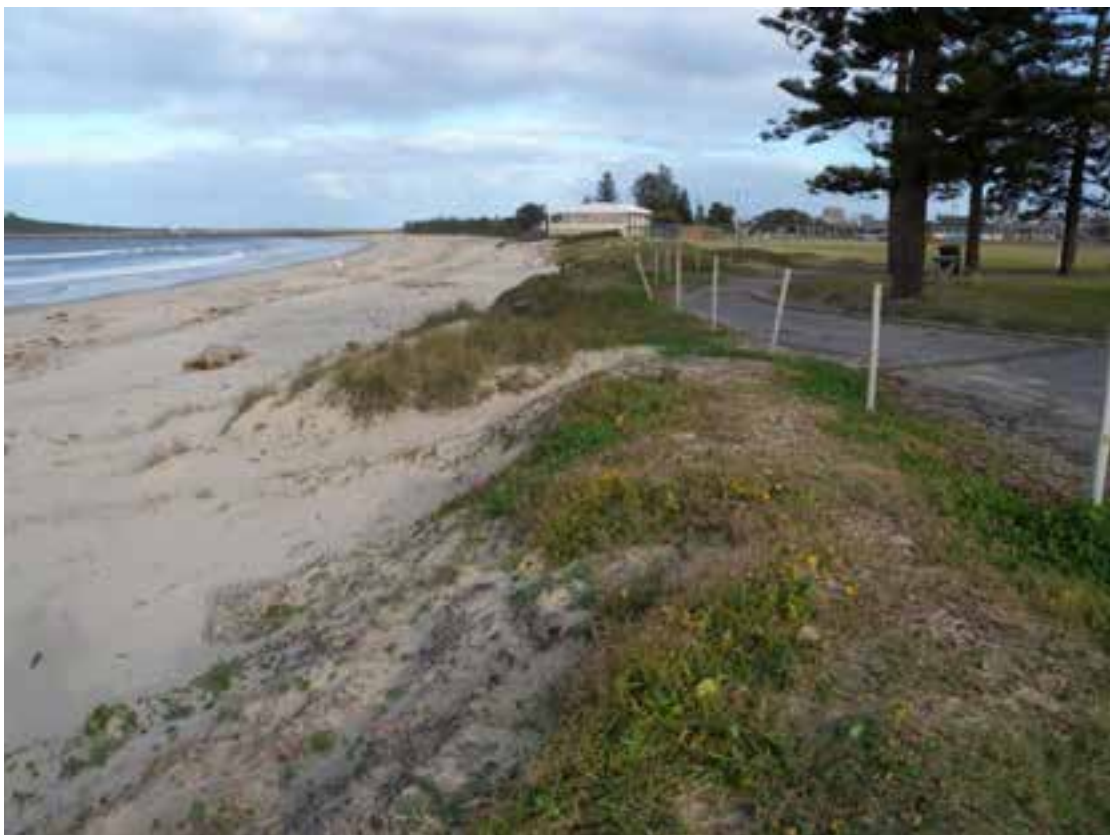
Figure 4-21 Stockton Beach (June 2011) Looking South to the Surf Club

evident; and Figure 4-21 illustrates accretion over former erosion escarpments north of the Stockton Surf Club.

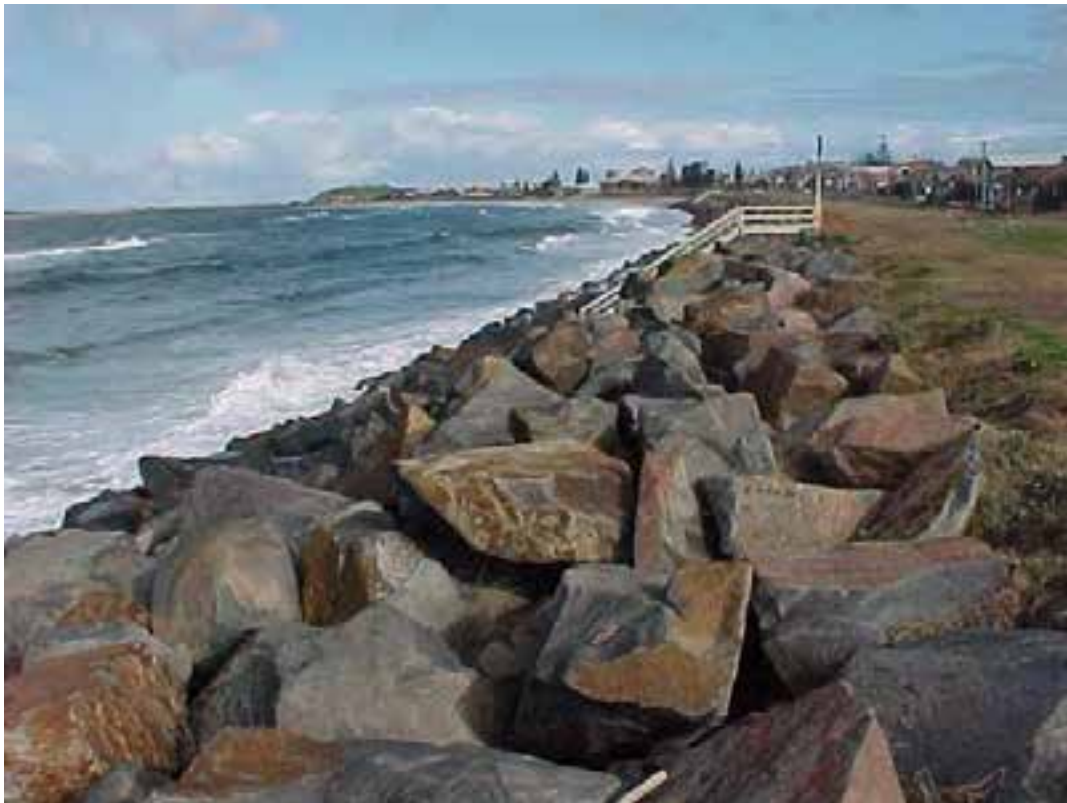
**Figure 4-22 Stockton Beach (July 1999) Without Sand at Mitchell St Seawall**

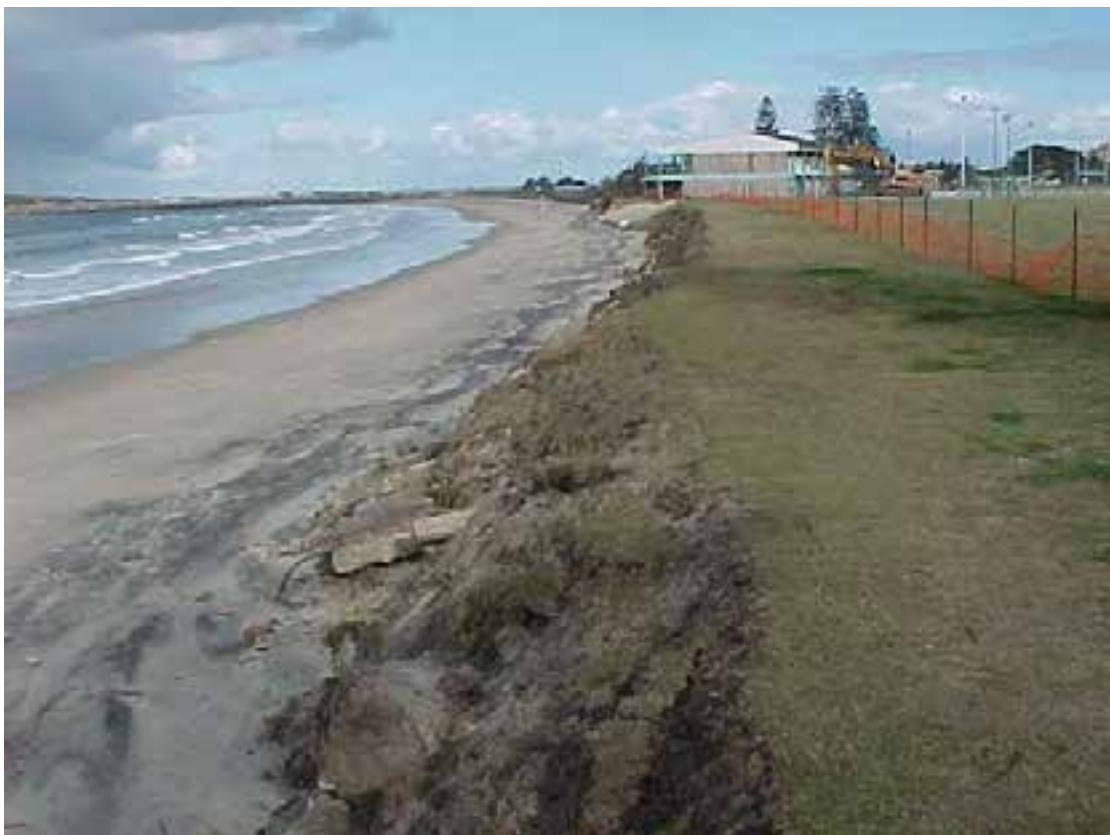
**Figure 4-23 Stockton Beach (July 1999) Looking South to the Surf Club**

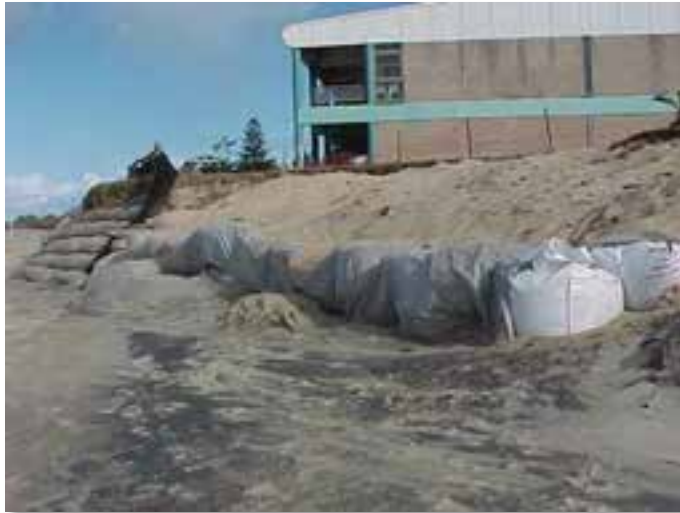
**Plate 2.18.** A temporary geotextile sand filled container wall was constructed in 1996 to protect the Stockton Surf Club building. This has recently been upgraded and extended further north. There are no formal protection works between the Surf Club and the Mitchell St. seawall. **Photo:** BMT WBM 26/07/1999.

The old and the new revetments are constructed of sand filled geotextile containers on a geotextile underlayer. The crest level varies from about 4.0 m AHD on the original works to 4.4 m AHD for the more recent works (GBA, 2010). The original section appears to have a toe level about -1.5m AHD and the more recent section is slightly elevated with the toe at -1.0m AHD. Both walls are constructed at a slope of 1.0V to 1.5H. The design life quoted for the most recent works is 20 years while the older section in front of the SLSC has exceeded its design life but is still in place. The older section of works were tested during a storm around 2000 when the structure was overtopped with water and sand washing through the ground floor of the SLSC (GBA, 2010).

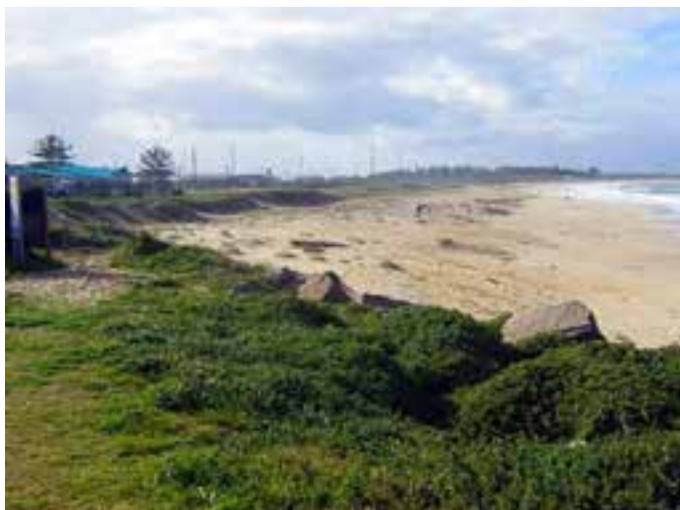
**Plate 2.20.** North of the end of the Mitchell St seawall at Stone St., there is no protection of the back beach area which has eroded into the dune fronting the child care centre and further north. **Photo:** Coastal Environment 30/04/2011.

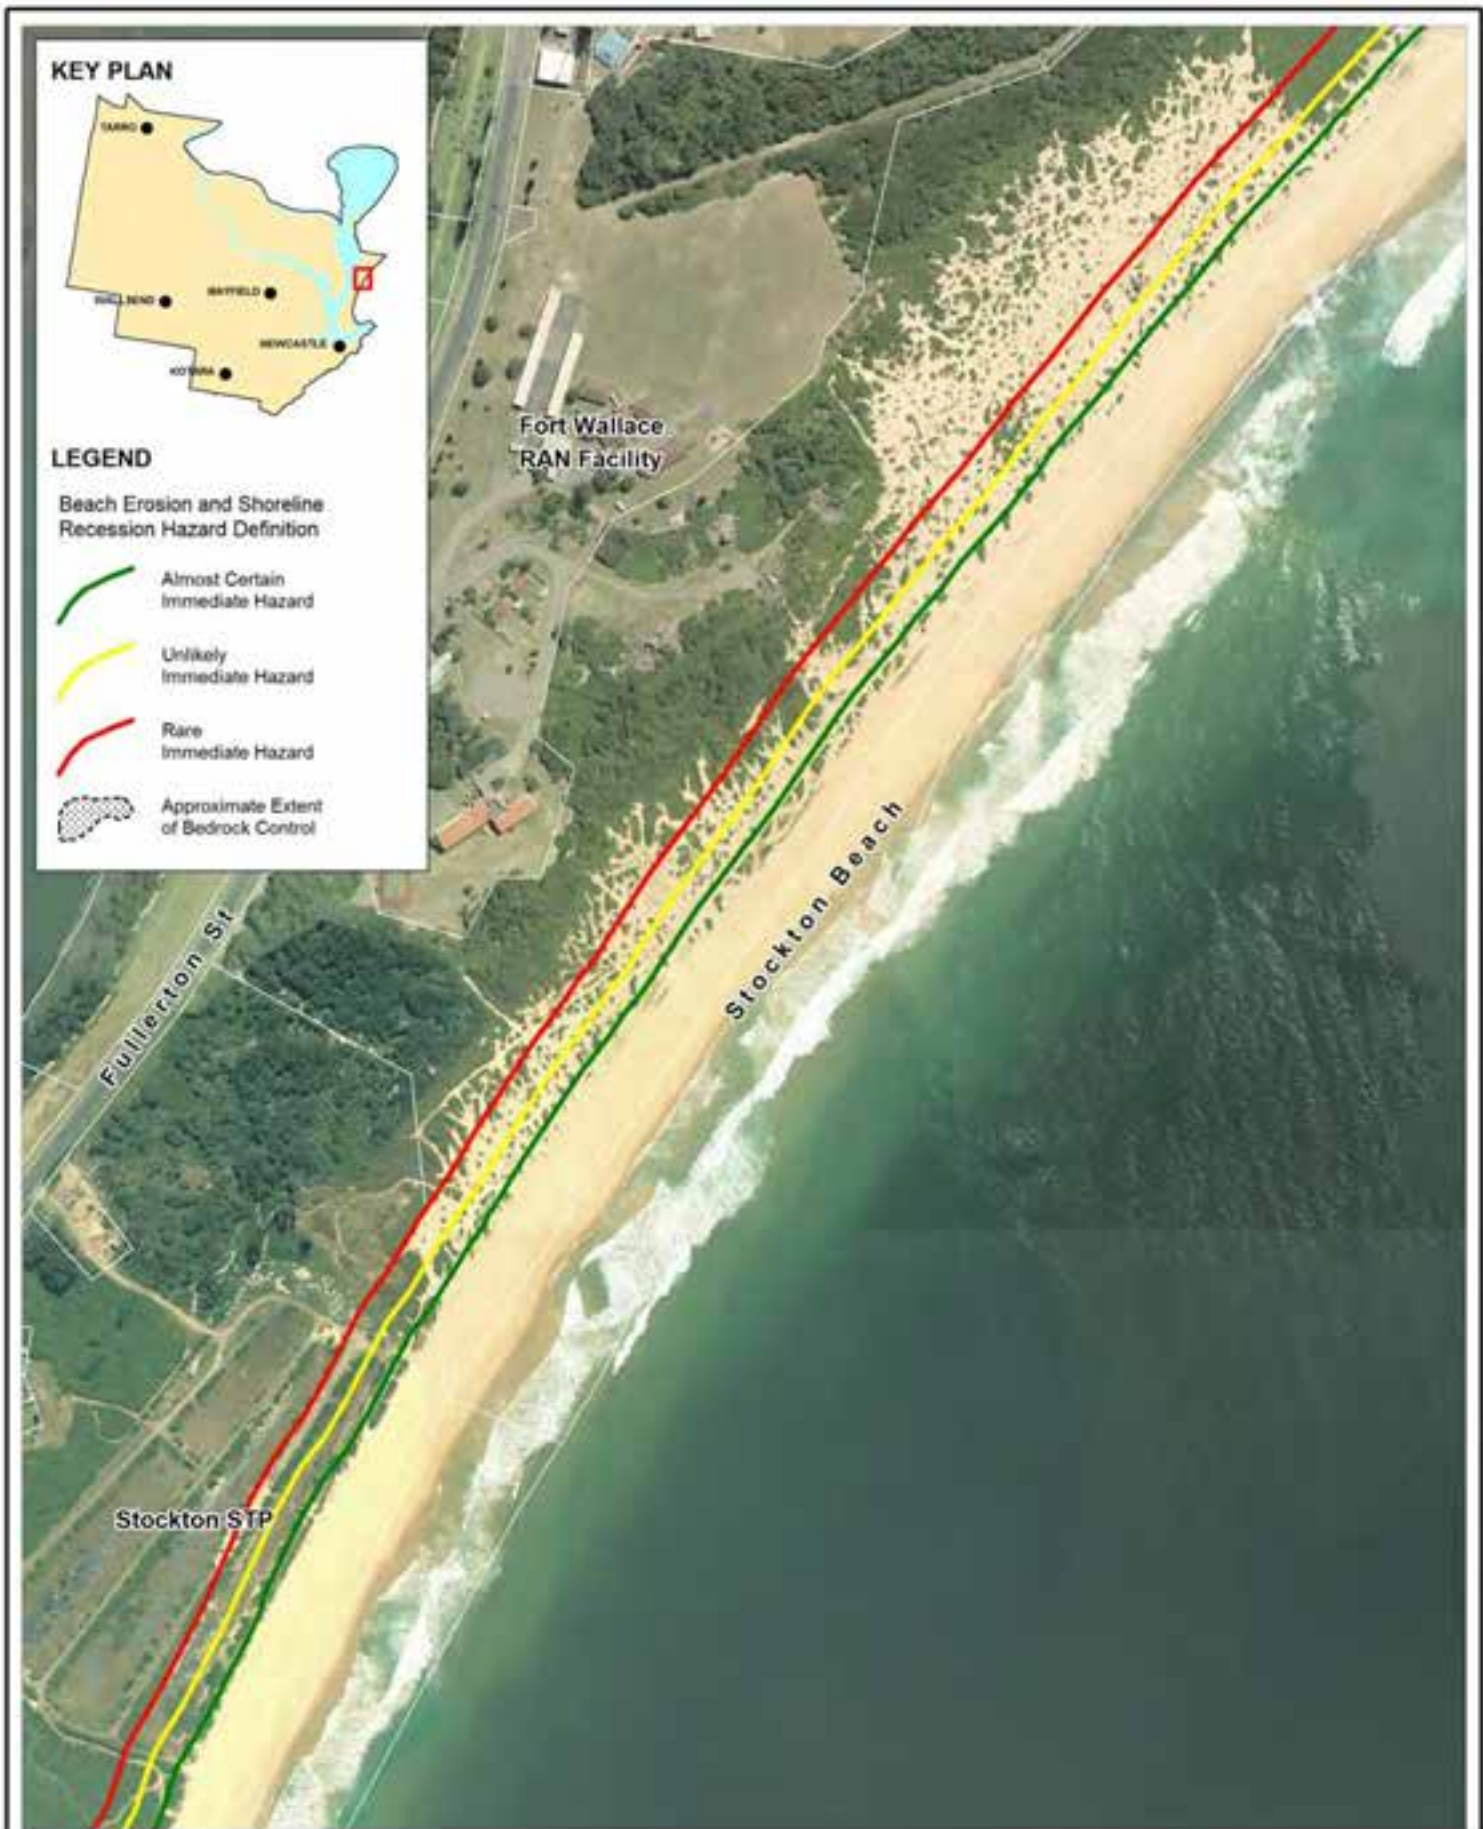
Figure:  
**A-2**

Title:  
**Erosion and Recession Hazard Definition  
 Immediate Planning Horizon - Fort Wallace**

<sup>1</sup> Erosion distances increase in a northerly direction, see Hazard Maps, Figures A-1 to A-4

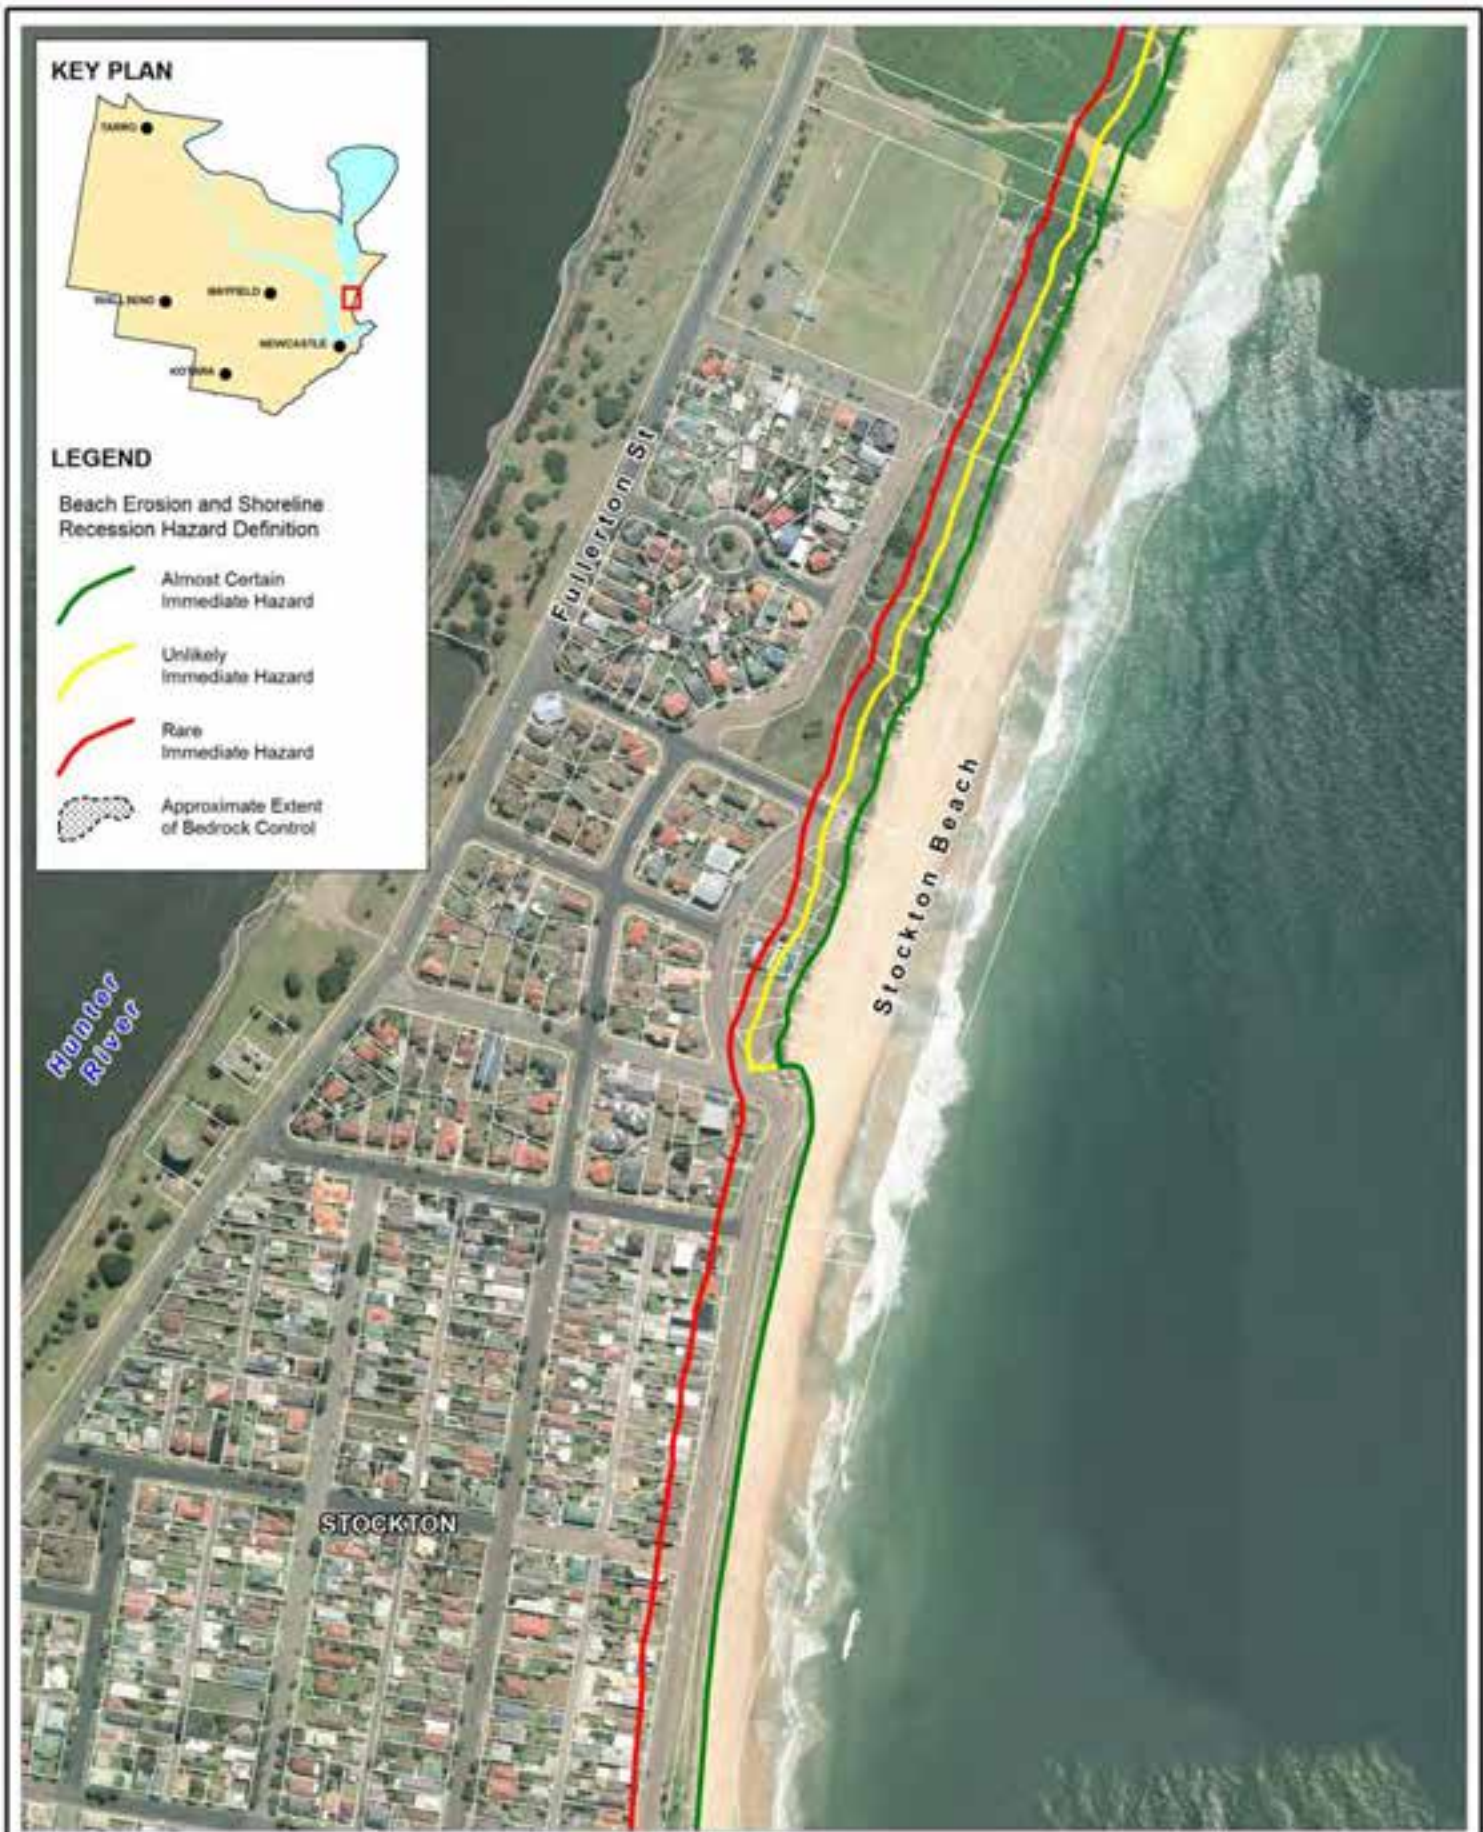
Figure:  
**A-3**

Title:  
**Erosion and Recession Hazard Definition  
 Immediate Planning Horizon - Stockton North**

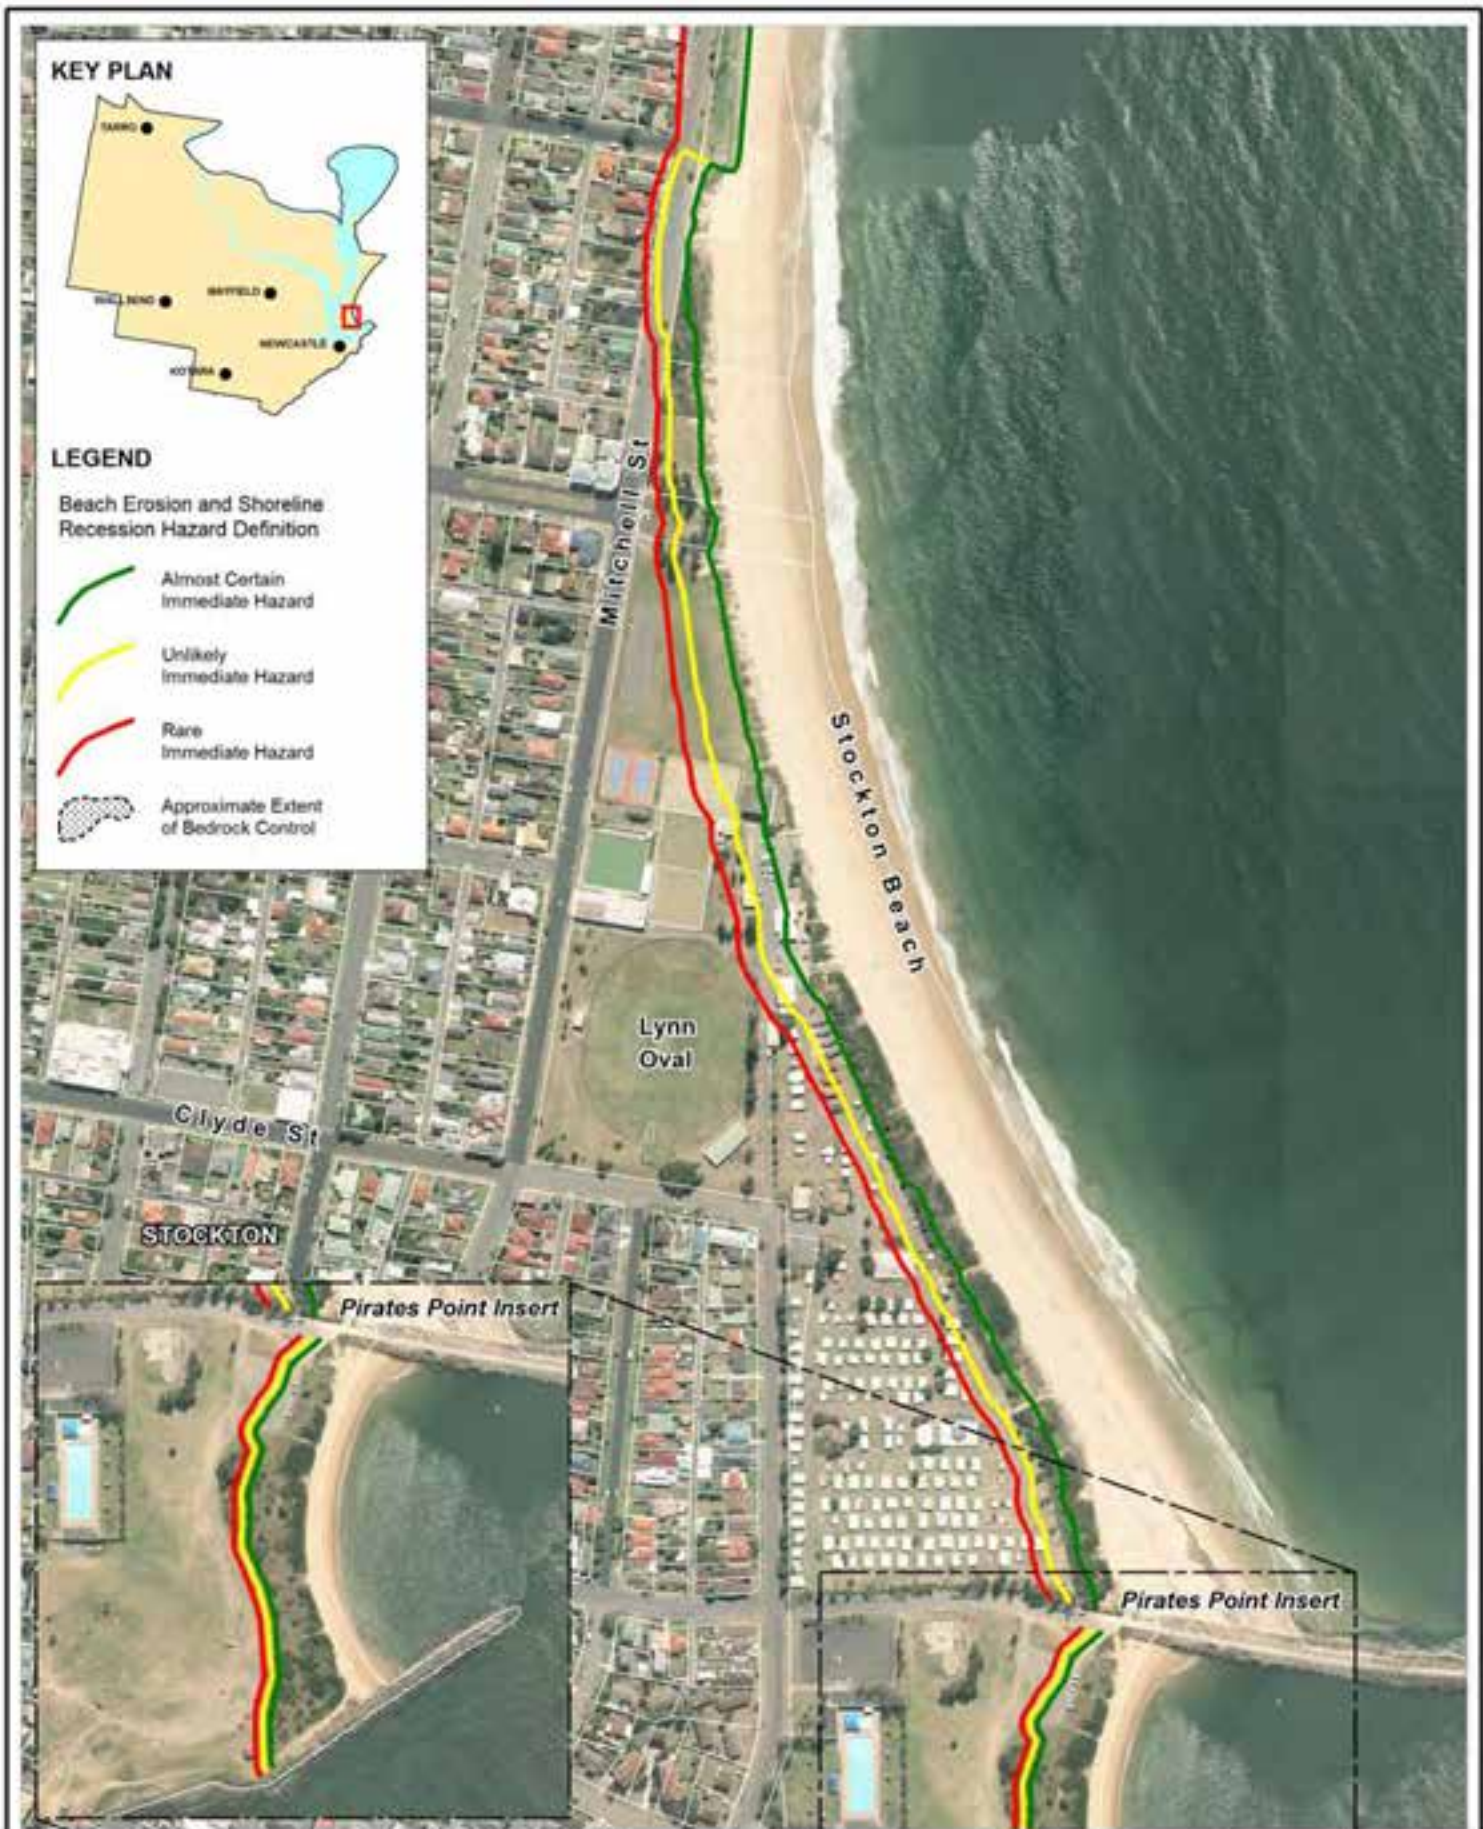
Figure:  
**A-4**

Title:  
**Erosion and Recession Hazard Definition  
 Immediate Planning Horizon - Stockton South**

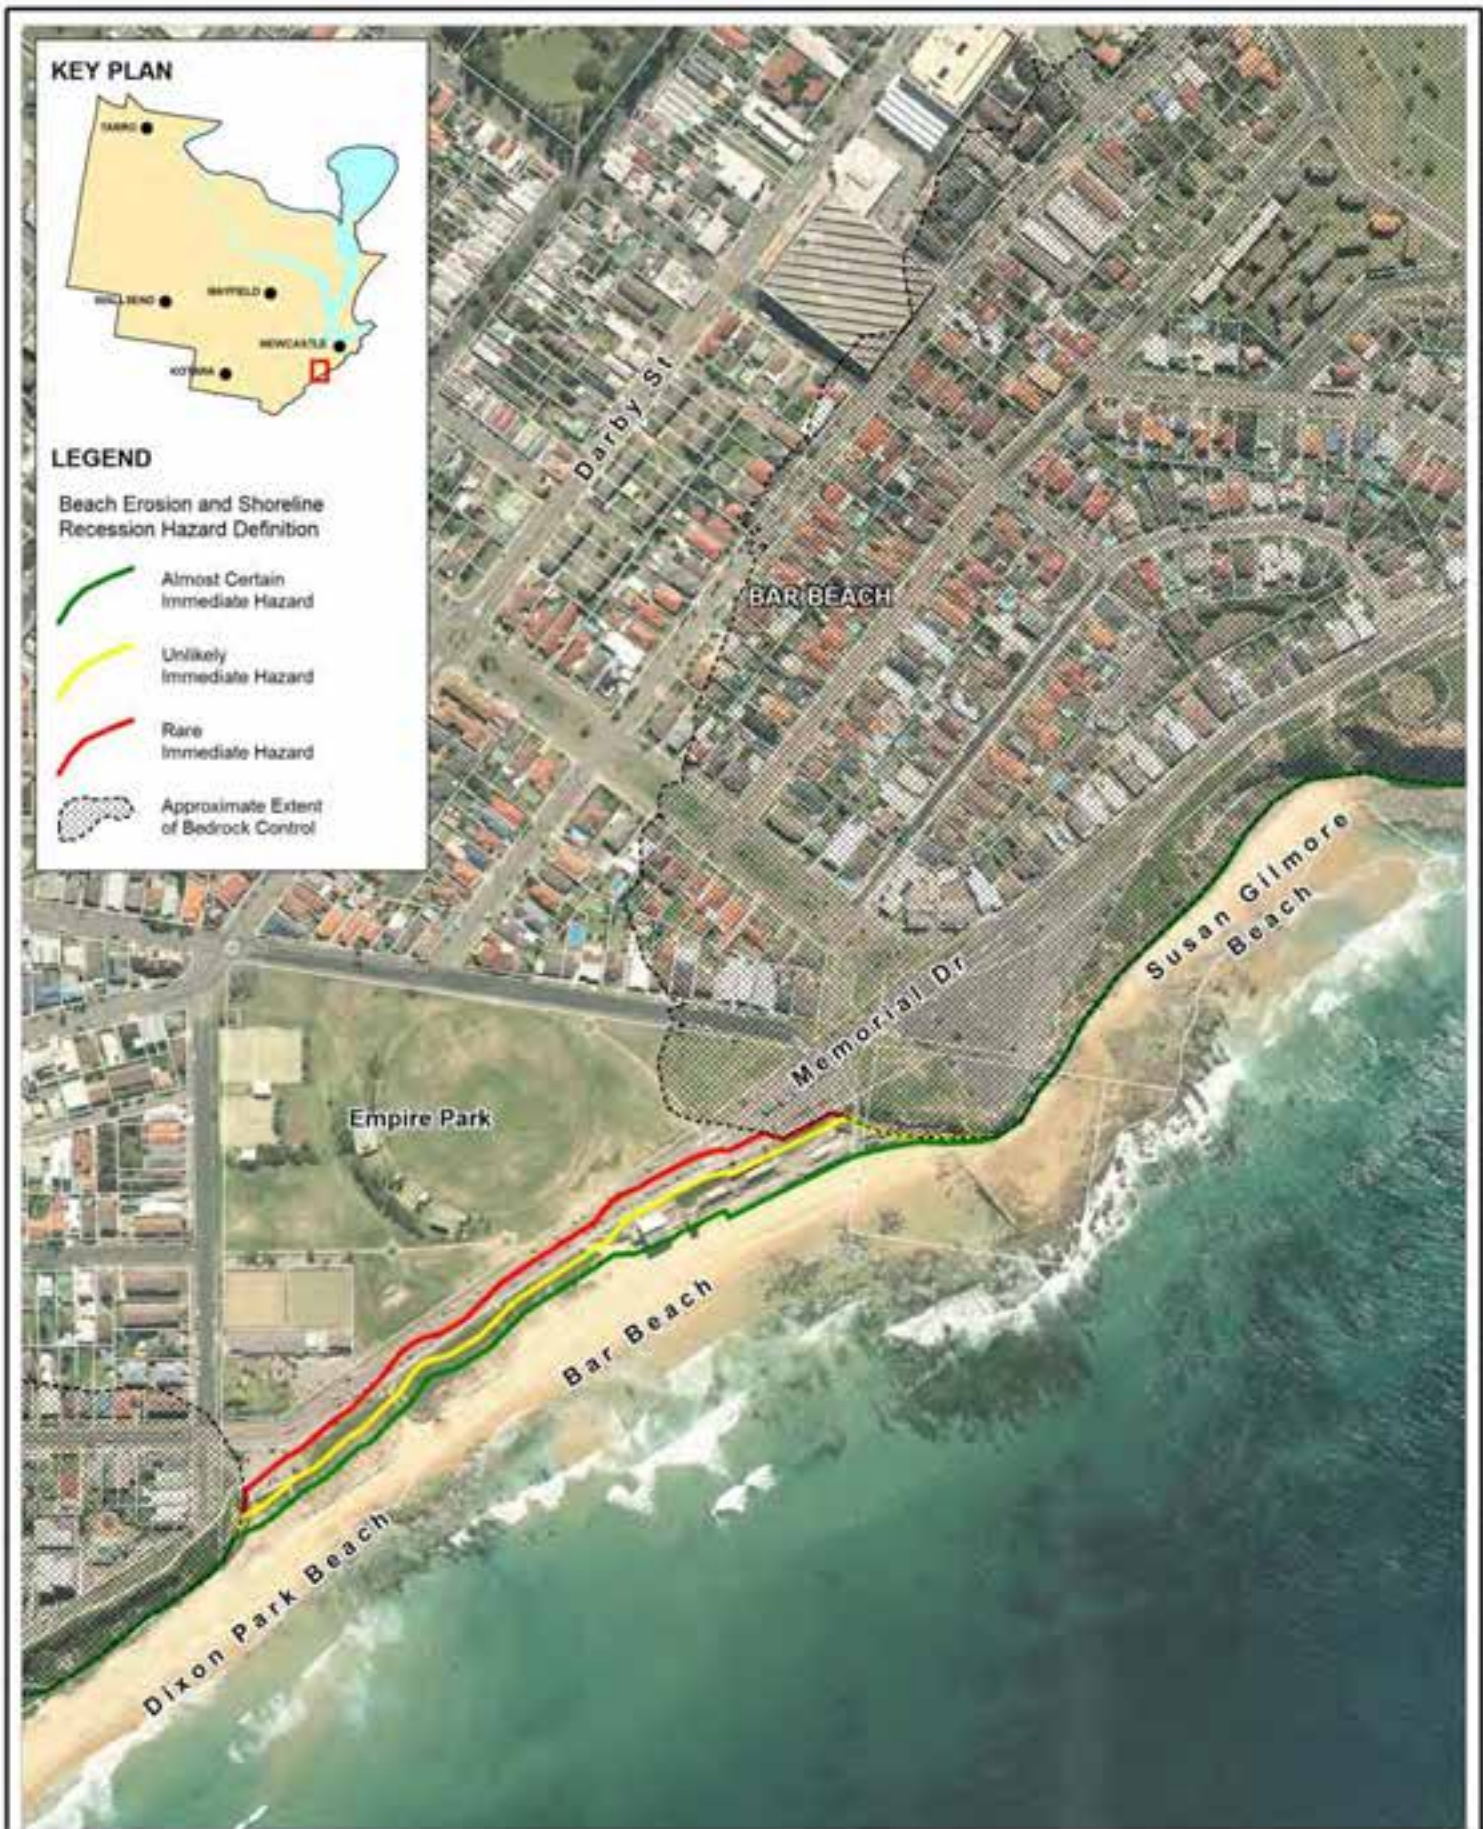
Figure:  
**A-8**

Title:  
**Erosion and Recession Hazard Definition  
 Immediate Planning Horizon - Bar Beach**

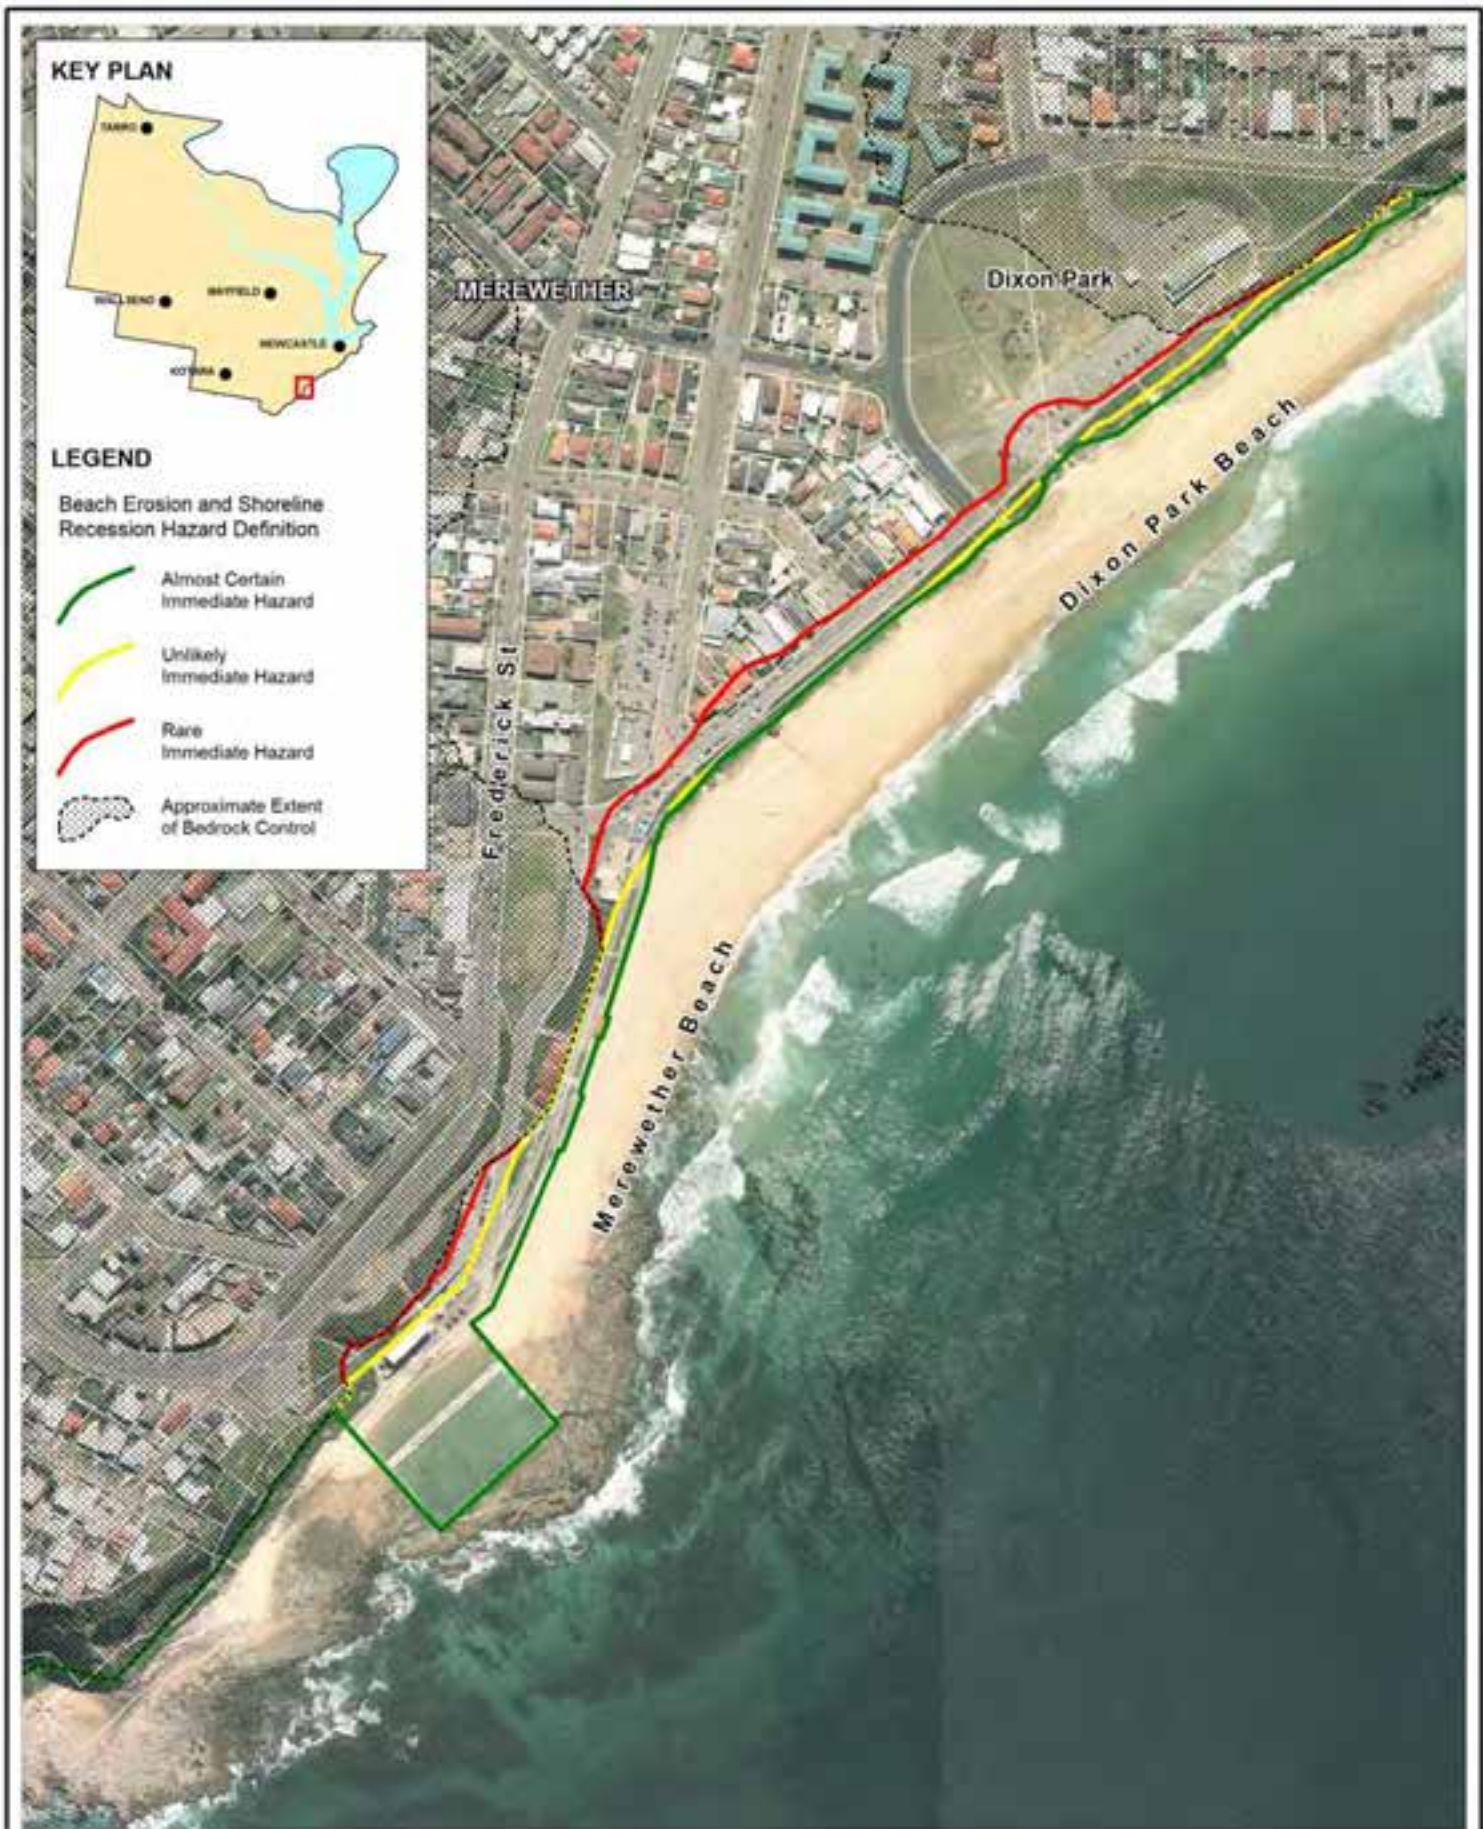
Figure:  
**A-9**

Title:  
**Erosion and Recession Hazard Definition  
 Immediate Planning Horizon - Merewether Beach**
