# Newcastle Coastal Zone Hazards Study

## *Final Report*

Prepared For: City of Newcastle

Prepared By: BMT WBM Pty Ltd (Member of the BMT group of companies)

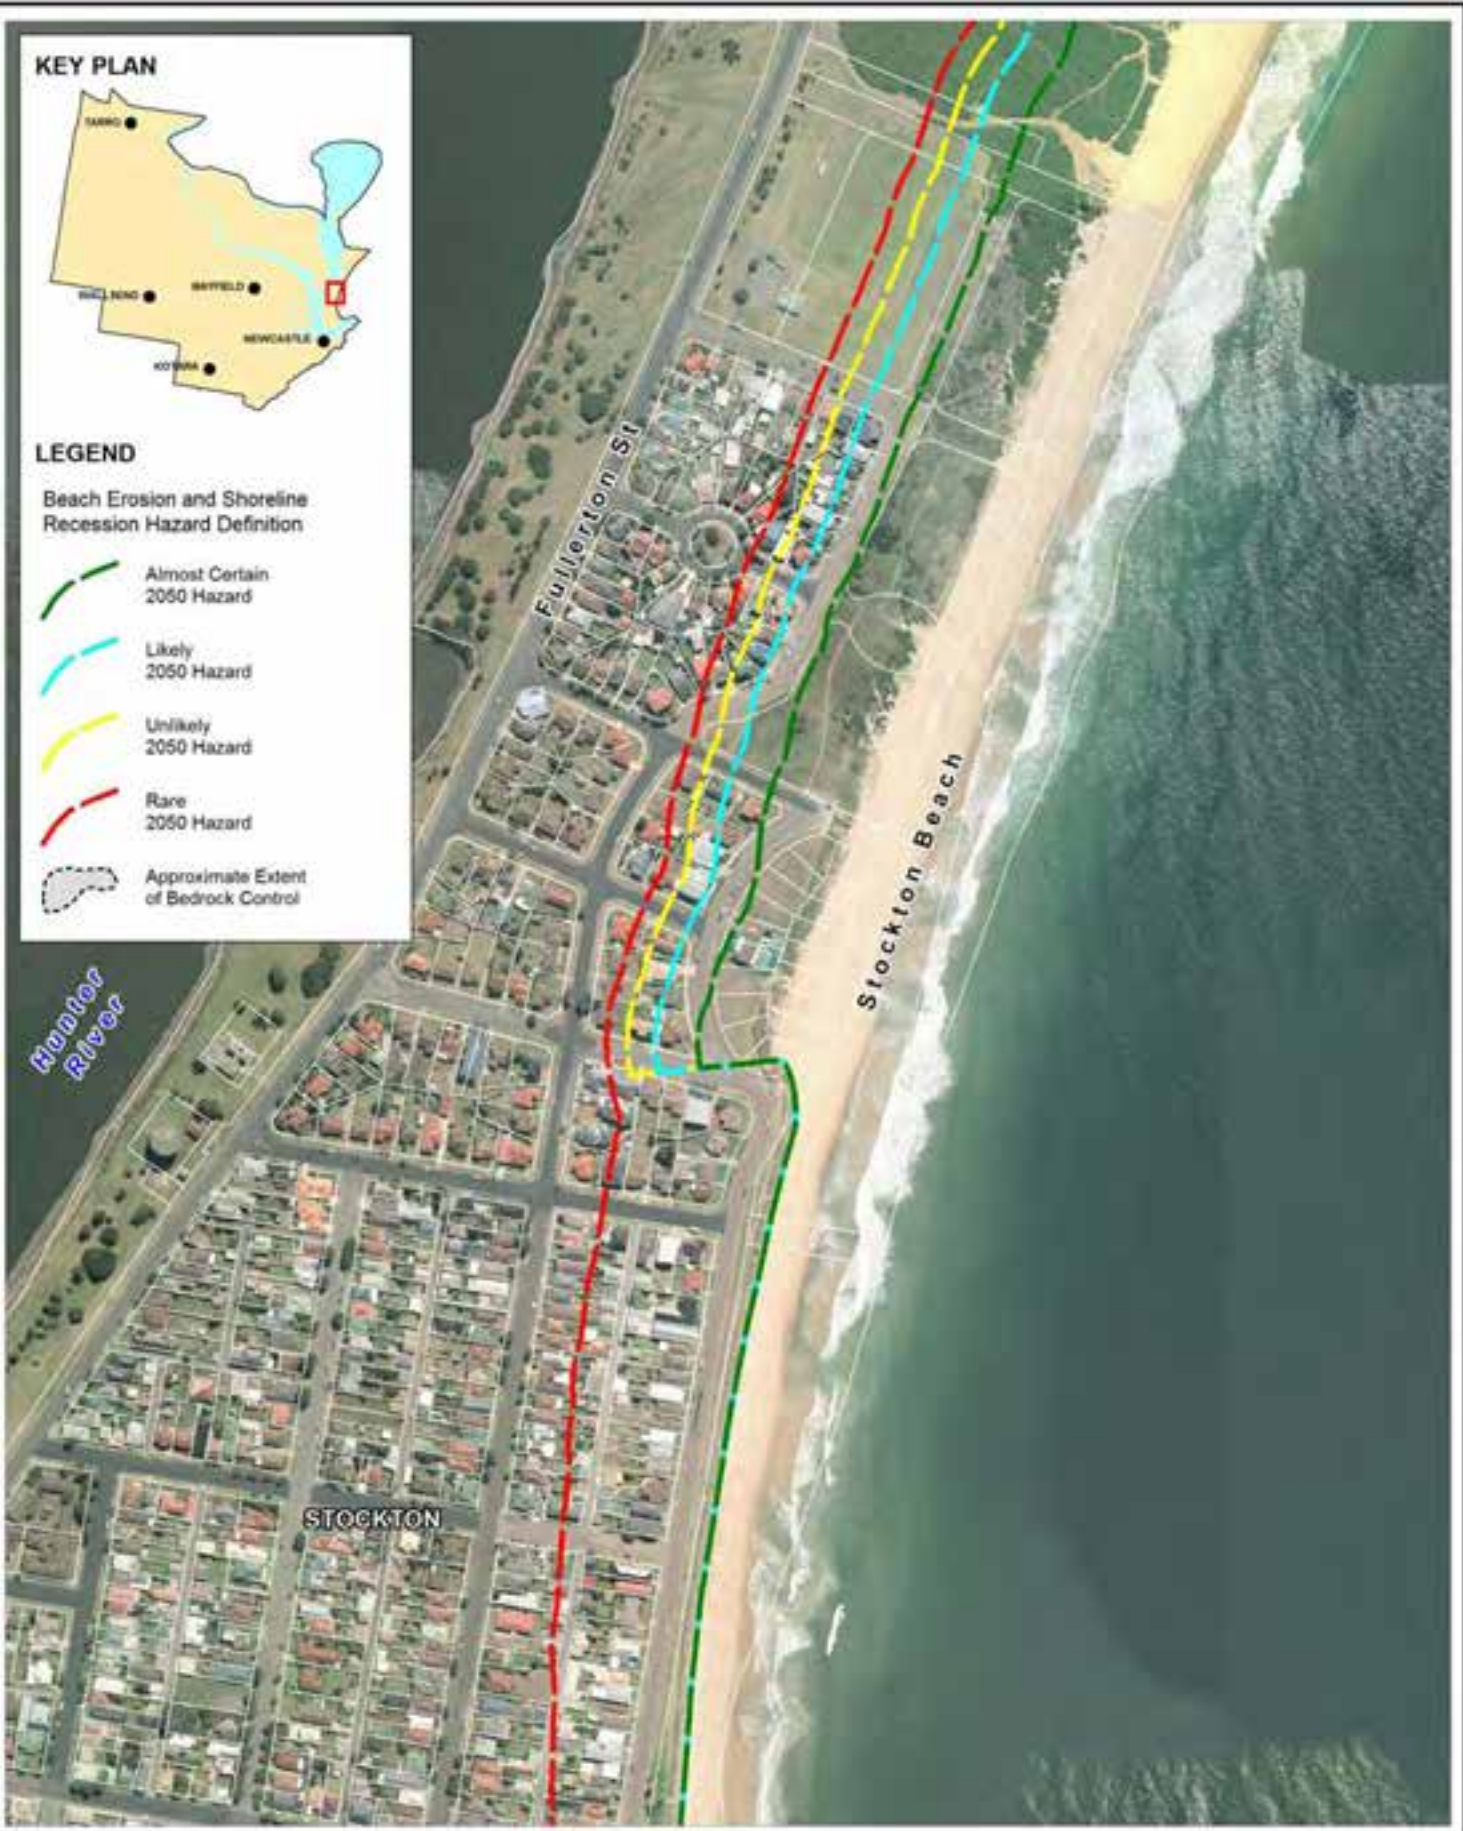
**Erosion and Recession Hazard Definition  
2050 Planning Horizon - Stockton North**

<sup>1</sup> Erosion distances increase in a northerly direction, see Hazard Maps, Figures B-1 to B-4

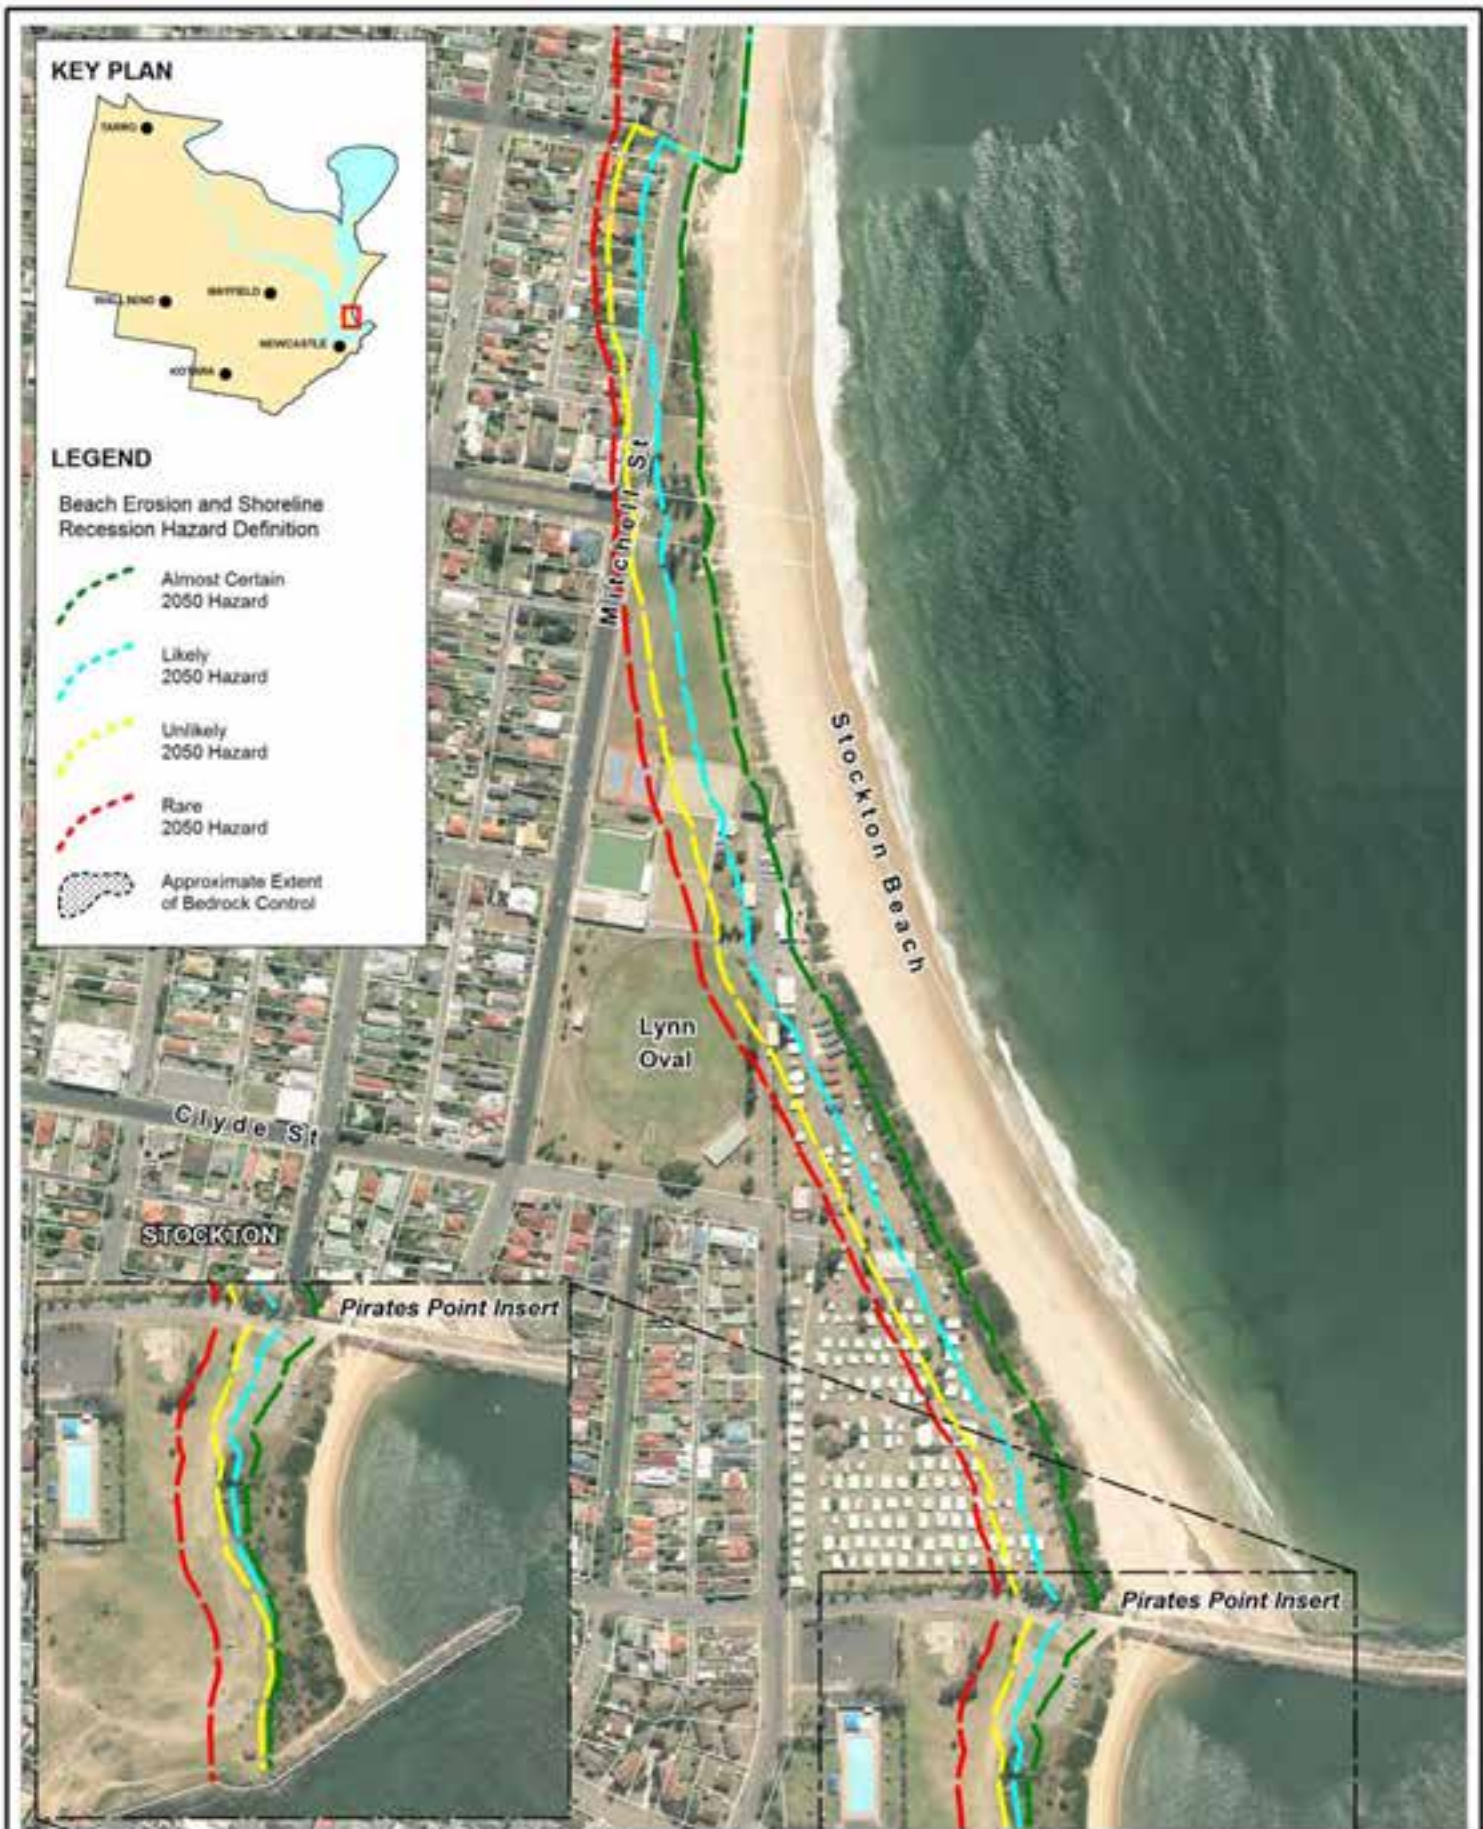
Figure:  
**B-4**

Title:  
**Erosion and Recession Hazard Definition  
 2050 Planning Horizon - Stockton South**

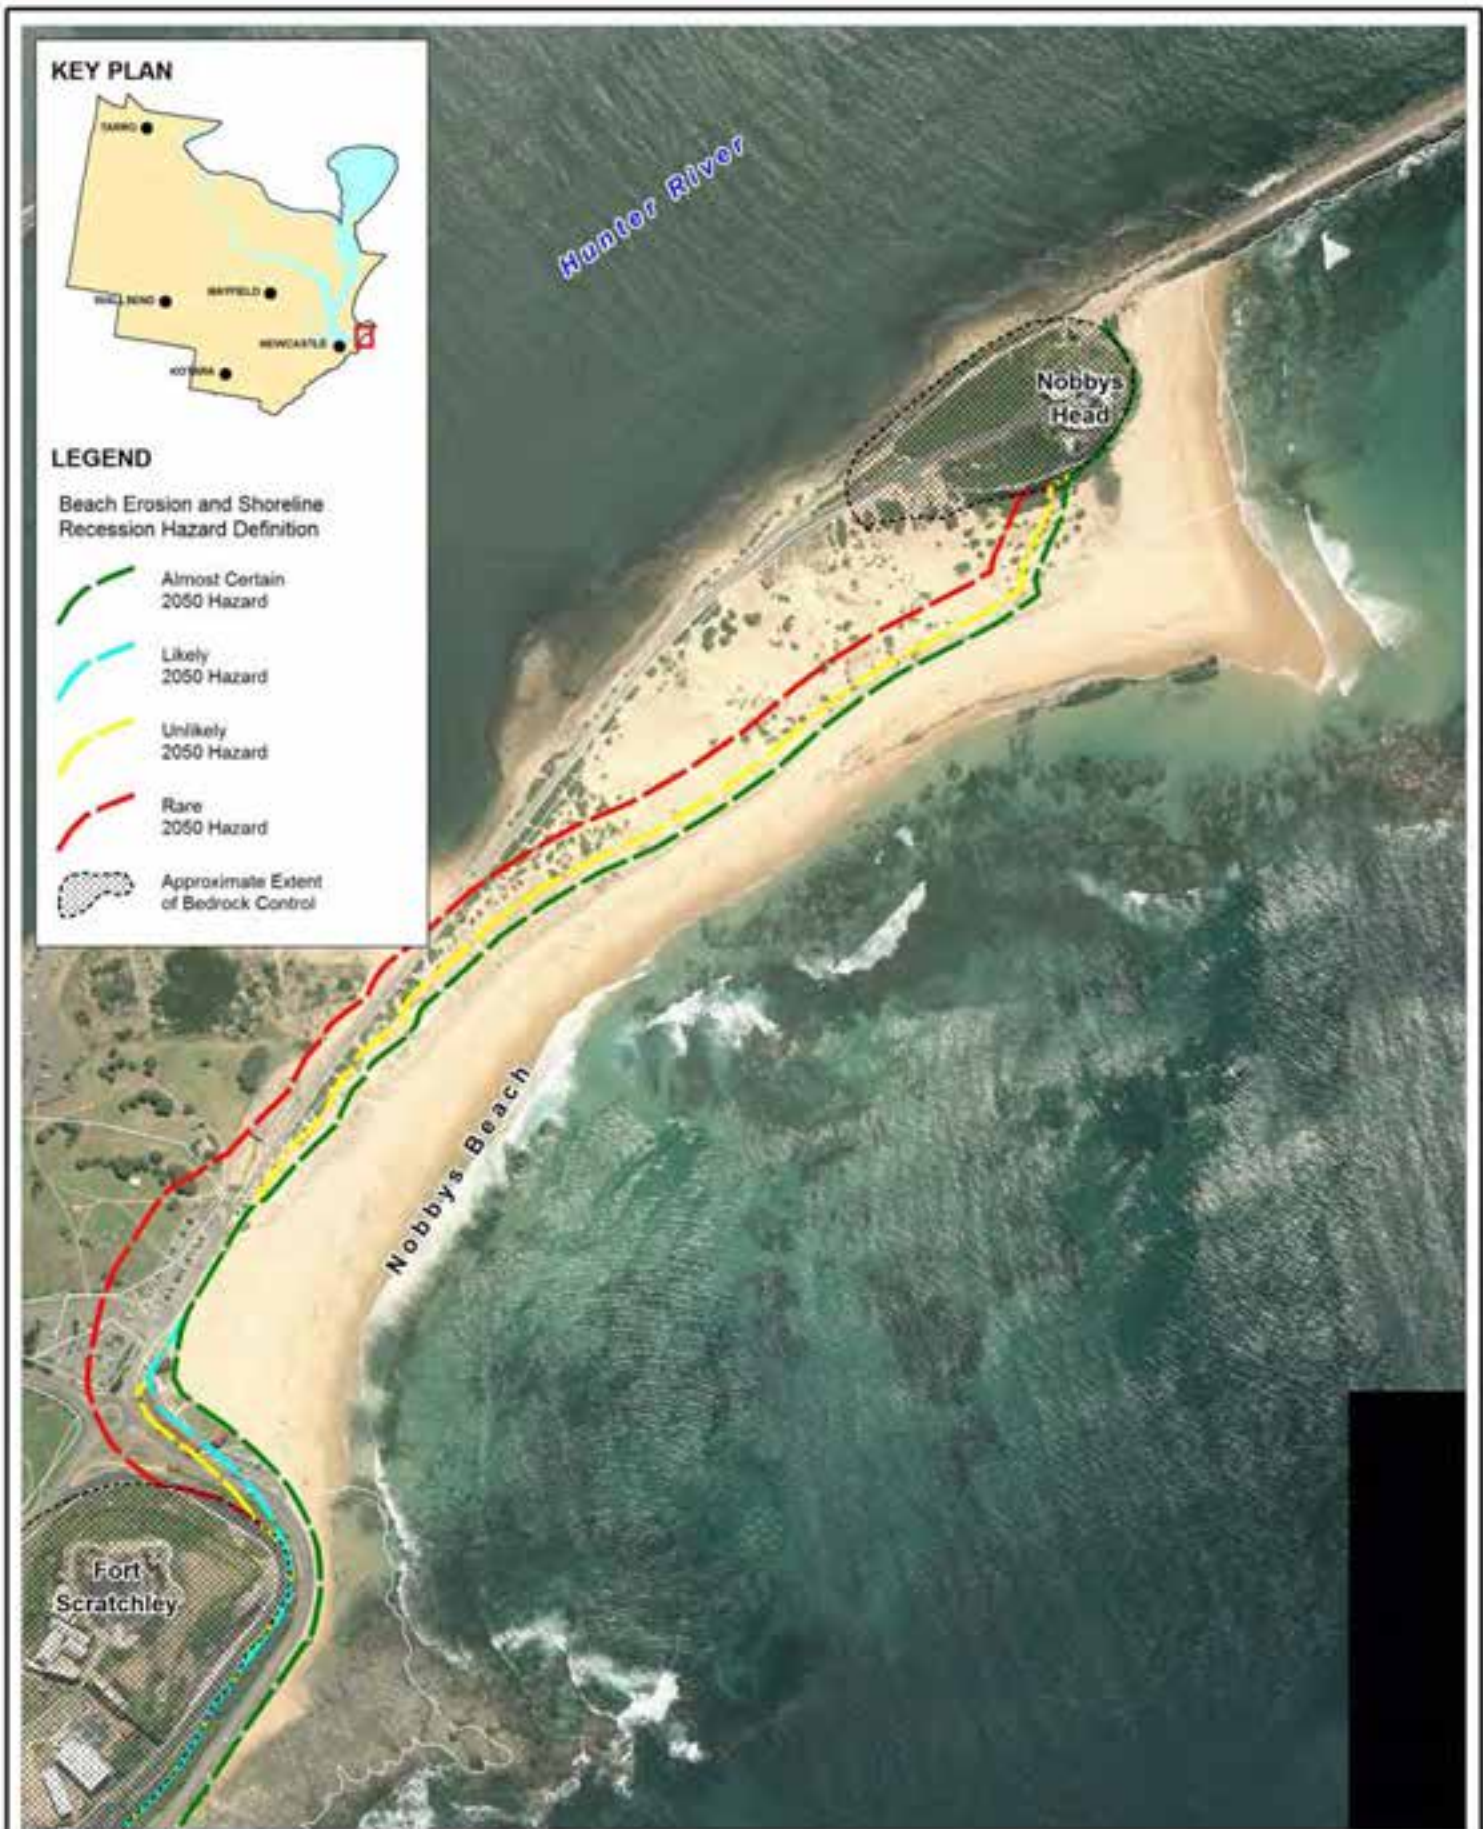
Figure:  
**B-5**

Title:  
**Erosion and Recession Hazard Definition  
 2050 Planning Horizon - Nobbys Beach**

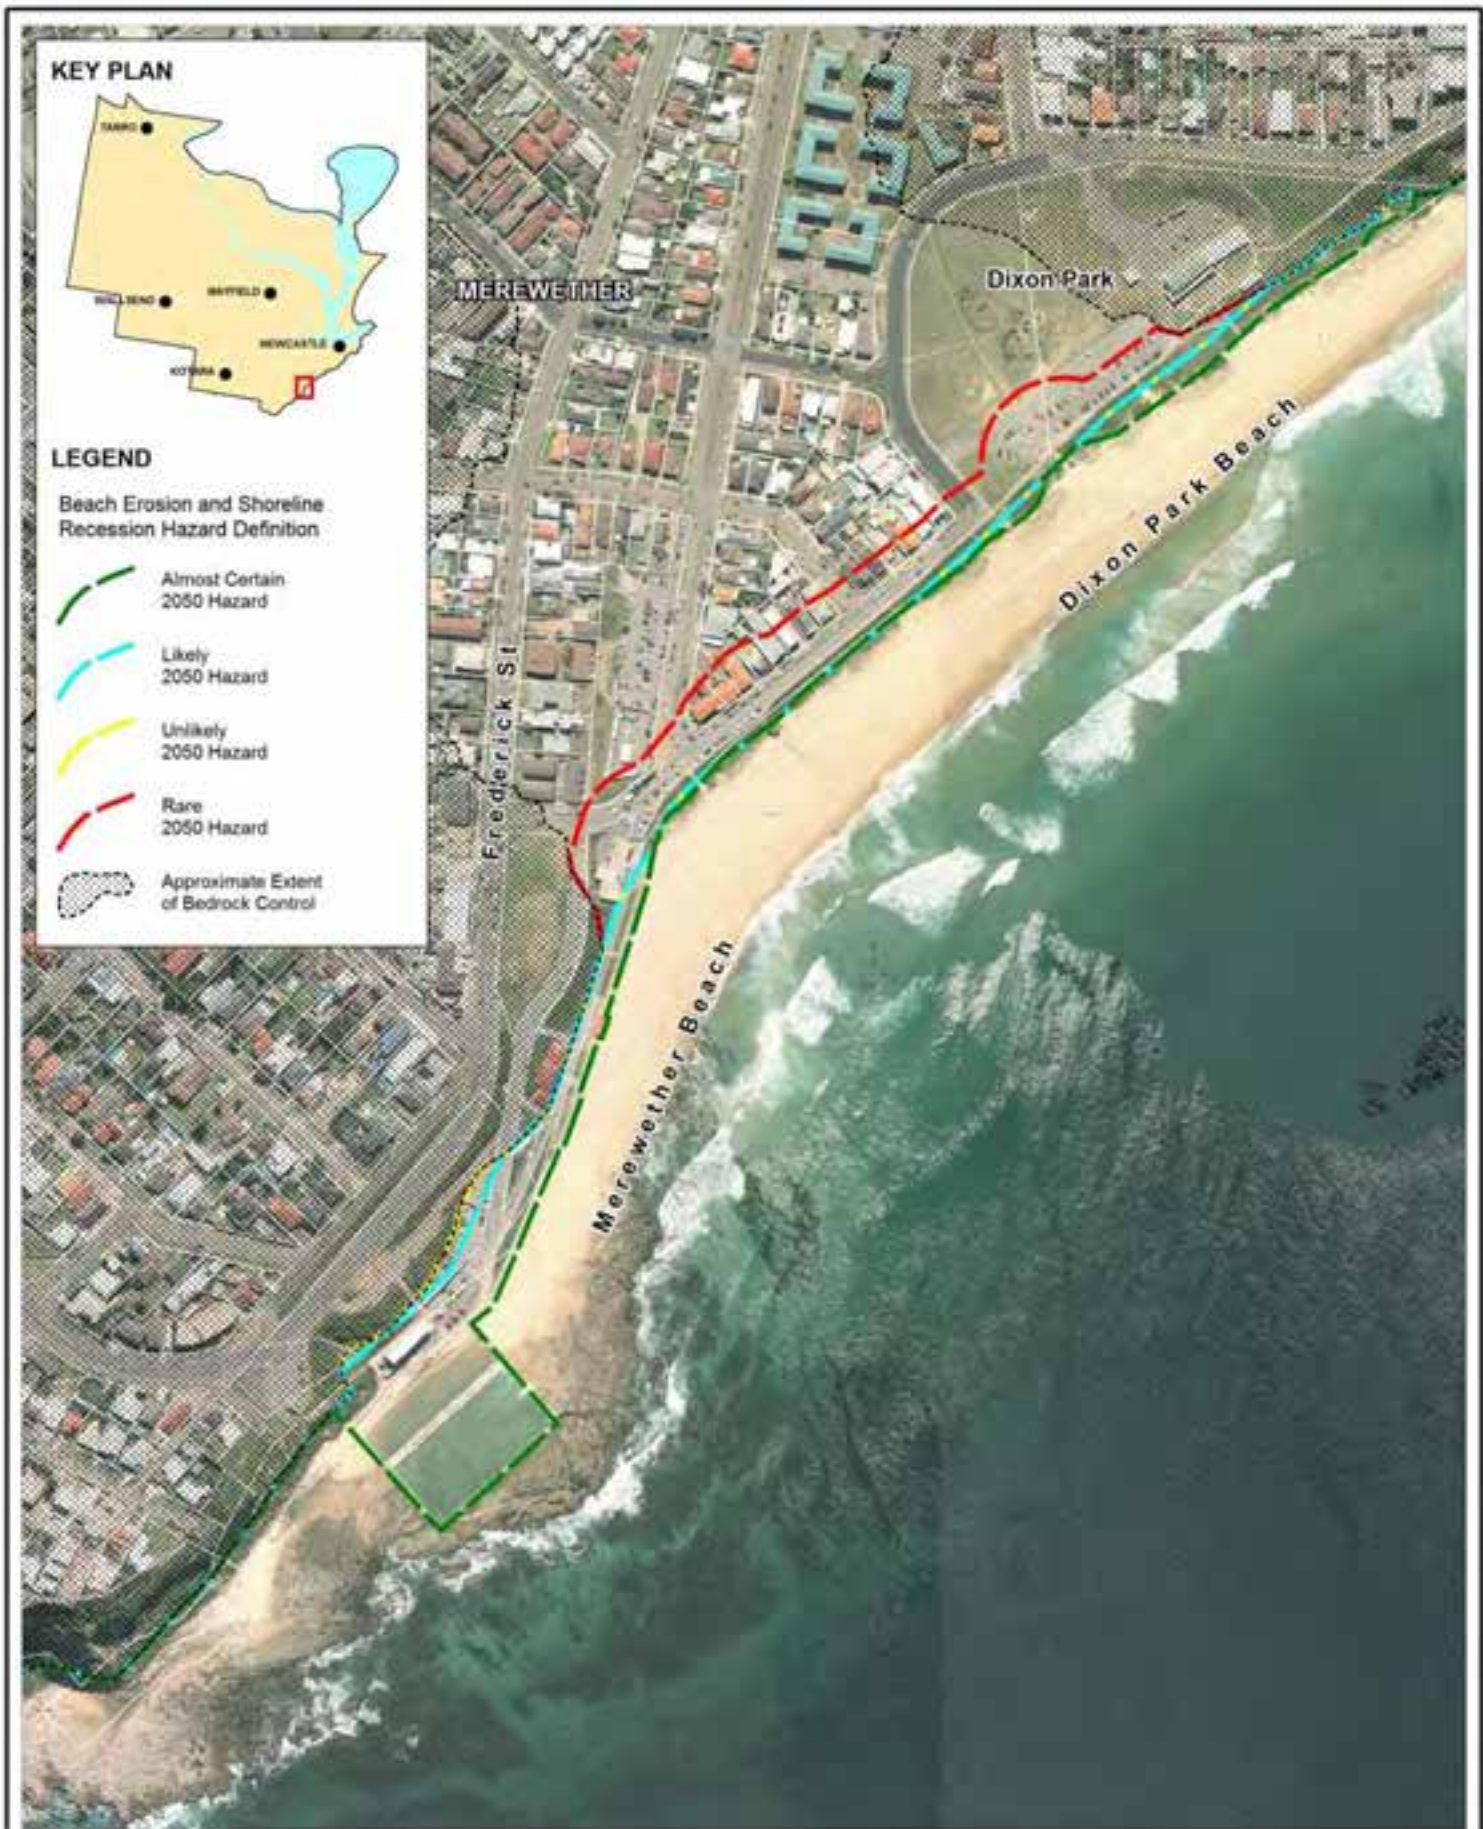
Figure:  
**B-9**

Title:  
**Erosion and Recession Hazard Definition  
 2050 Planning Horizon - Merewether Beach**

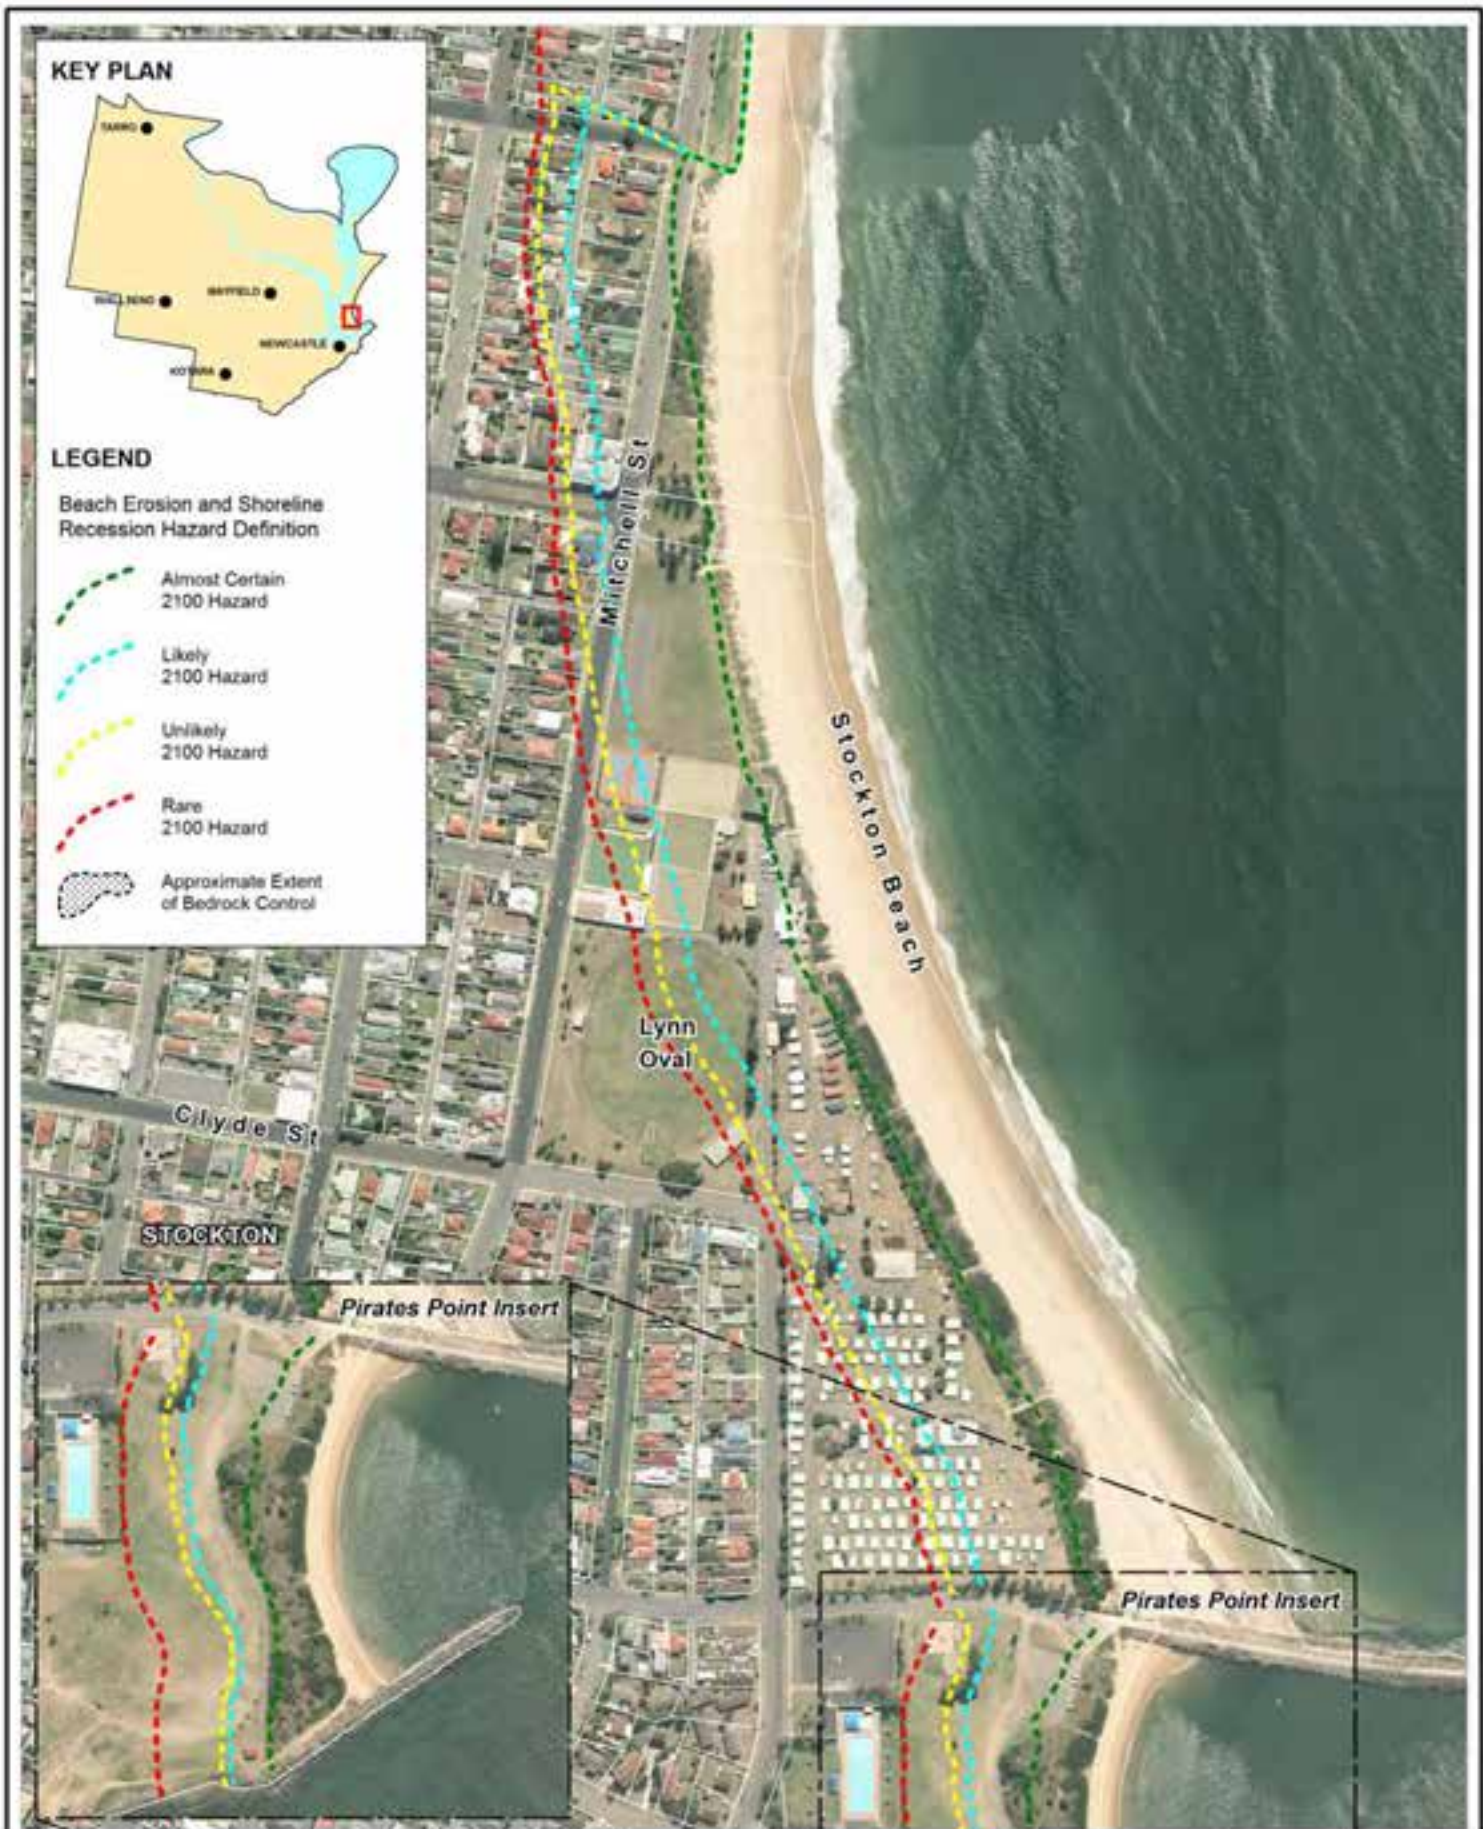
Figure:  
**C-4**

Title:  
**Erosion and Recession Hazard Definition  
 2100 Planning Horizon - Stockton South**

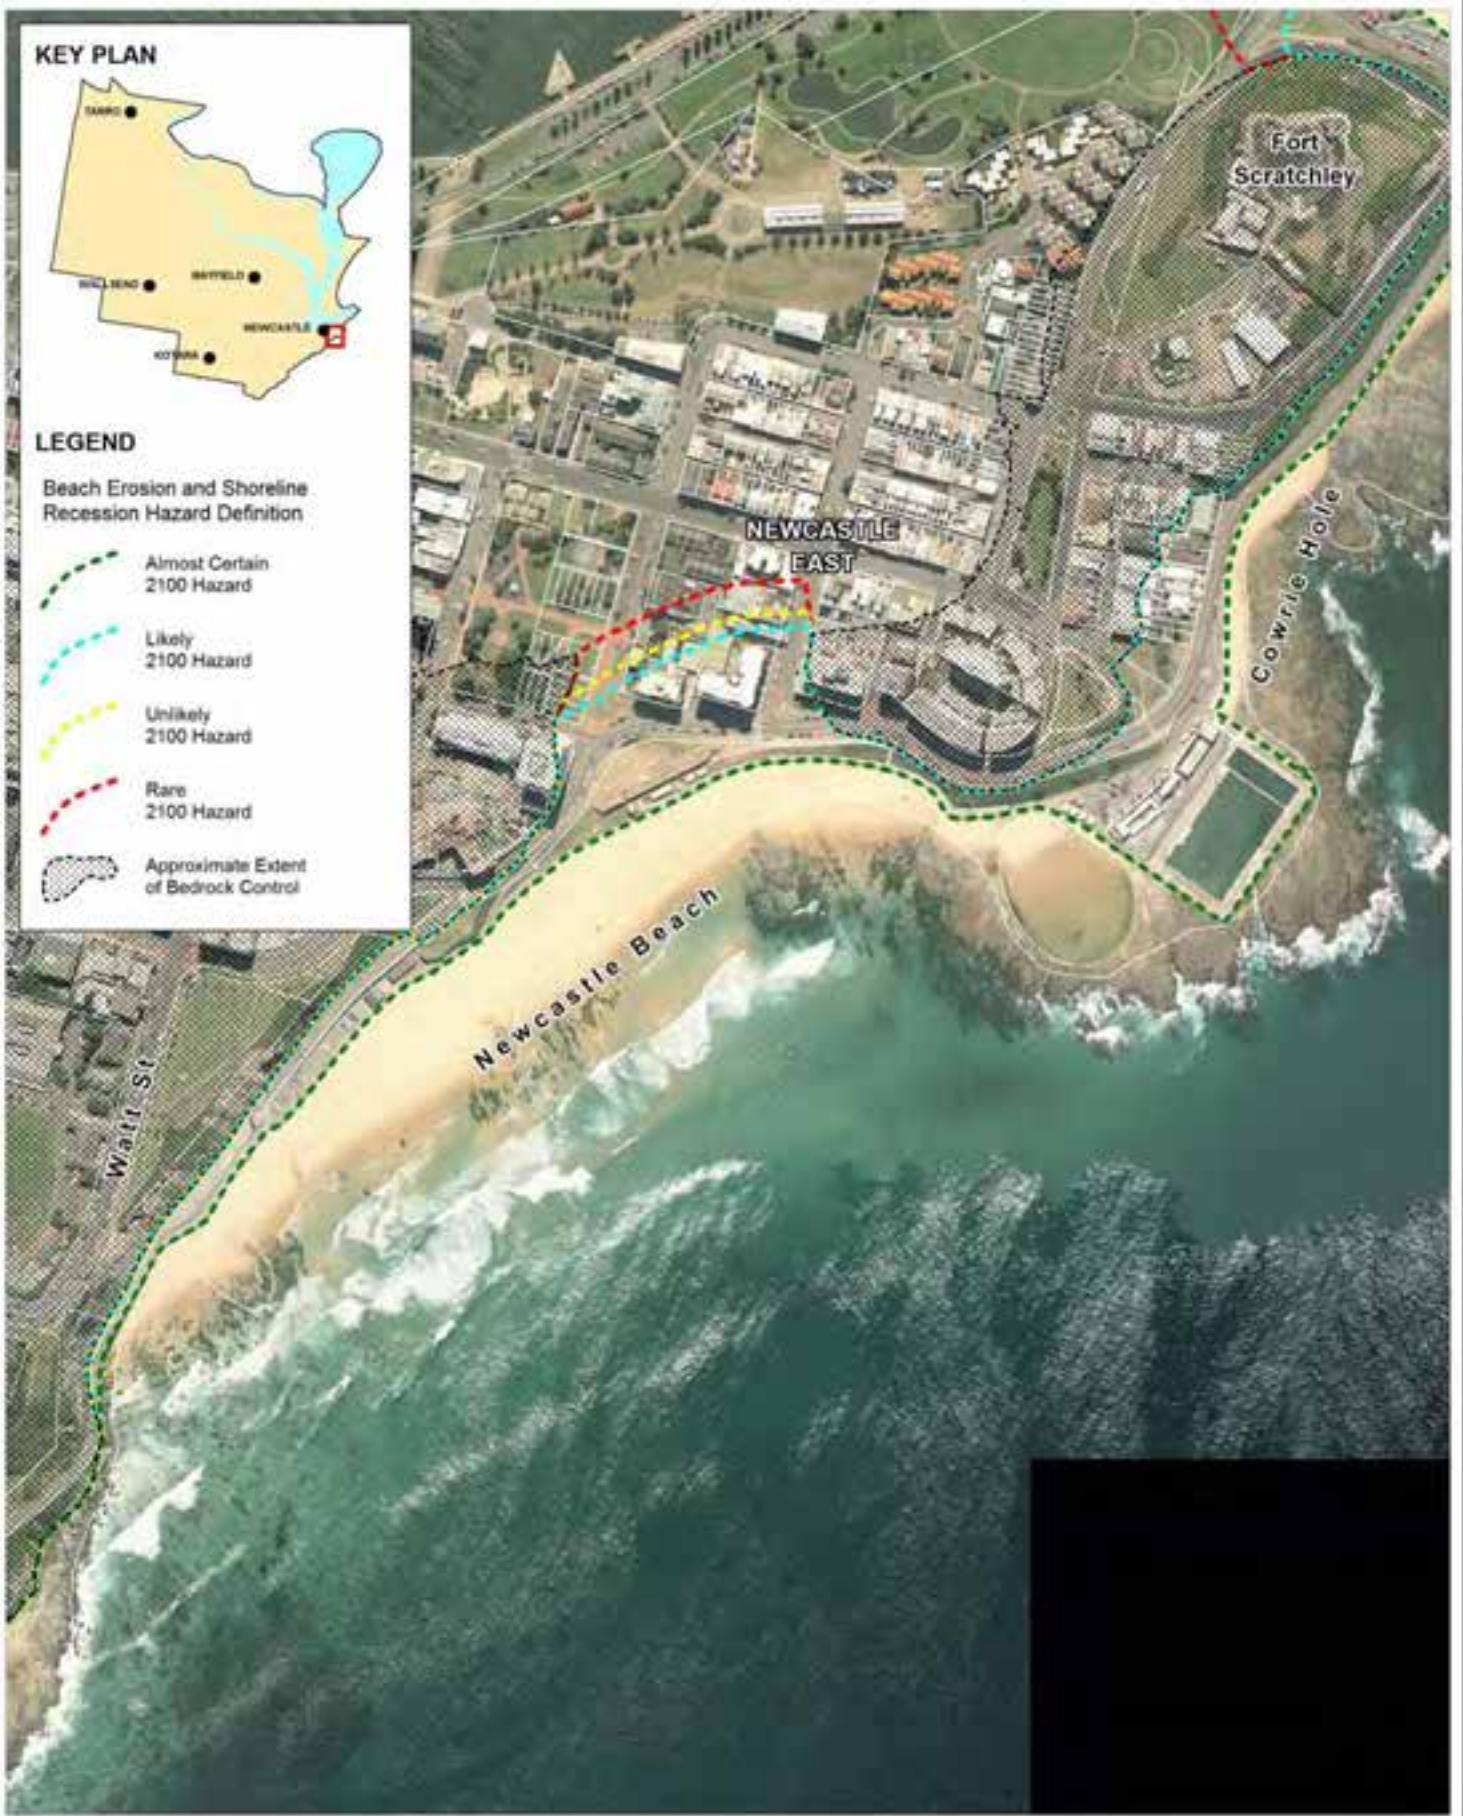
Figure:  
**C-6**

Title:  
**Erosion and Recession Hazard Definition  
2100 Planning Horizon - Newcastle Beach**

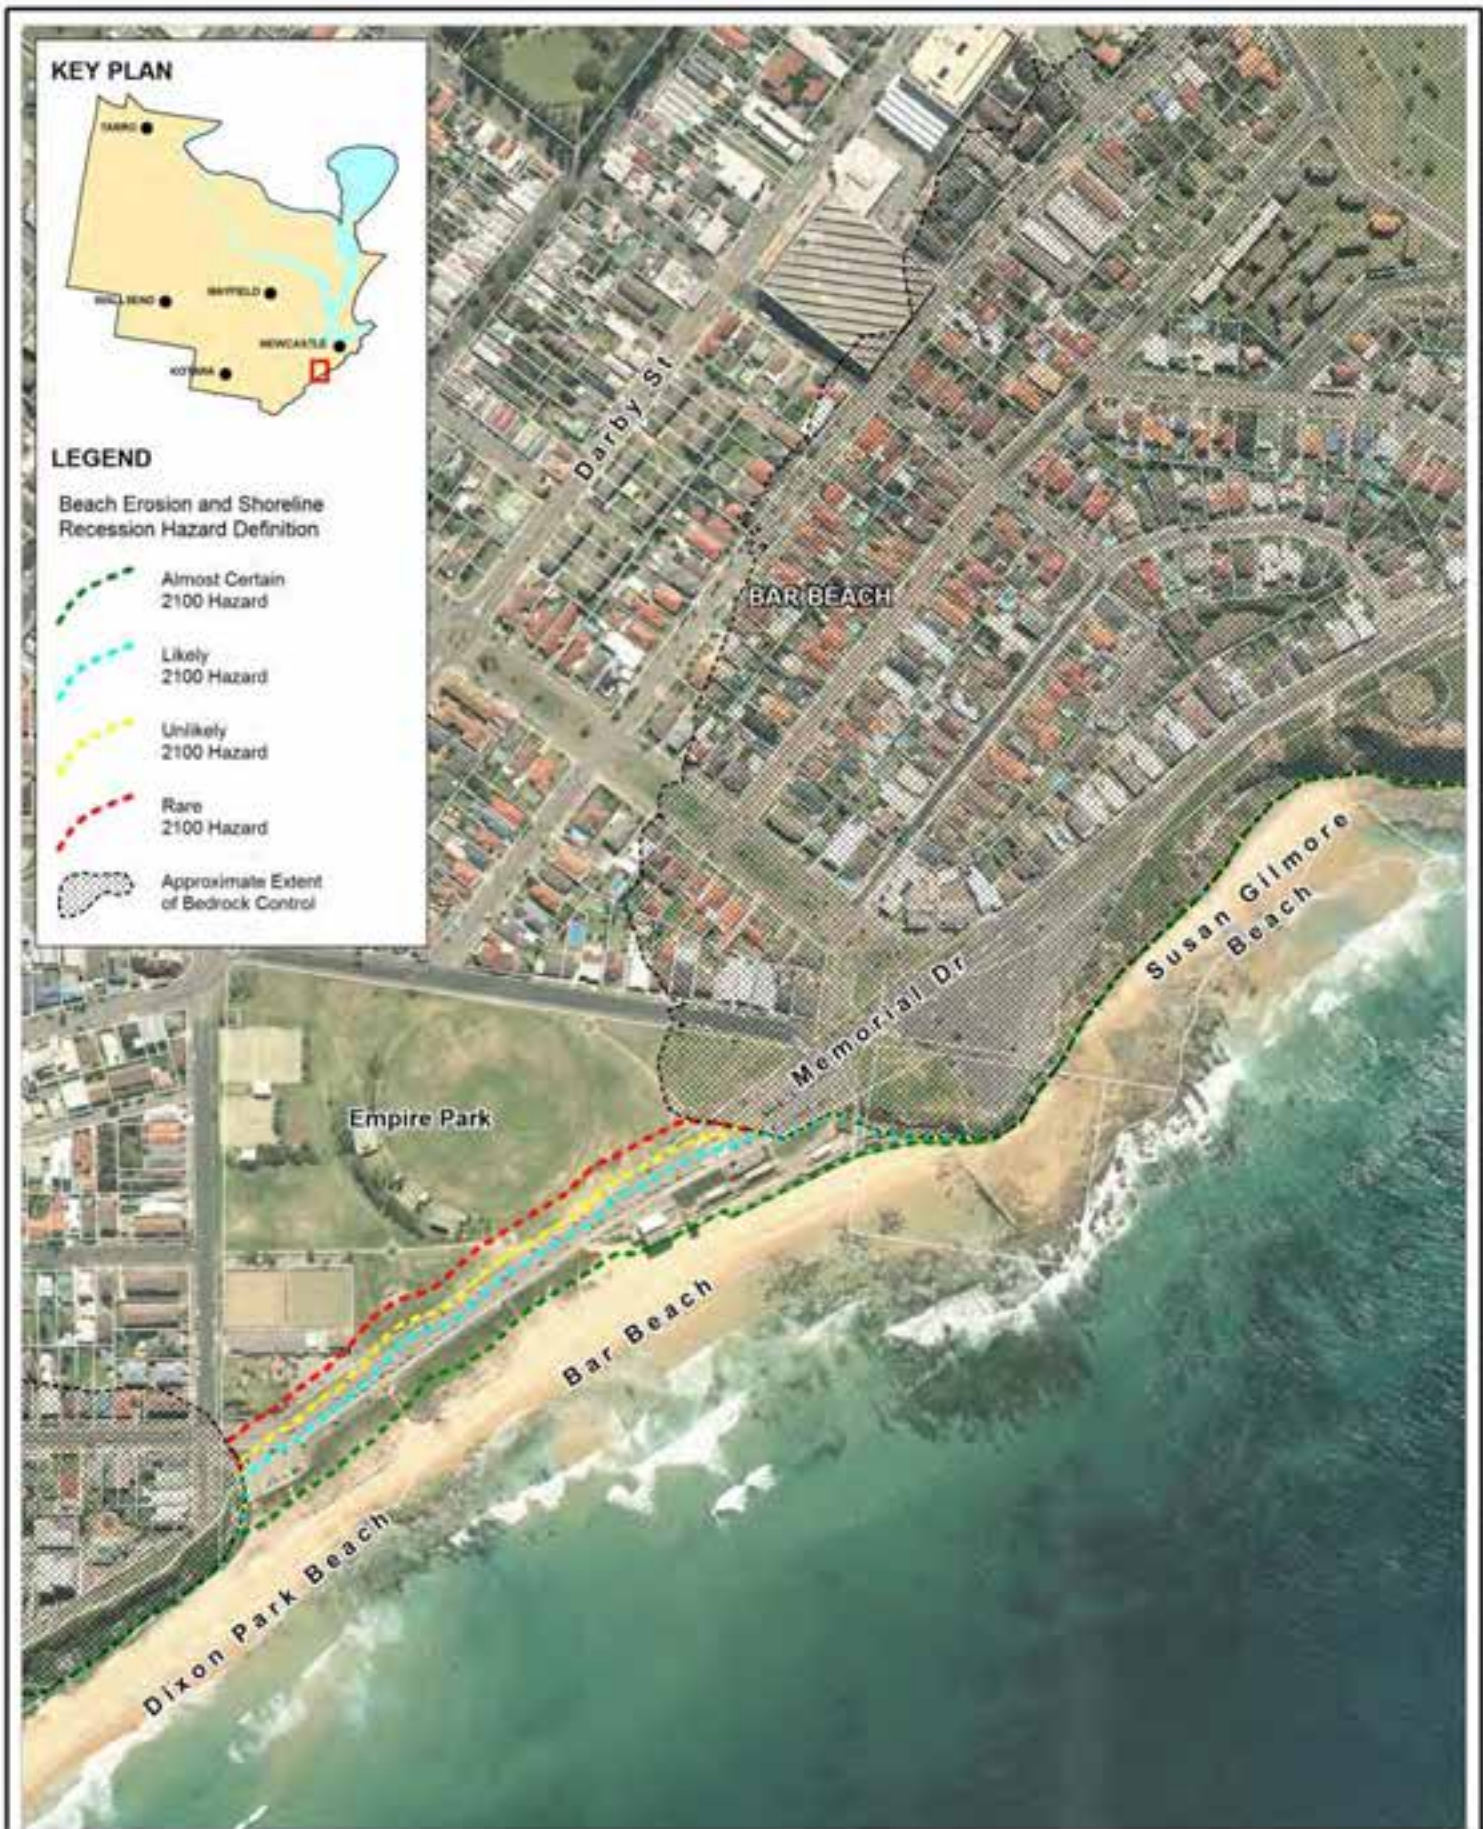
Figure:  
**C-8**

Title:  
**Erosion and Recession Hazard Definition  
 2100 Planning Horizon - Bar Beach**

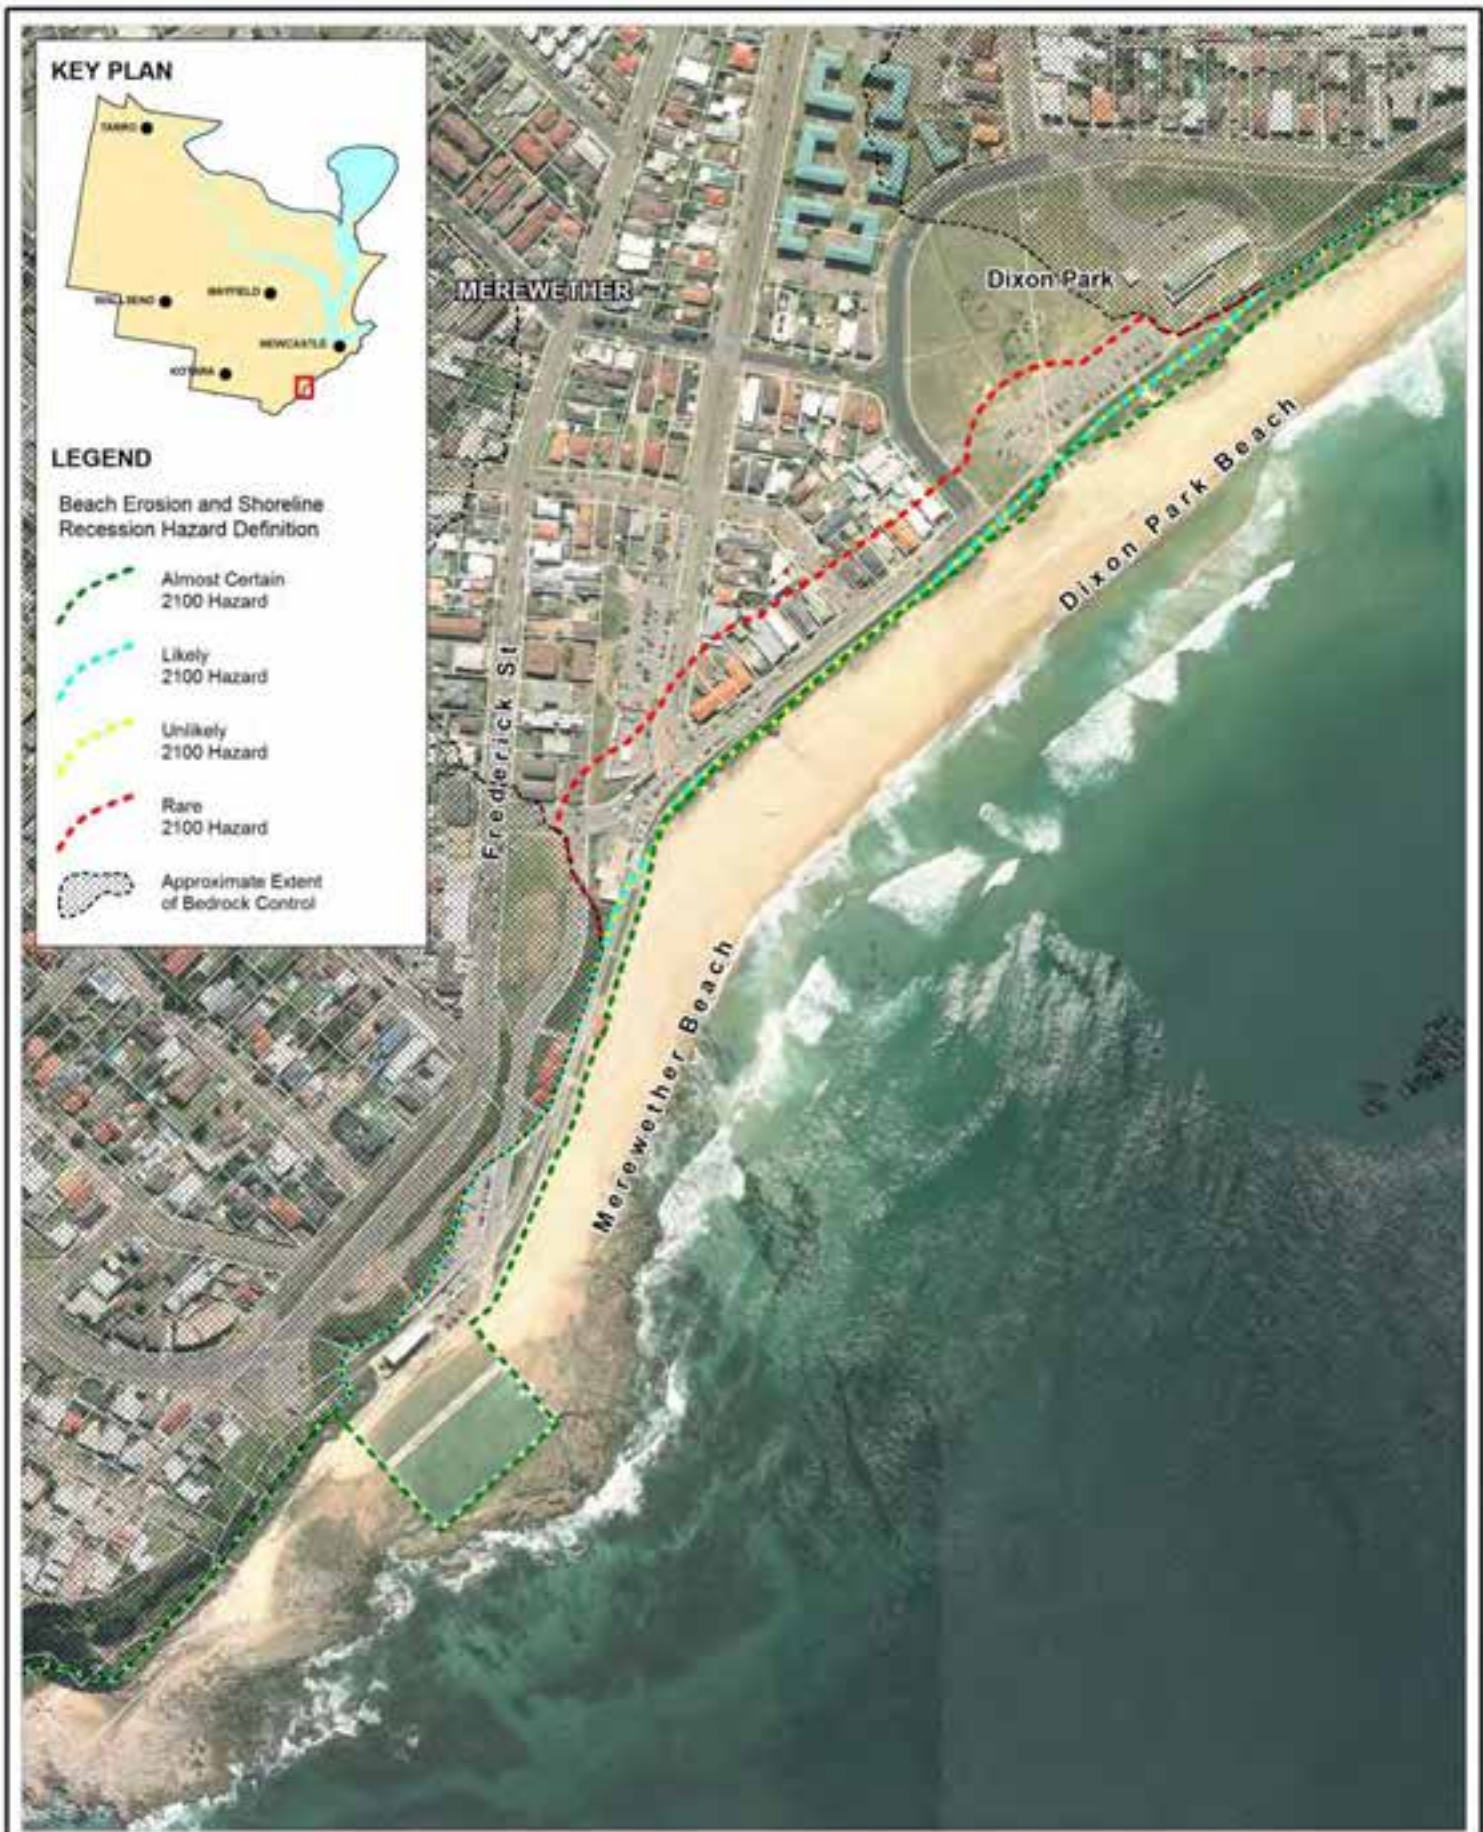
Figure:  
**C-9**

Title:  
**Erosion and Recession Hazard Definition  
 2100 Planning Horizon - Merewether Beach**
