# Newcastle Coastal Zone Hazards Study

## *Final Report*

Prepared For: City of Newcastle

Prepared By: BMT WBM Pty Ltd (Member of the BMT group of companies)

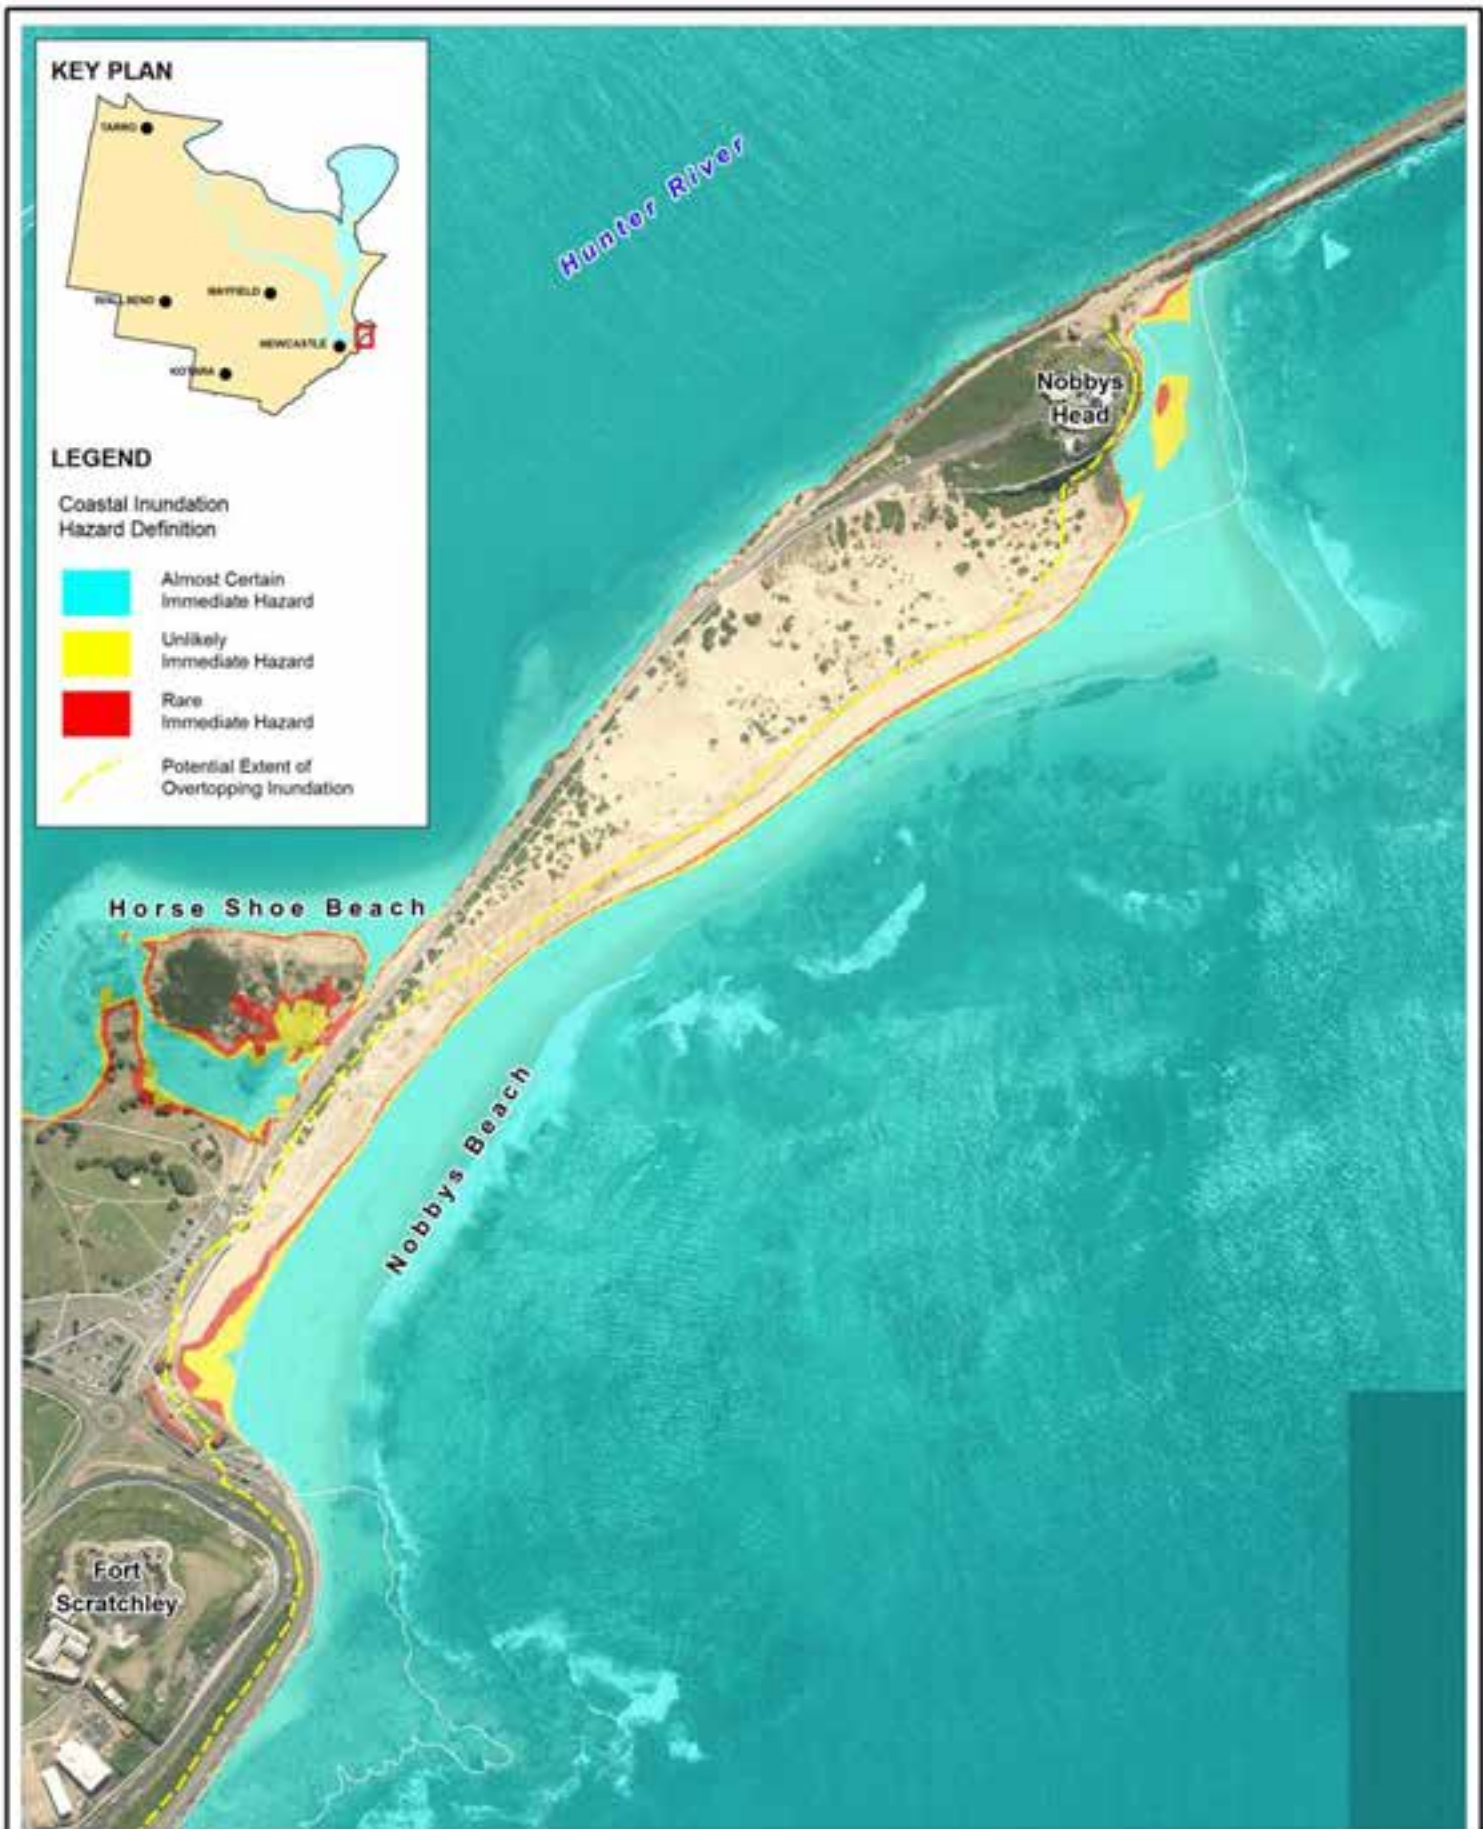
Figure: <b>D-5</b>	Rev: <b>A</b>
-----------------------	------------------

Title:  
**Coastal Inundation Hazard Definition  
 Immediate Planning Horizon - Nobbys Beach**

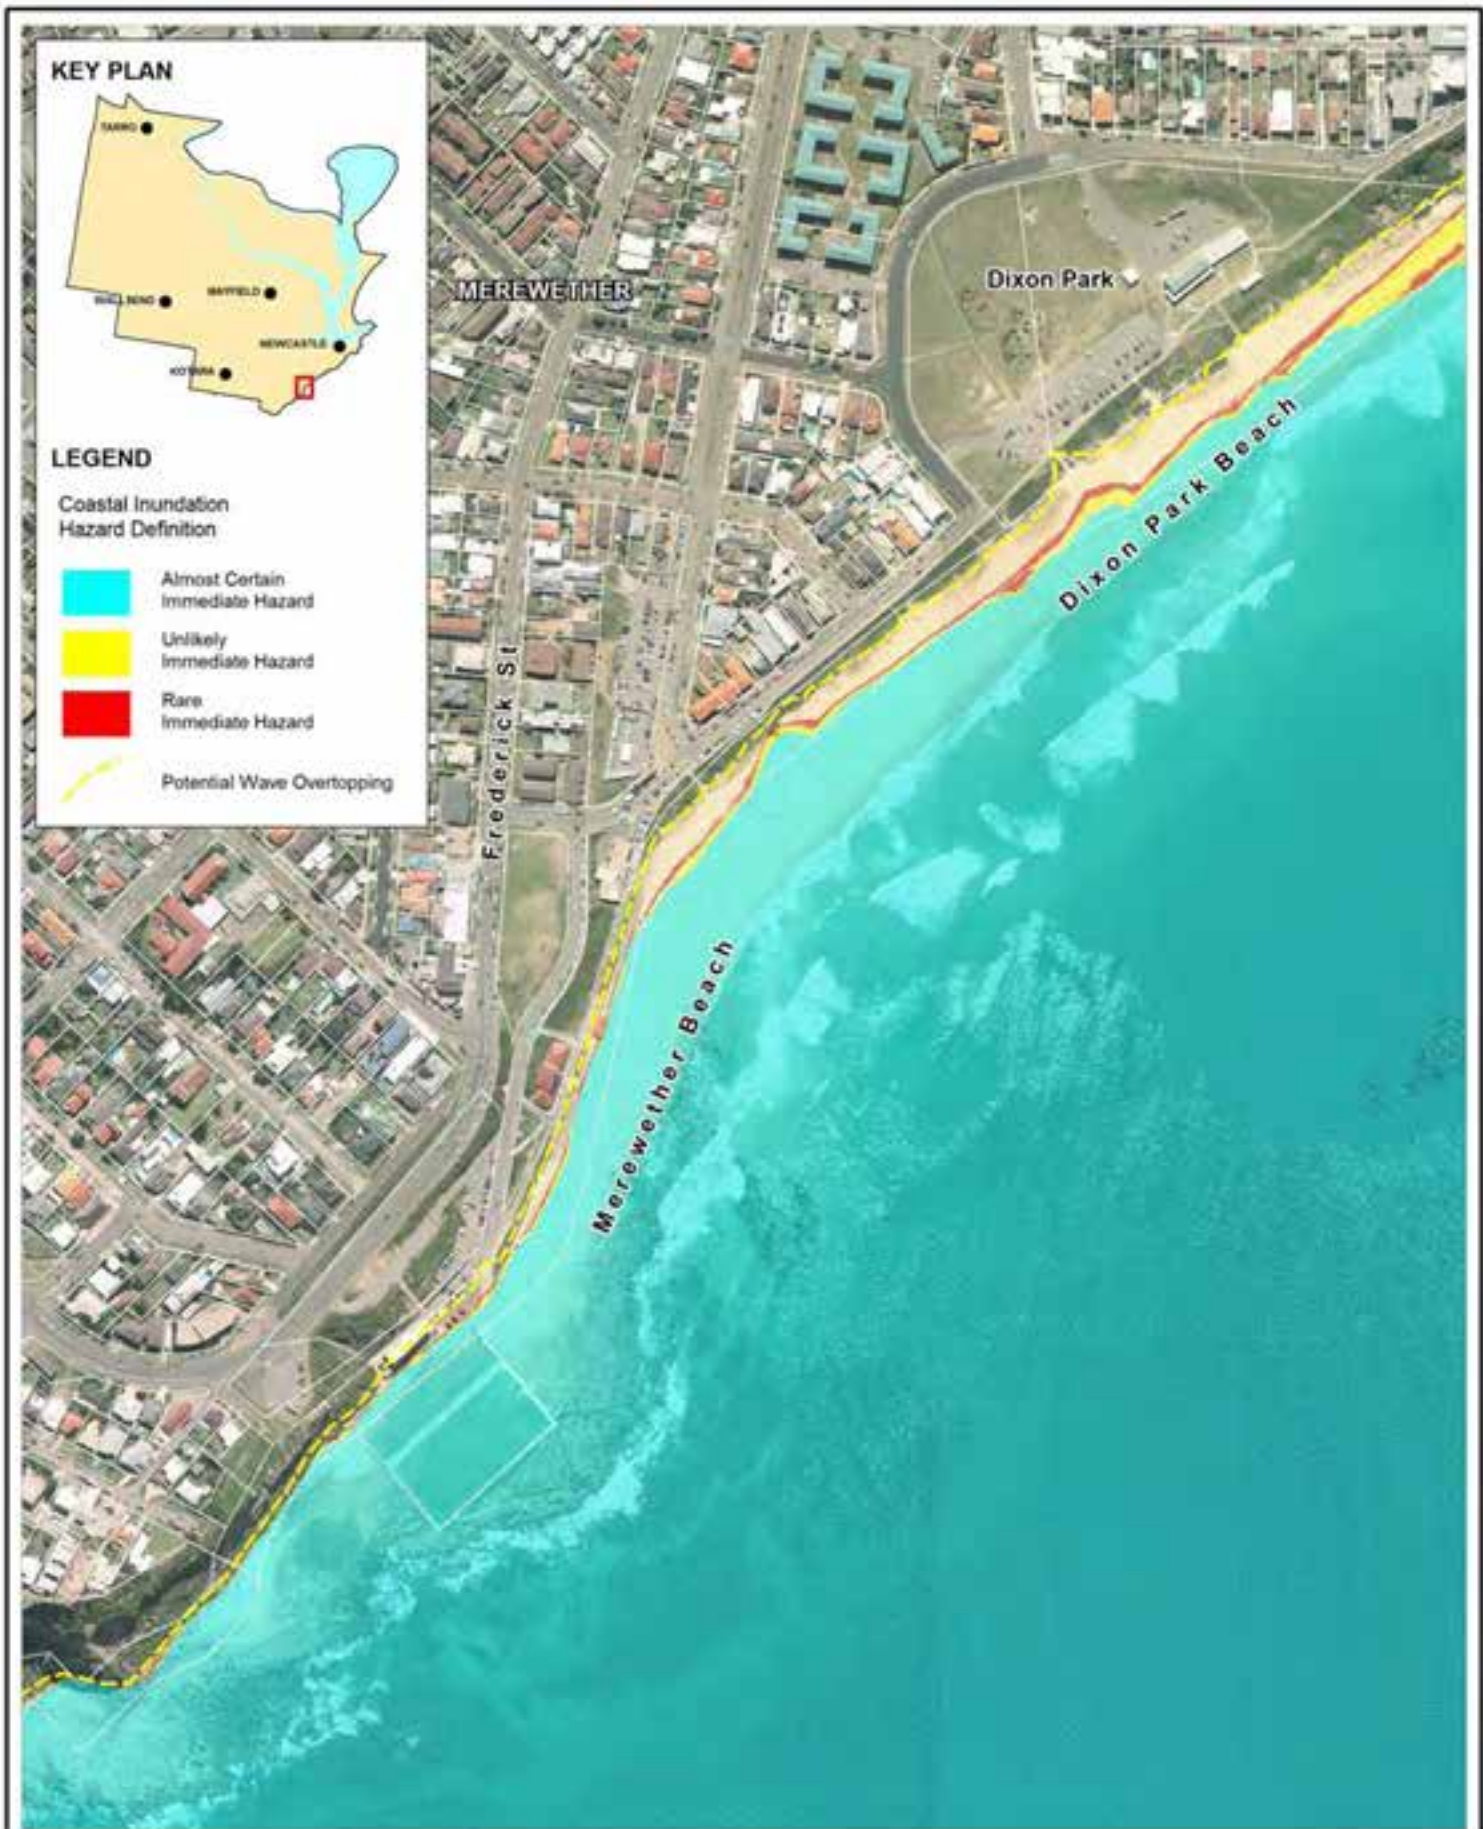
Figure:  
**D-9**

Title:  
**Coastal Inundation Hazard Definition  
 Immediate Planning Horizon - Merewether Beach**

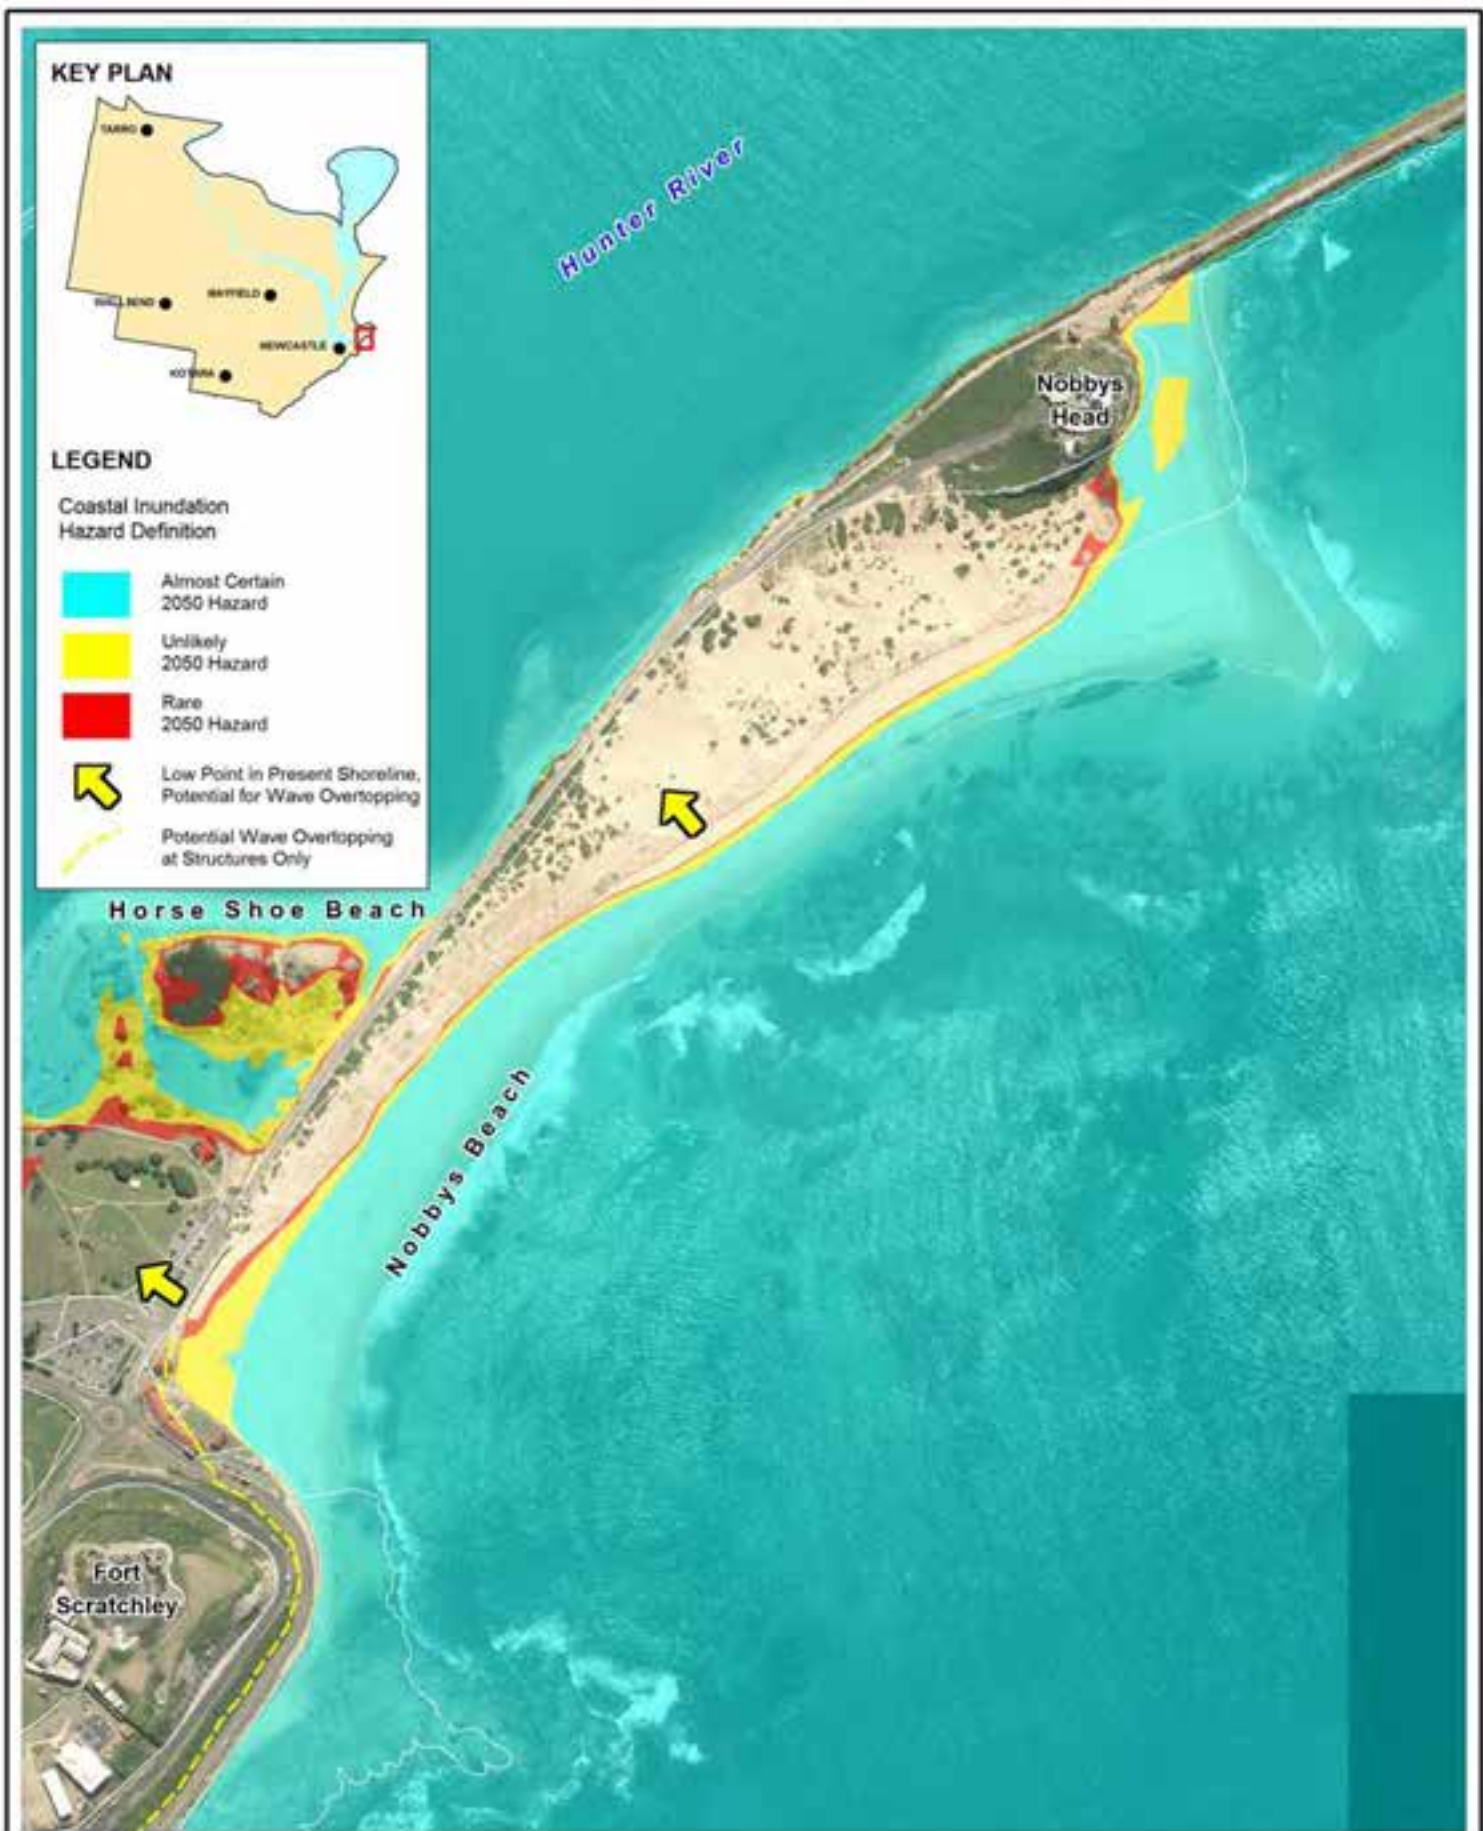
Figure:  
**E-5**

Title:  
**Coastal Inundation Hazard Definition  
 2050 Planning Horizon - Nobbys Beach**

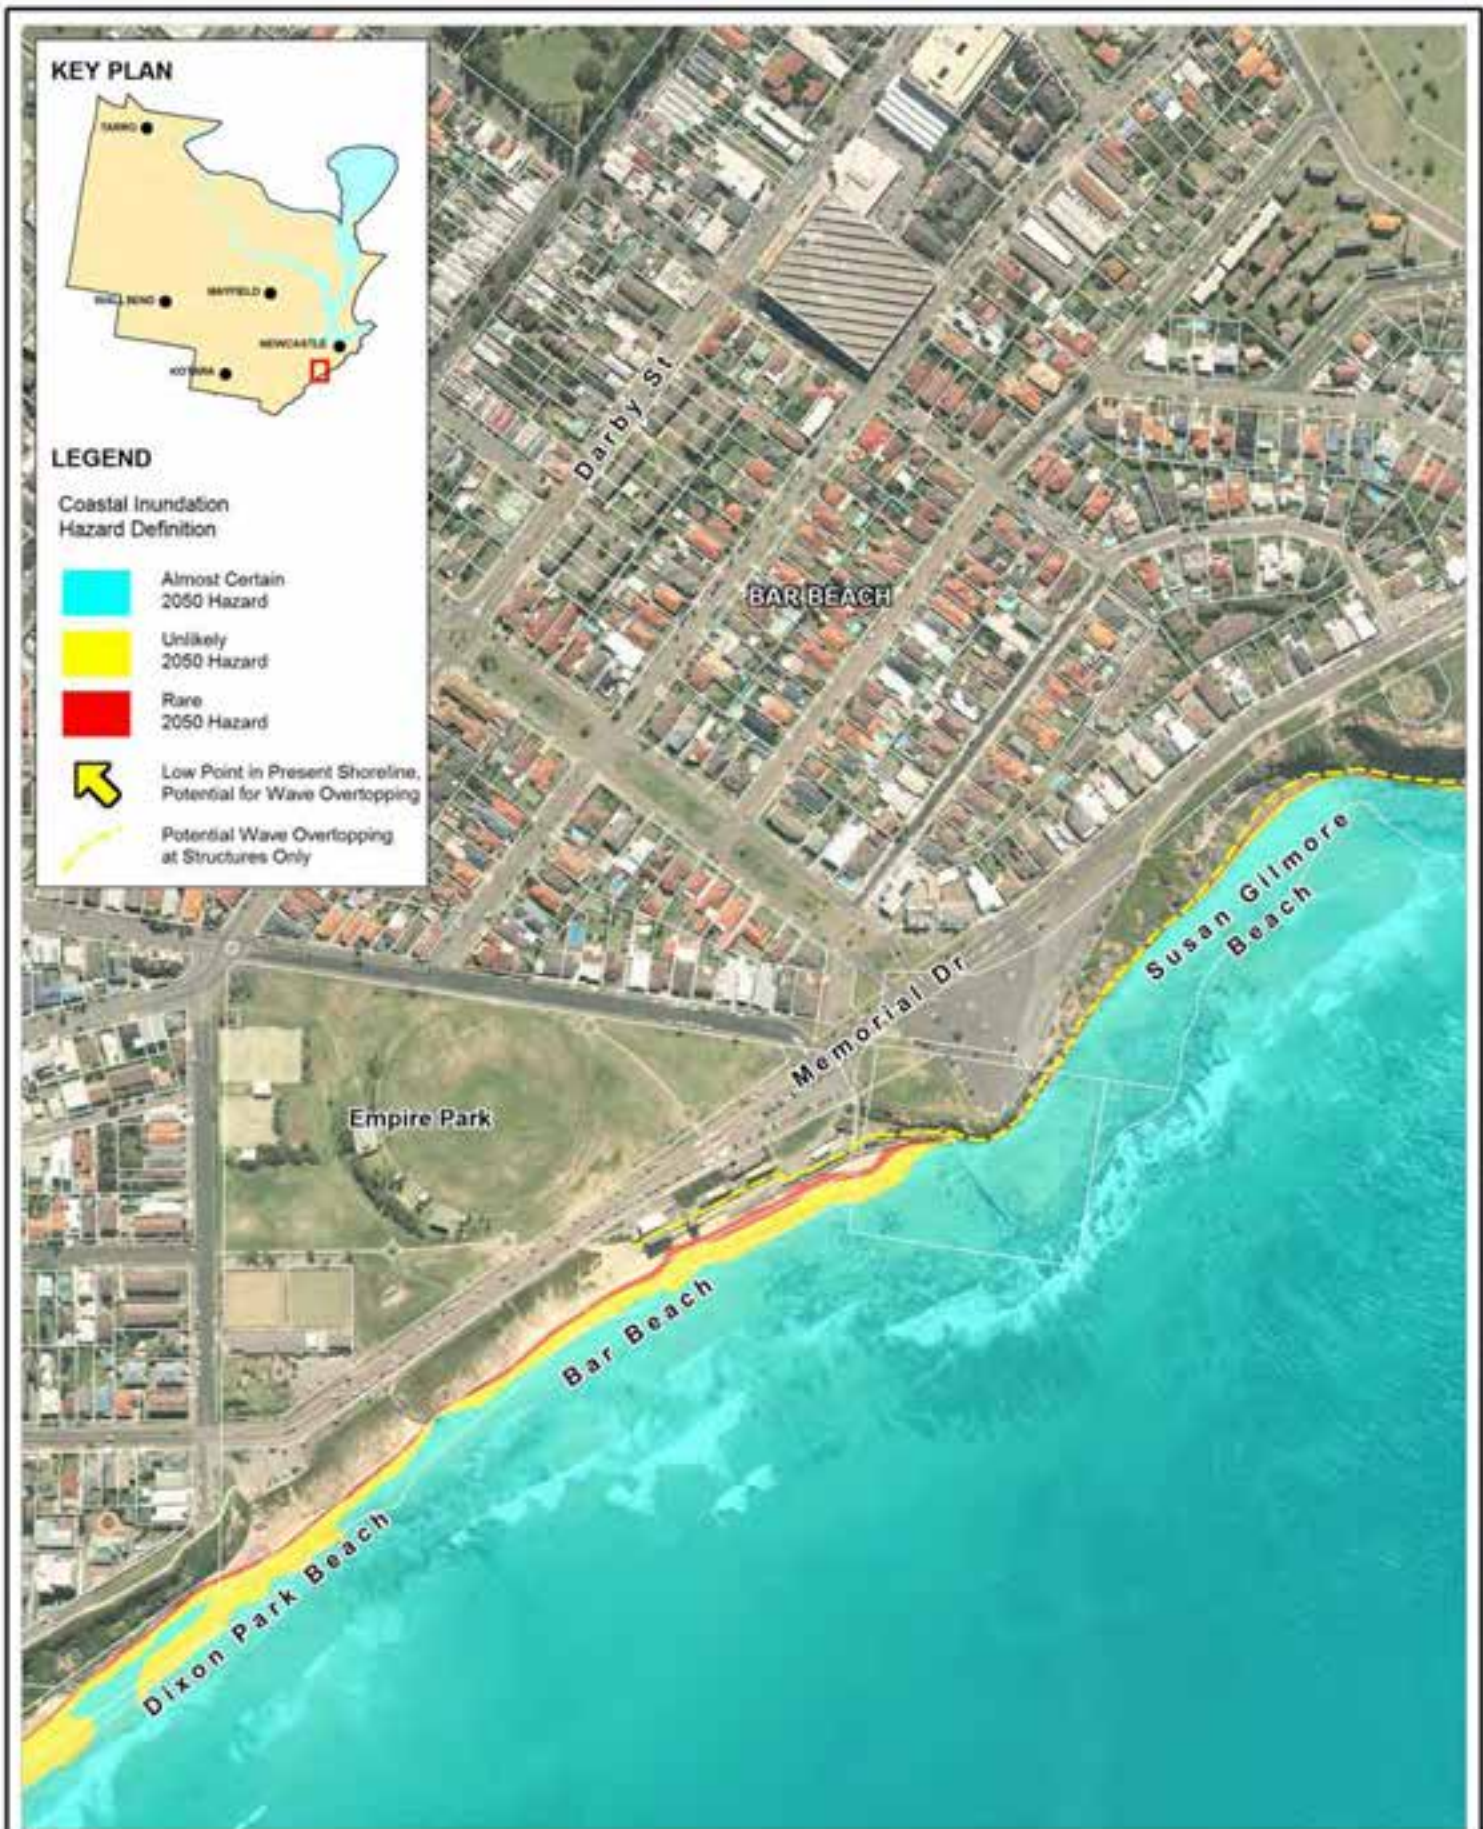
Figure:  
**E-8**

Title:  
**Coastal Inundation Hazard Definition  
 2050 Planning Horizon - Bar Beach**

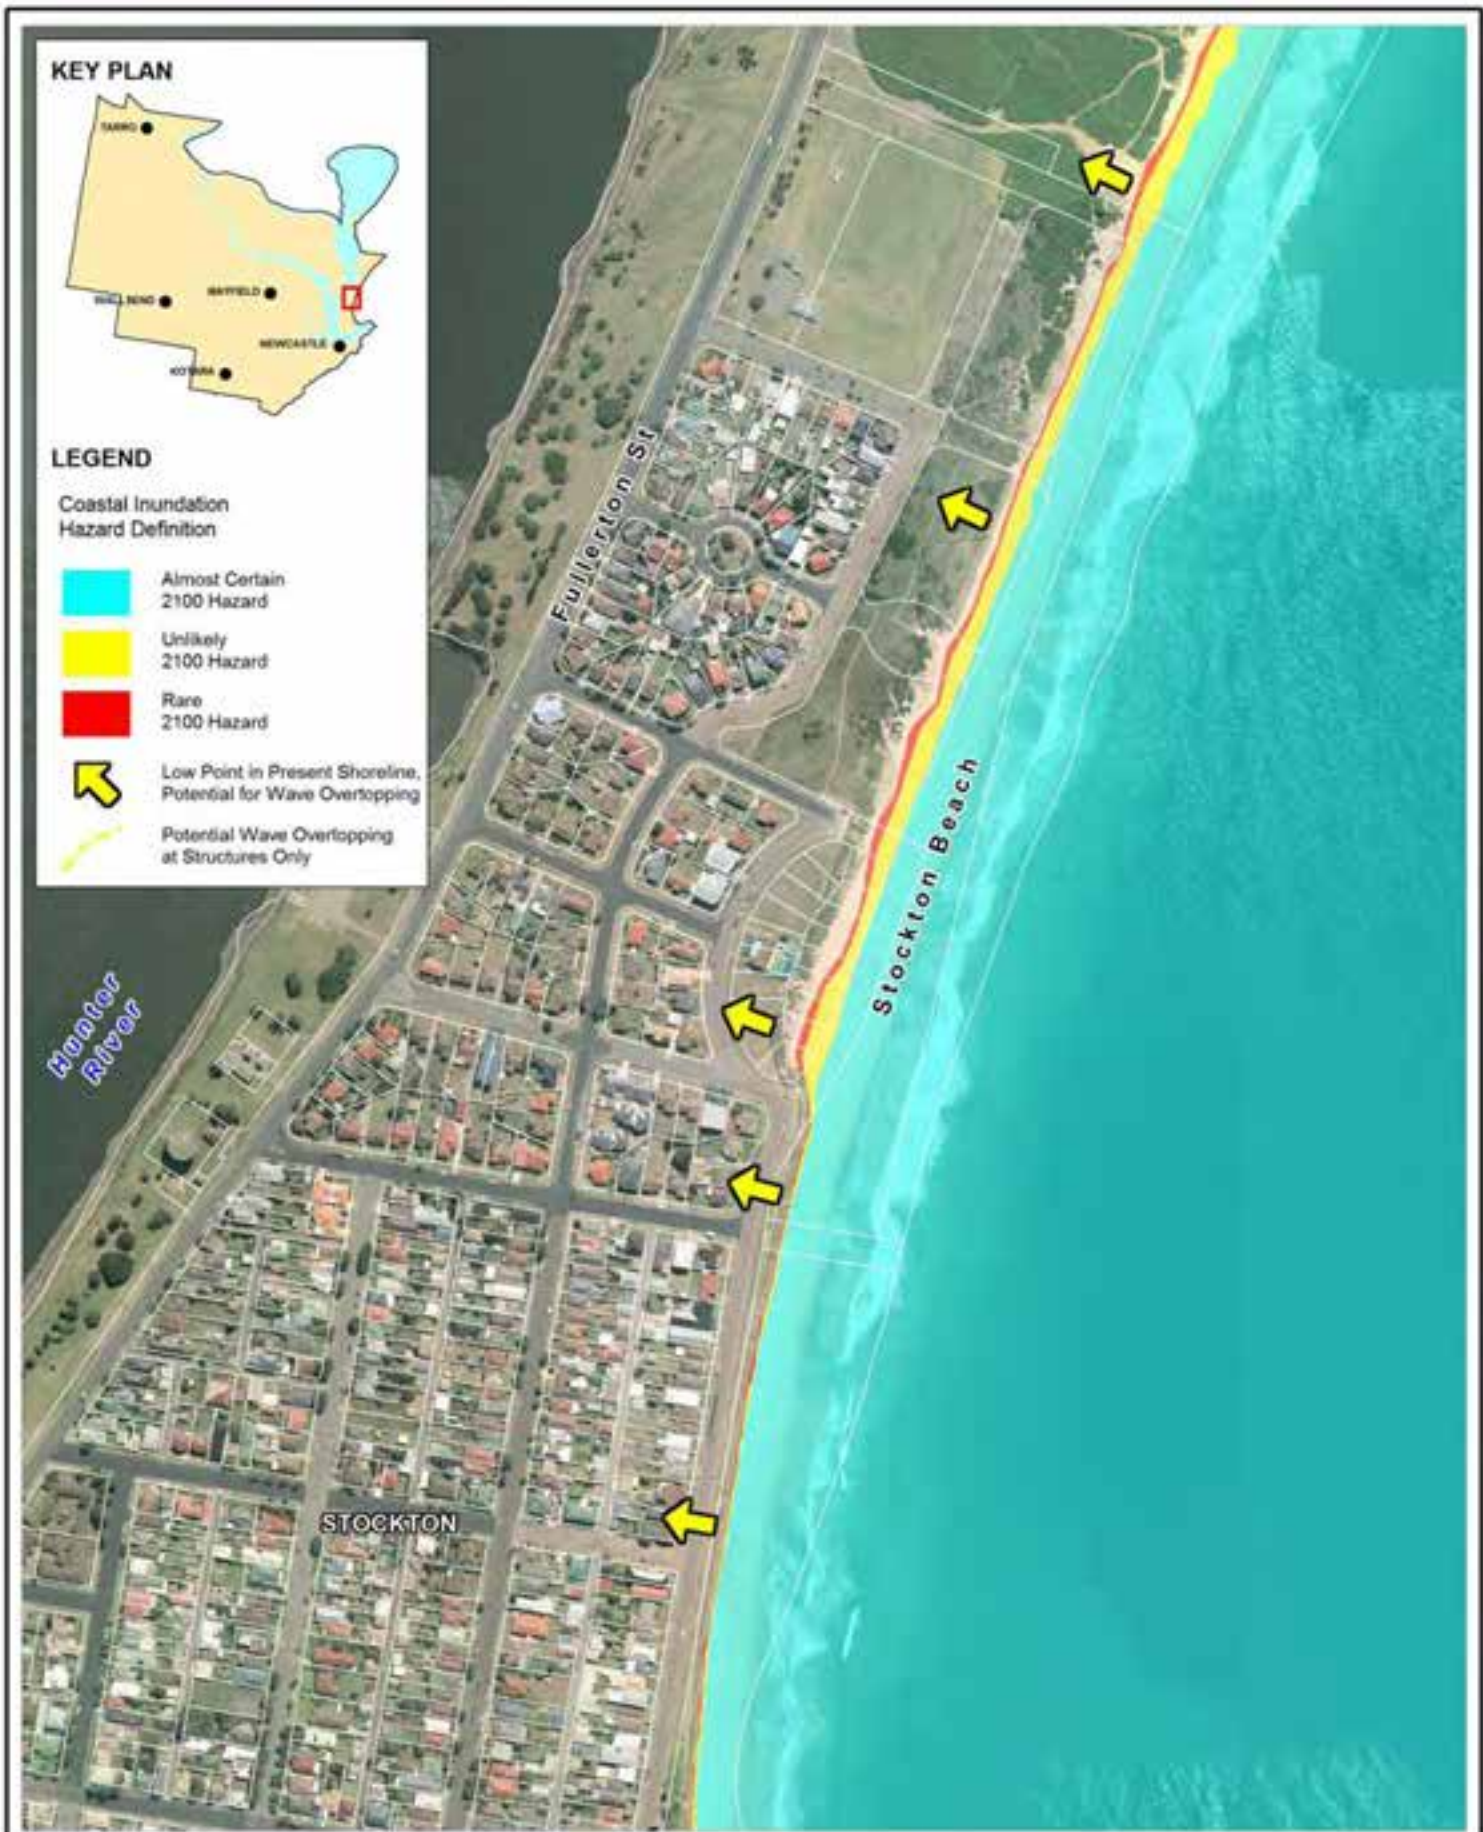
Figure:  
**F-3**

Title:  
**Coastal Inundation Hazard Definition  
 2100 Planning Horizon - Stockton North**

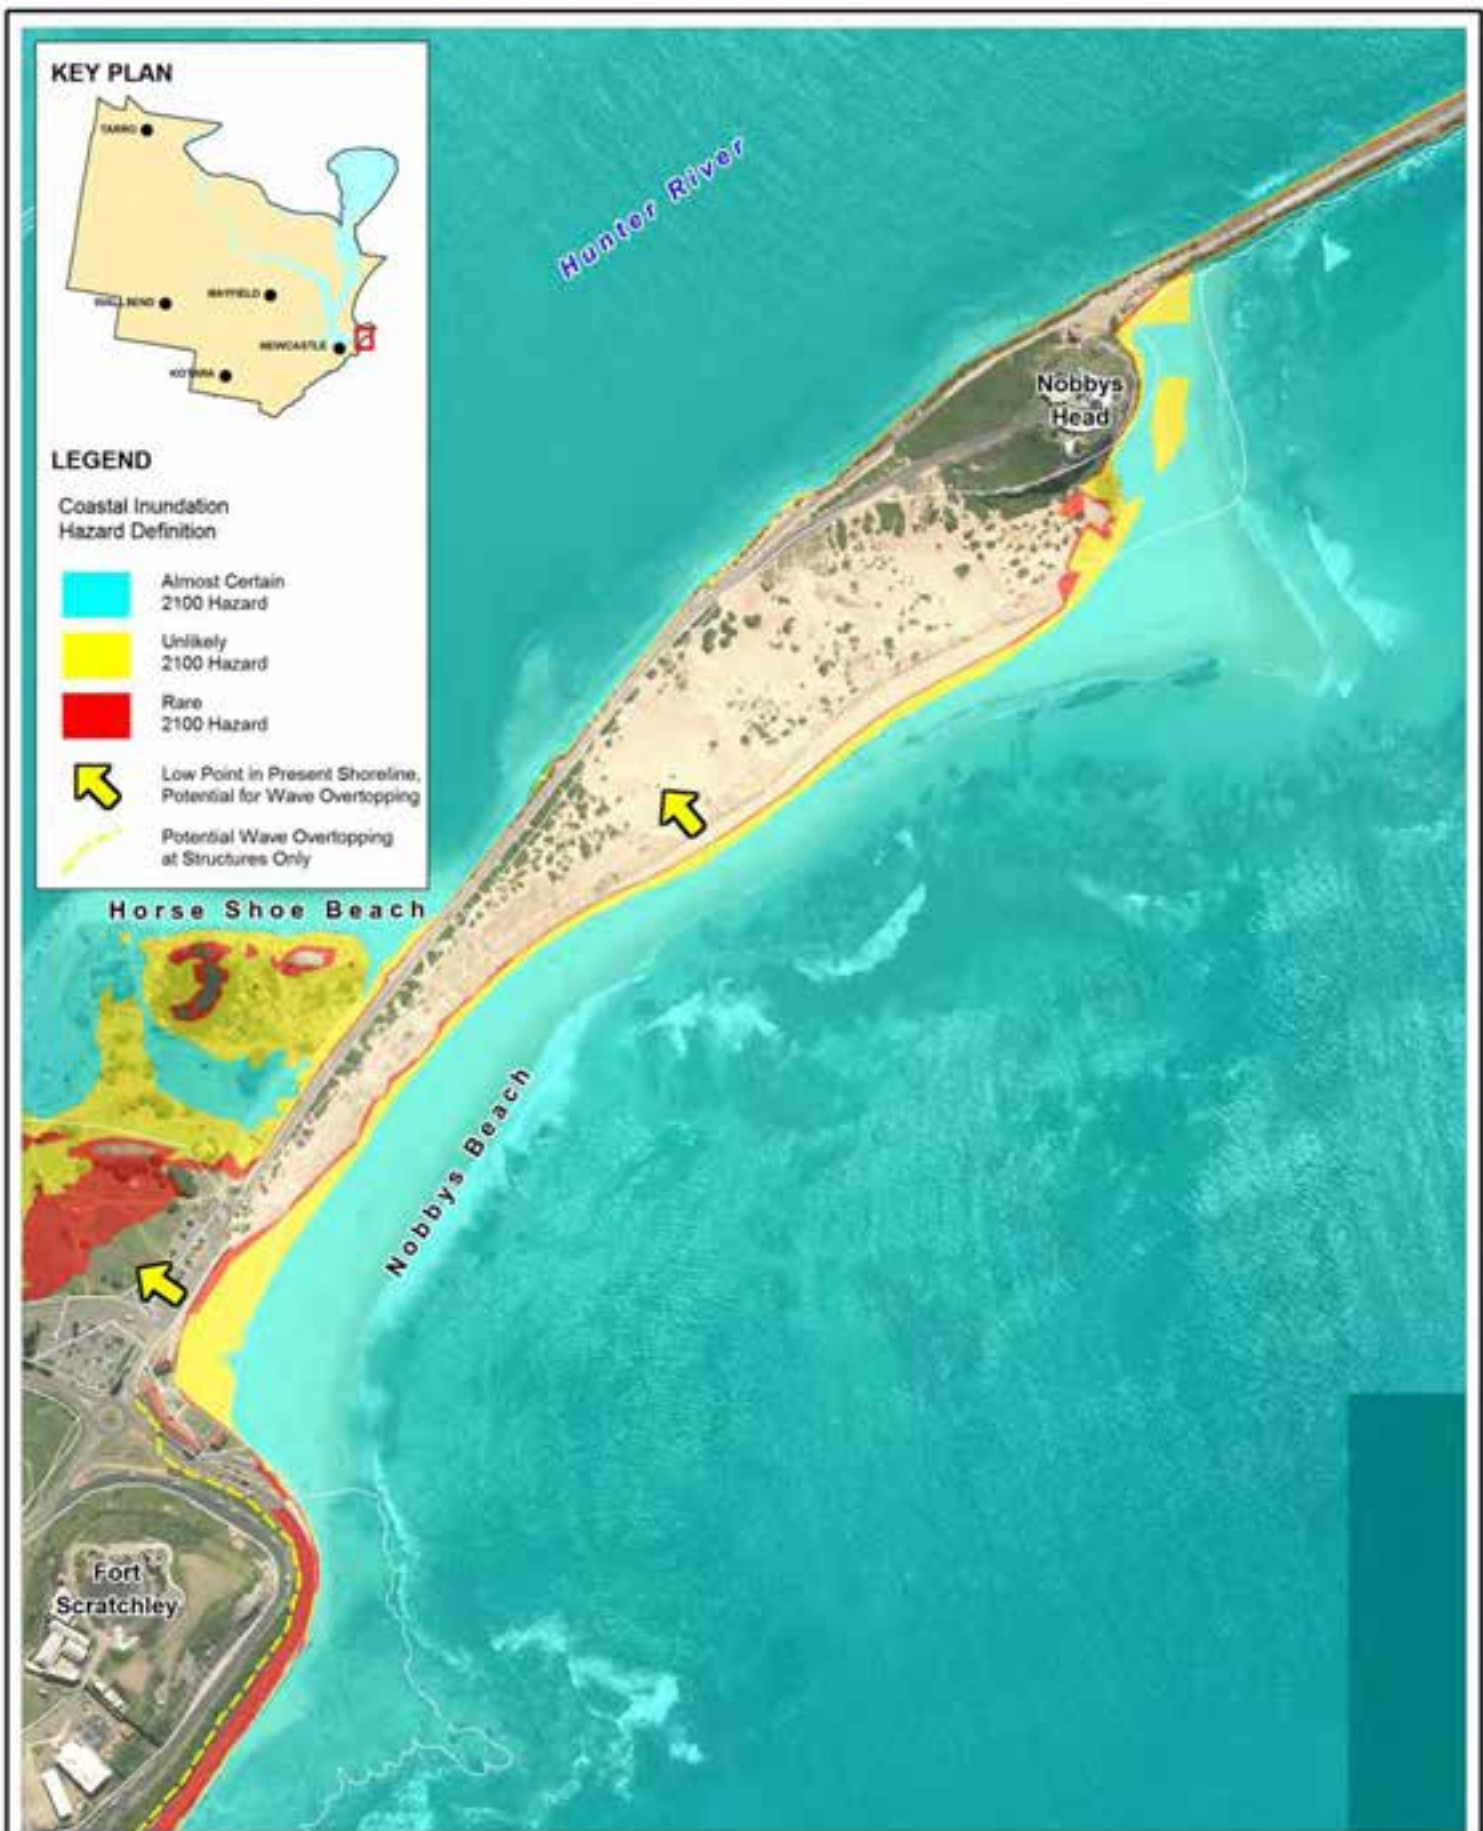
Figure:  
**F-5**

Title:  
**Coastal Inundation Hazard Definition  
 2100 Planning Horizon - Nobbys Beach**

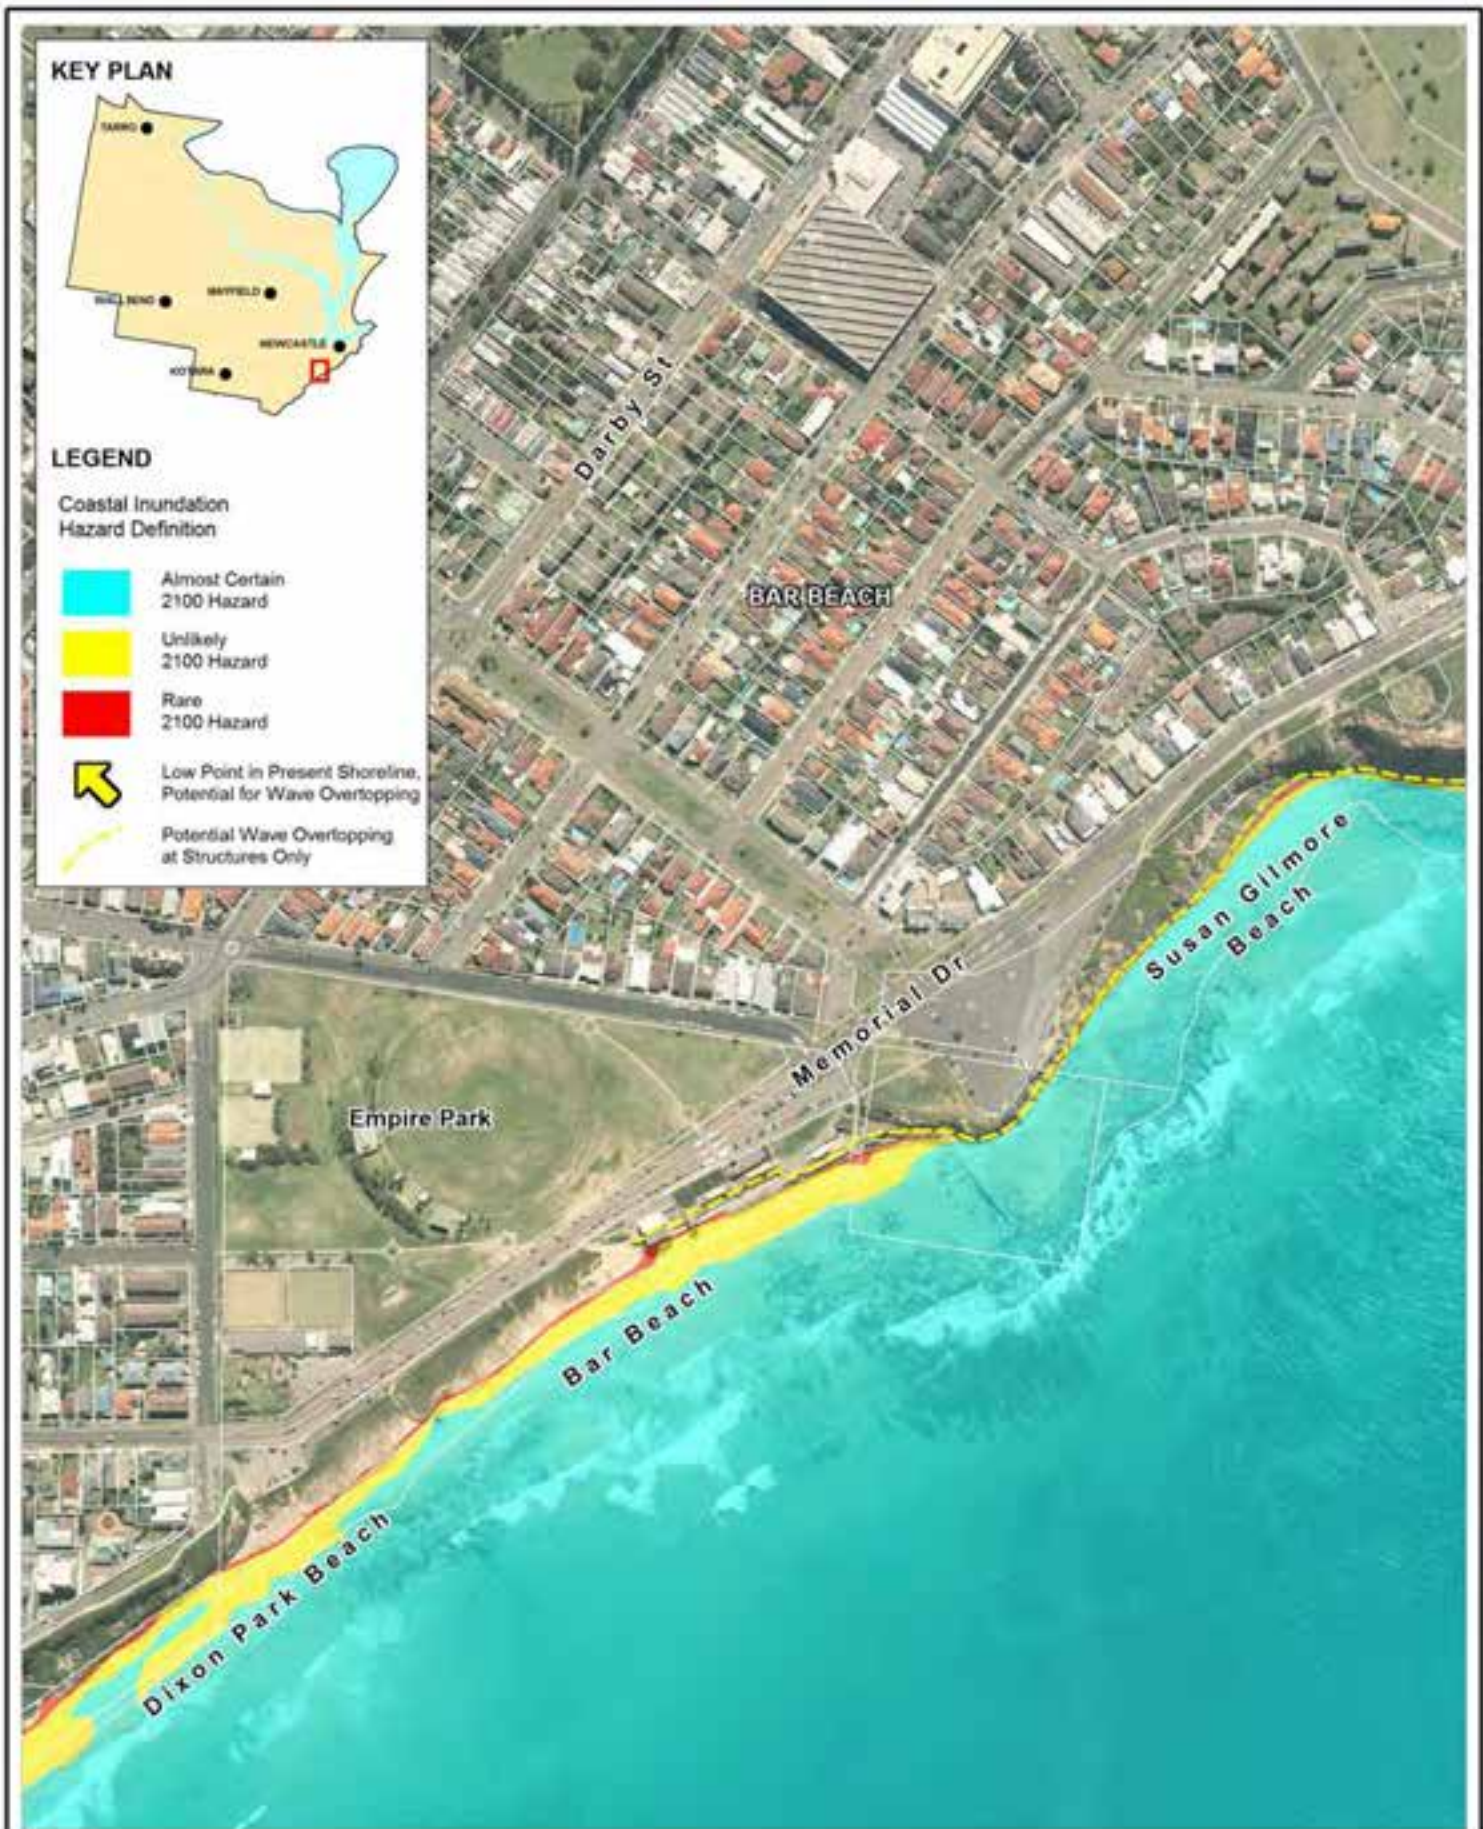
Figure:  
**F-8**

Title:  
**Coastal Inundation Hazard Definition  
 2100 Planning Horizon - Bar Beach**

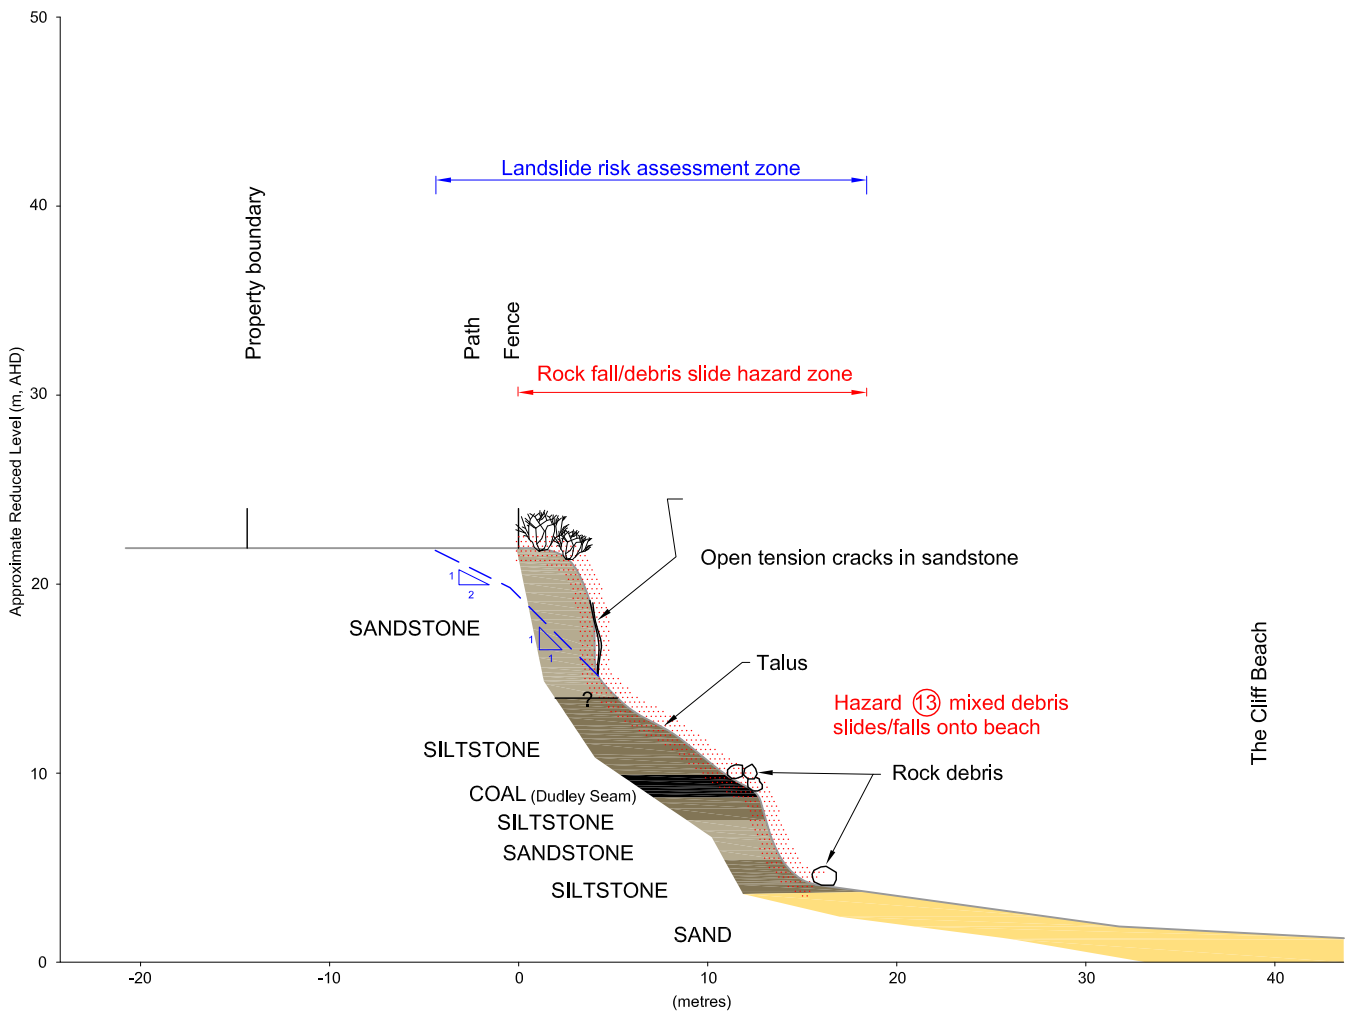
**CROSS - SECTION SKETCH S17  
NEWCASTLE COASTLINE GEOTECHNICAL ASSESSMENT  
KILGOUR AVENUE  
DIXON PARK (THE CLIFF)**

Details of the geo-hazard are shown on **Drawing 3, Long-section G5, and Cross-section S17** in **Appendix A**. Annotated photographs of the identified geo-hazard/ risk(s) are presented as **Figure 18** in **Appendix B**.

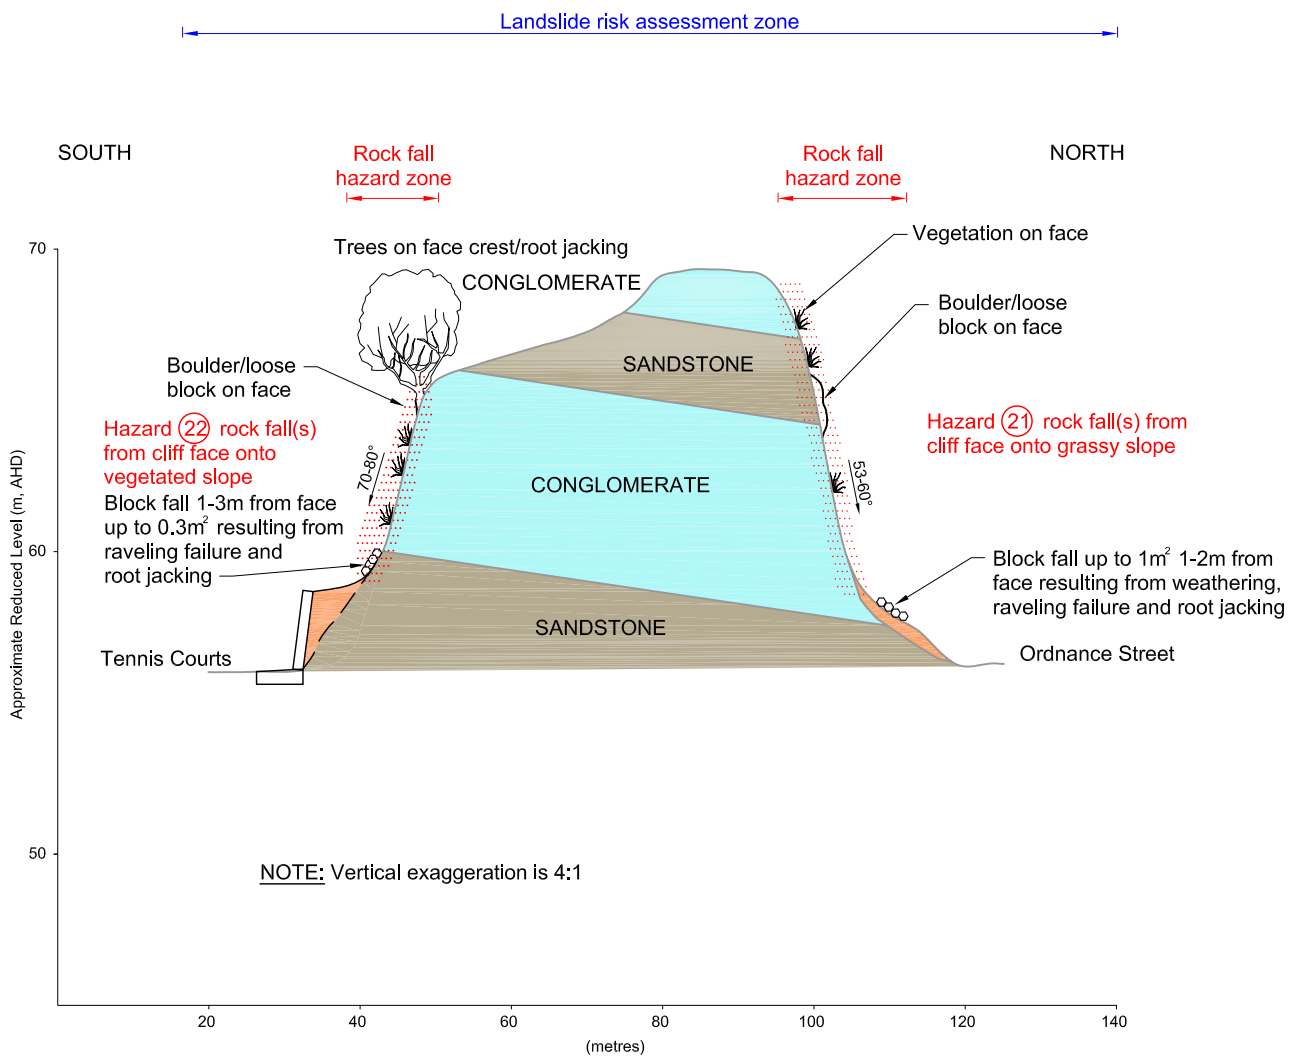
The section is a sketch only  
RL's inferred from LIDAR

NOTE: Vertical exaggeration is 4:1

Refer to figure 22 in Appendix B for photo of Hazard (21)

Refer to figure 23 in Appendix B for photo of Hazard (22)

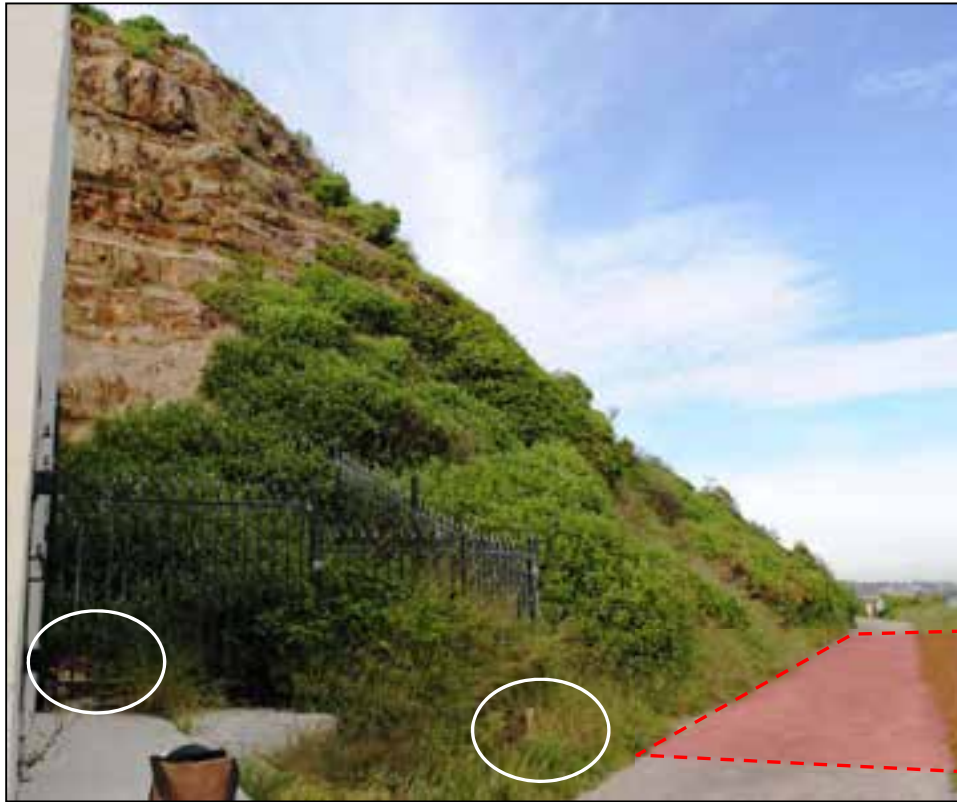
**Figure 1** *Geo-hazard #1 – Rock fall(s) into vegetation, existing fence or onto Nobby’s breakwater shared pathway. Pathway rock fall risk area shown in red. Past rock falls circled.*
