# Newcastle Coastal Zone Hazards Study

## *Final Report*

Prepared For: City of Newcastle

Prepared By: BMT WBM Pty Ltd (Member of the BMT group of companies)

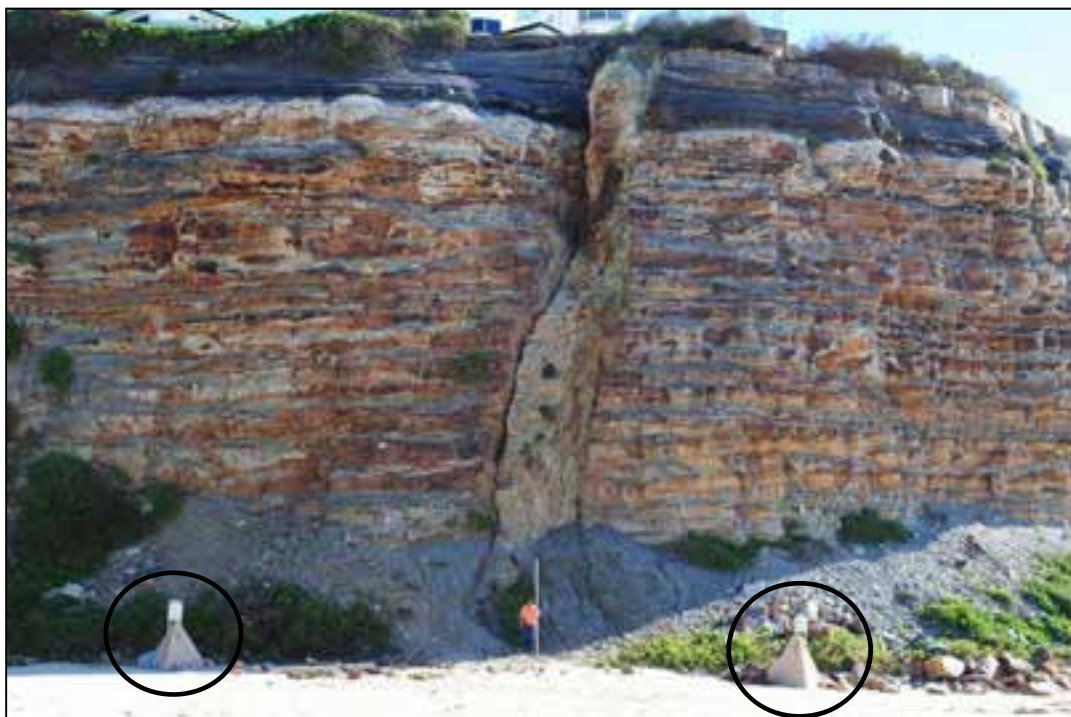
**Figure 2** *Geo-hazard #2 – rock fall(s) from cliff face onto beach. Warning signage (circled) provides visual warning; however ~ 10% of rock blocks have ‘run out’ past signs.*

Nobbys Headland	2	Rock-fall from near vertical face, with talus 'ramp' at toe falls/runs out onto beach below up to a distance of 16m from cliff face. Hazard poses a risk to persons sitting/ lying on beach within 16m of face	Almost Certain	1.00E-01	People within 16m of cliff face	1	3	0.18	0.05	0.5	4.46E-04	1.34E-03	1. Prob Spatial impact estimated from rock fall analysis. 2. Annual temporal spatial probability based on a maximum of 4 people/day in rock fall zone, with up to 30 min exposure = 360 mins per day for five days every week of the year
Nobbys Headland	3	Failure from cliff-top erosion/regression threatening existing structures (historical and contemporary structures);	Unlikely	5.00E-04	Visitors to Nobbys complex within cliff top risk zone	1	4	0.0015	0.05	0.1	3.72E-09	1.49E-08	1. Prob Spatial impact estimated from rock fall analysis. 2. Annual temporal spatial probability based on a maximum of 4 visitors occupy an at risk section of the Nobbys complex for 30 minutes, 2 days a week, once a month each year.

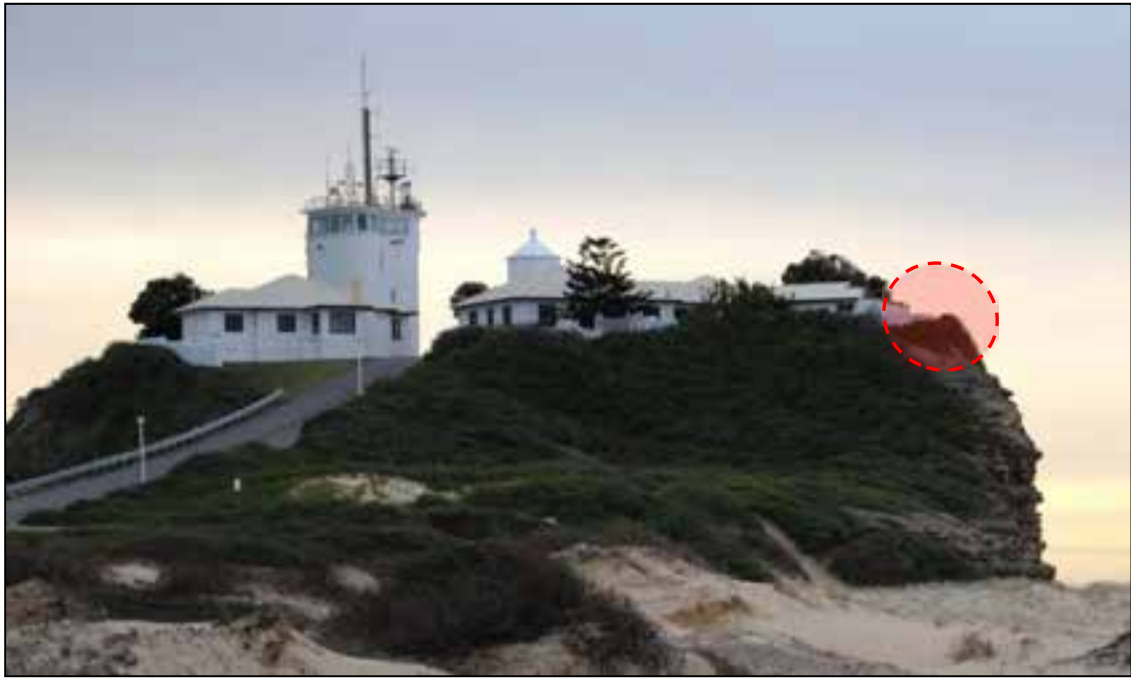
**Figure 3** Geo-hazard #3 – Cliff top regression encroaching into existing development on the south side of Nobby’s Headland. At risk structures (hi-lighted in red) are setback less than 3-5m from crest of weathering cliff face, with one corner of boundary fence ‘suspended’ over steep slope.

Nobbys Headland	3	Cliff-top failure/ erosion/regression damages existing structures (historical and contemporary structures); assumed design life of 120 years	Unlikely	Minor	Low	Very Slow* (15mm-1.6m/yr)	*Individual rock falls are likely to fail very rapidly (5m/sec to 3m/min) Observations indicated cliff top/ slope crest regression due to erosion had reached the perimeter brick fence at two locations, still at least 2m from other structures	Relevant authority to monitor cliff top retreat. Conduct AGS LRM landslide risk assessment at least once every 10 years and/or Upgrade existing brick wall to protect buildings from cliff retreat.
Fort Scratchley Hill	4a	Rockfall from Sandstone outcrops impacts and/or partially blocks a 30m length of Shortland Esplanade adjacent to rock face	Almost Certain	Insignificant	Low	Very Rapid (5m/sec to 3m/min)	Cliff face – undercut/erosion with potential block fall(s) up to 0.6m in dimension into the path of northbound traffic on Shortland Esplanade	Remediate rock face

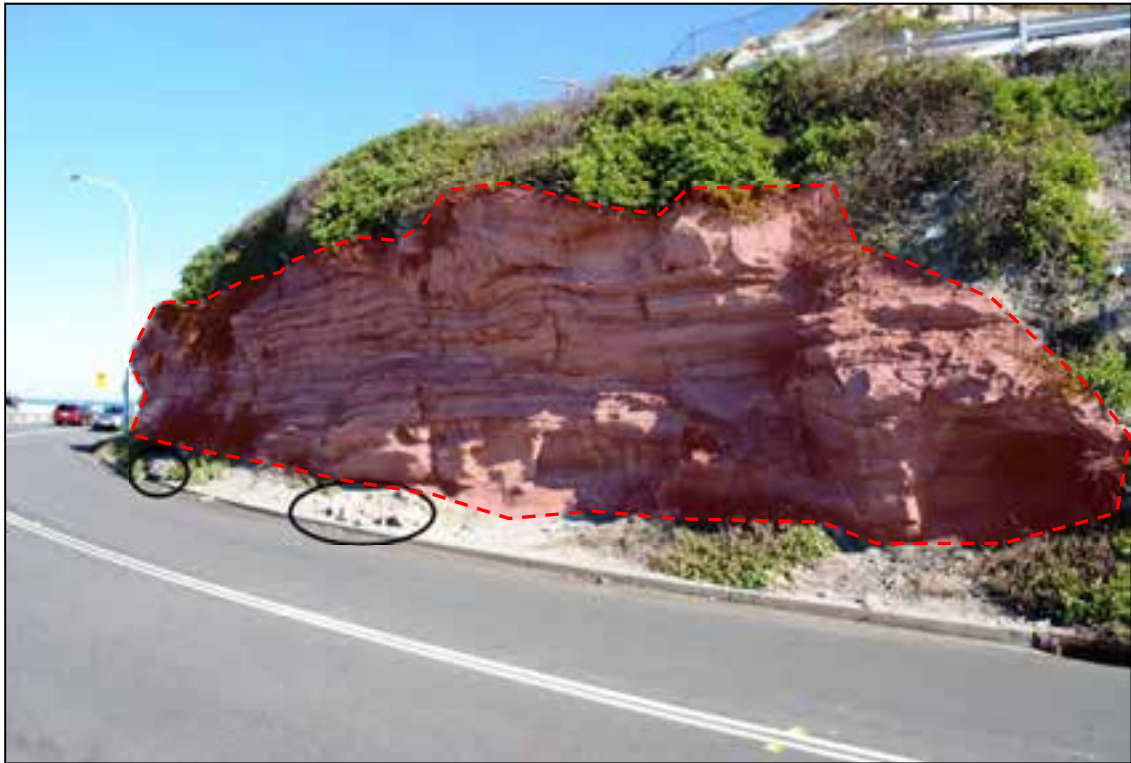
**Figure 4** Geo-hazard #4a – Rock fall(s) onto Shortland Esplanade, hazard area outlined in red. Past rock fall debris, circled in black. Historical photos show rock debris on road.

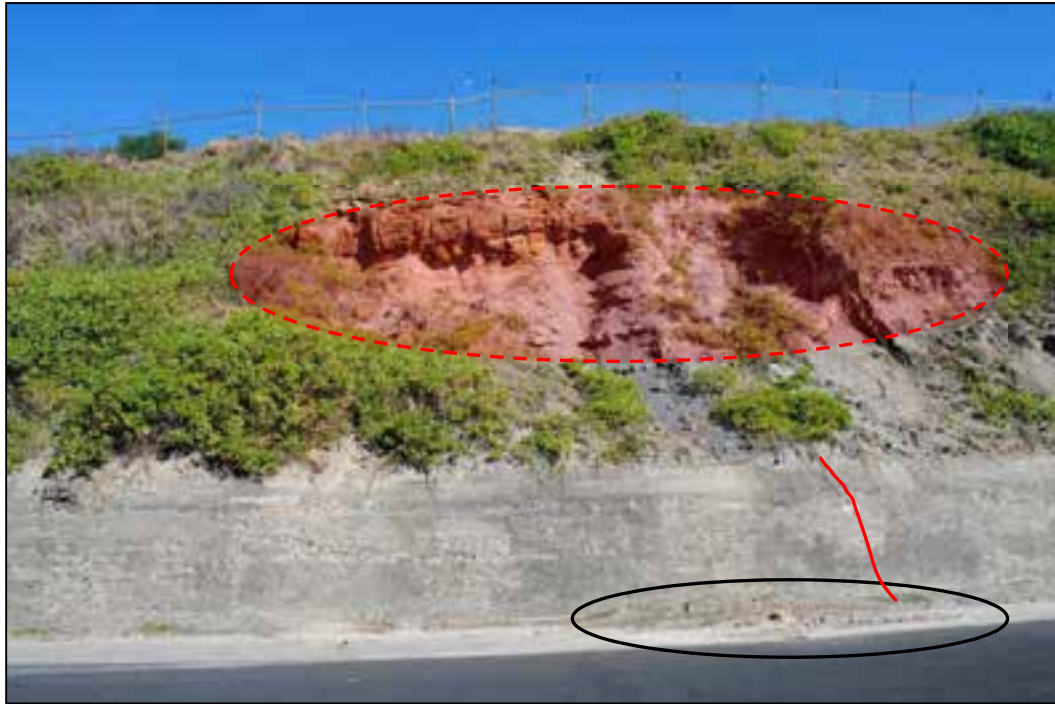
**Figure 5** *Geo-hazard #4b – Rock fall(s) from blocky outcrop (shown in red) onto Fort Drive. Past sediment and rock falls circled. Note, crack (red line) in concrete wall; cracks were observed at several other locations along this wall.*

Fort Scratchley Hill	4b	Rockfall from Sandstone outcrops impacts and/or partially blocks Fort Drive for up to 60m length of roadway	Likely	Insignificant	Low	Very Rapid (5m/sec to 3m/min)	Rock outcrop – undercut/erosion with potential block fall(s) up to 0.6m in dimension into the path of westbound traffic on Fort Drive. Unmarked car parking area adjacent to Northbound lane is at risk.	Install 'No stopping rock fall hazard signs'. Prevent car parking along toe of slope, revetments and retaining walls
Fort Scratchley Hill	5	Landslip of vegetated shallow fill/ soil slope impacts and/ or partially blocks Fort Drive or Shortland Esplanade	Possible	Minor	Moderate	Rapid (3m/min to 1.8m/hr)	No such landslide has been recorded to date; however cracking of concrete retaining wall along toe of northern slopes above Fort Drive indicates potential for failure increasing as condition of wall deteriorates.	Structural engineer to assess condition of the existing concrete revetments and retaining walls.

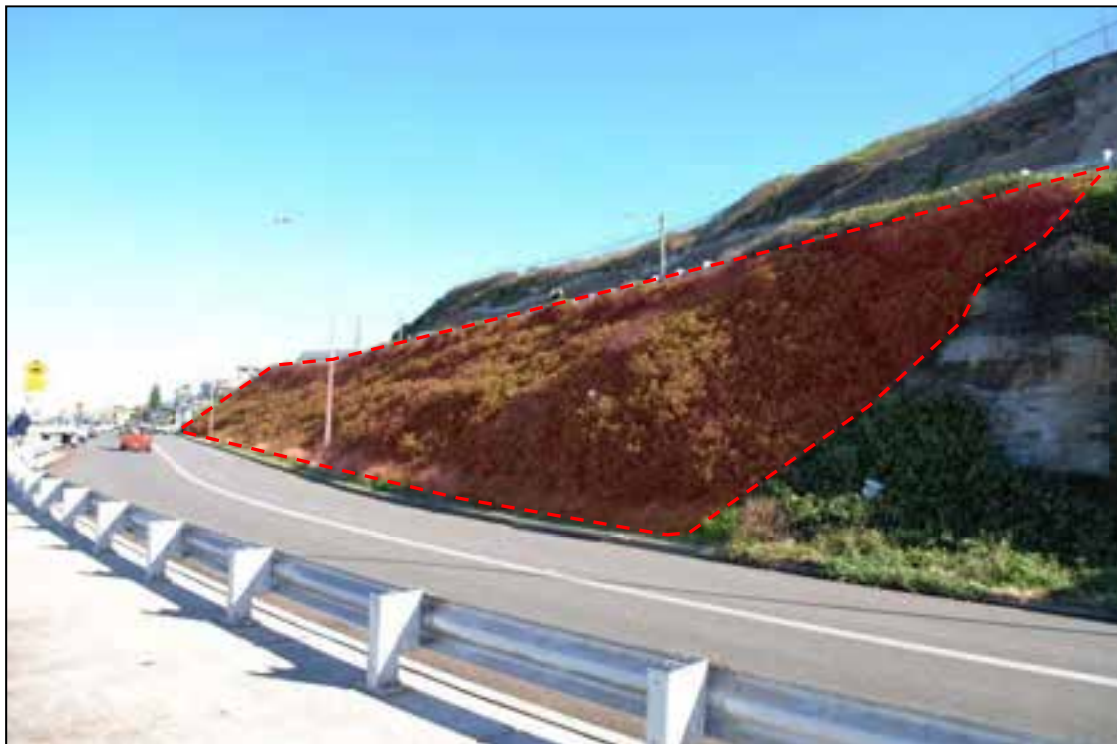
**Figure 6** *Geo-hazard #5 – Vegetation covered fill batter/ shallow soil slope above road, shown in red. Potential for shallow failure of mixed debris onto Shortland Esplanade.*

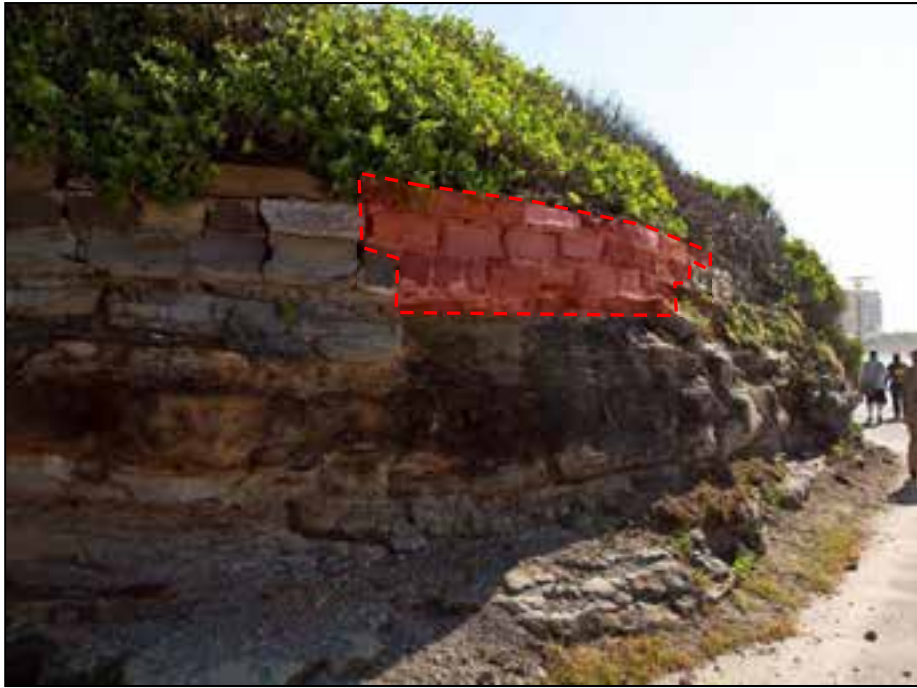
**Figure 7** *Geo-hazard #6 – Unsupported section of block wall (shown in red) falls onto Newcastle Beach footpath. At a meeting on 23/3/2012 CoN reported this section of wall had failed.*

Newcastle Beach	6	Landslide/ block fall due to failure of a section of the old sandstone block wall without footing impacts and/ or partially blocks Bather's footpath	Almost Certain	Insignificant	Low	Rapid (3m/min to 1.8m/hr)	At meeting with CoN on the 23/3/2012, RCA was advised this failure had occurred and wall was to be demolished and slope re-graded. No loss of life, injury or damage to pavement was recorded.	Recommend soil slopes are battered at $\leq 2\text{H}: 1\text{V}$ ; weathered rock cut at $\leq 1.5\text{H}: 1\text{V}$ ; Fresh competent rock cut at $\leq 0.75\text{H}: 1\text{V}$ ; or support steeper slopes with engineer designed retaining wall(s).
Cliff behind Newcastle Beach Skate Park	7	Rock fall/ landslide from cliff impacts talus slope and/or Shortland Esplanade pavement behind waratah mesh fence, with locked gate.	Almost Certain	Insignificant	Low	Very Rapid (5m/sec to 3m/min)	Rock fall analysis indicated rock fall hazard zone extends up to 11m from rock face. Access to rock fall zone is controlled by a 1.9m high waratah mesh fence, with locked gate.	Cliff/slope to be inspected for rock fall/landslide risks prior to any work being undertaken behind fence.

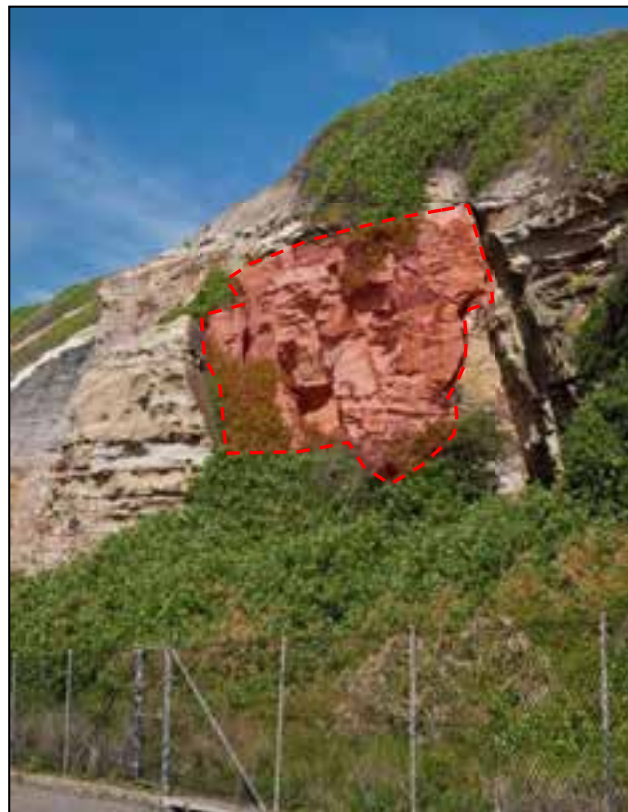
**Figure 8** *Geo-hazard#7 – Massive block(s) fall risk, shown in red. Rock fall analysis indicates it is unlikely to reach fence.*

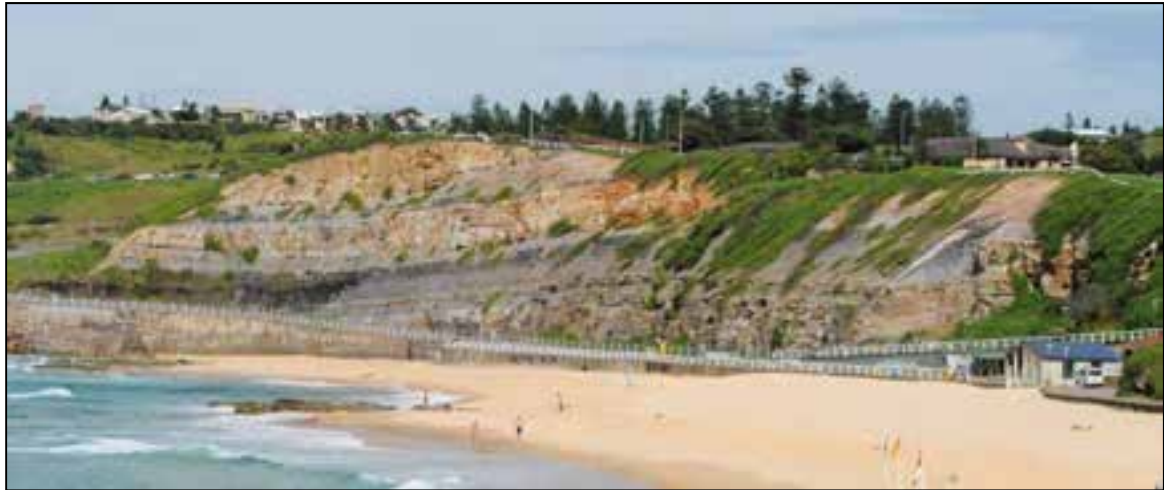
**Figure 9** *Geo-hazard #8– Rock falls from South Newcastle Cliff face.*

The cliff face was extensively re-shaped, 'groomed' and a rock fall barrier fence was installed in 2005 based on a detailed investigation & analysis by GHD Geotechnics. A review in 2011 by GHD Geotechnics indicates the rock fall barrier fence (see Figure 10 below) has stopped all rock falls to date. GHD noted no rock fall blocks in excess of 200mm diameter had occurred since the cliff/slope was re-shaped, 'groomed' and a rock fall barrier fence was installed.

- ⑧ Hazard 8 - Rock fall from cliff adjacent to Shortland Esplanade, South Newcastle Beach  
(See Figure 9 in Appendix B)
- ⑨ Hazard 9 - Shortland Esplanade, seawall rotates out, pavement settles/slumps  
(See Figure 10 in Appendix B)

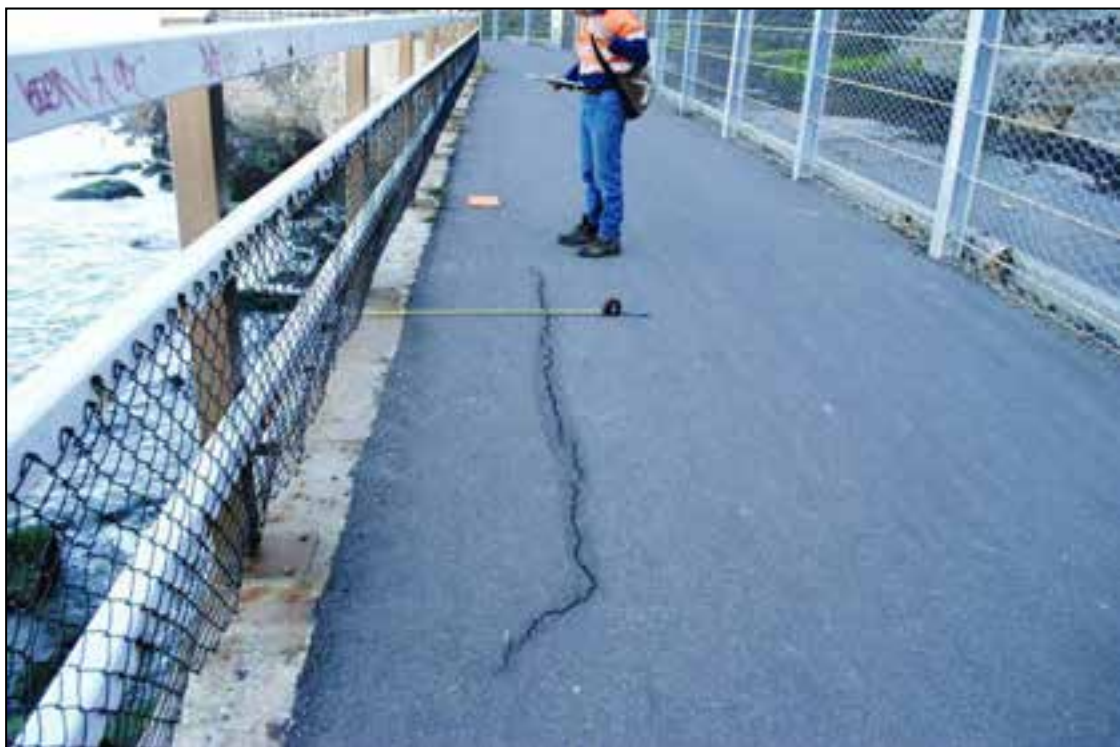
**Figure 10** *Geo-hazard #9– Tension crack/ differential settlement in recently sealed walkway. Hazard associated with deep fill behind sea wall at South Newcastle.*

Note rock fall hazard fence installed by GHD Geotechnics/ CoN to control geo-hazard #8 on right of picture.

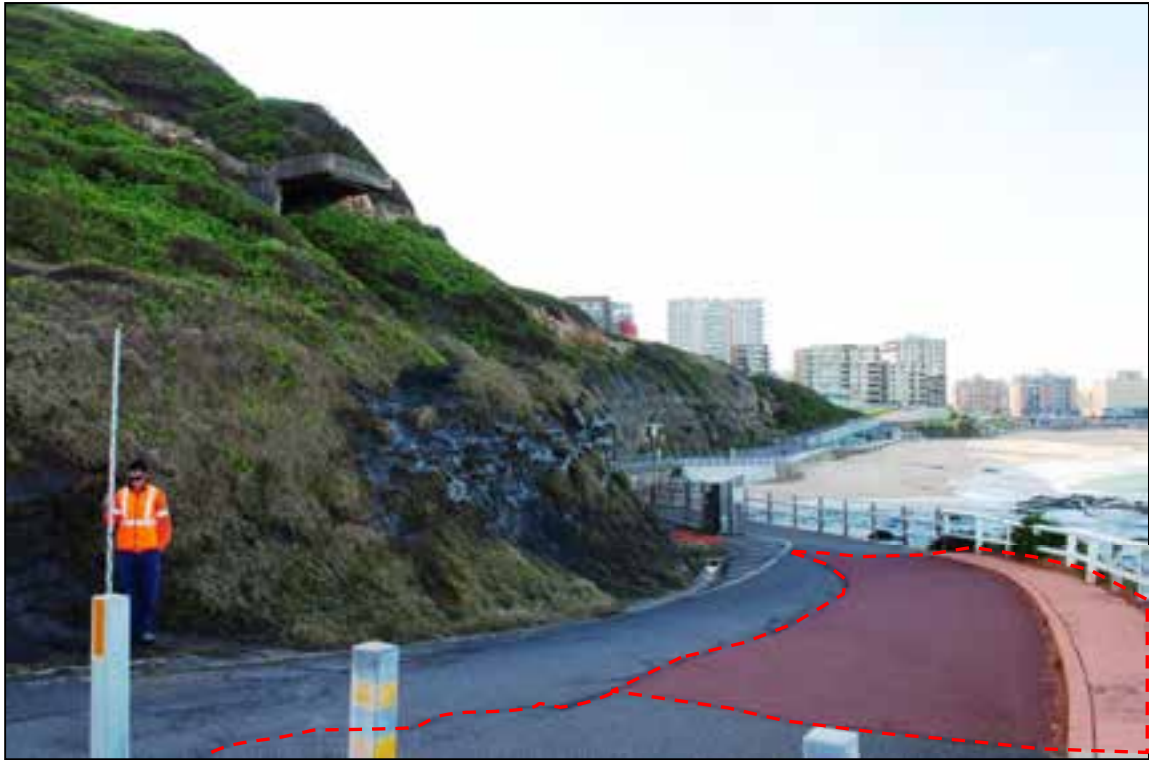
**Figure 11** *Geo-hazard #10 – Tension crack & settlement of coastal edge of Shortland Esplanade, shown in red. Hazard associated with deep fill supported by an old mortar block retaining wall.*

- ⑩ Hazard 10 - Tension cracks in Shortland Esplanade indicate creep settlement/subsidence of fill behind mortared block retaining wall  
(See Figure 11 in Appendix B)

Shortland Esplanade, King Edward Park	10	Loss of public access along Shortland Esplanade, due to stepped failure and/or voids in fill associated with seawall/ retaining wall failure.	Unlikely	Medium	Low	Extremely Slow* ( $<15\text{mm/yr}$ )	*If wall failed then fill could fail at a Rapid (3m/min to 1.8m/hr) rate, as defined in AGS LRM 2007 depending on mode of wall failure. Cracking and settlement of footpath and road pavement observed along coastal edge of Shortland Esplanade.	1. Remove broken footpath and cracked asphalt. 2. Re-grade and compact upper metre of fill. 3. Re-instate asphalt seal and concrete kerb & gutter. 4. Re-instate concrete footpath, optional.
Shortland Esplanade, access to Bogie Hole	11	Loss of public access along Shortland Esplanade, due to stepped failure and/or voids resulting from cliff top soil and/or fill embankment failure.	Likely	Medium	High	Very Slow* (15mm-1.6m/yr)	*Fill embankment could fail at a Rapid (3m/min to 1.8m/hr) rate, as defined in AGS LRM 2007 depending on mode of failure. Instability of fill embankment above sea cliff, with constant seepage along fill/soil interface and bedding dipping out of cliff face. Pronounced step and tension cracks noted in Shortland Esplanade. Abandoned footpath due to erosion/instability of fill embankment.	Subsurface investigation required, install 2-3 inclinometers to determine rate of movement and depth of existing failure.

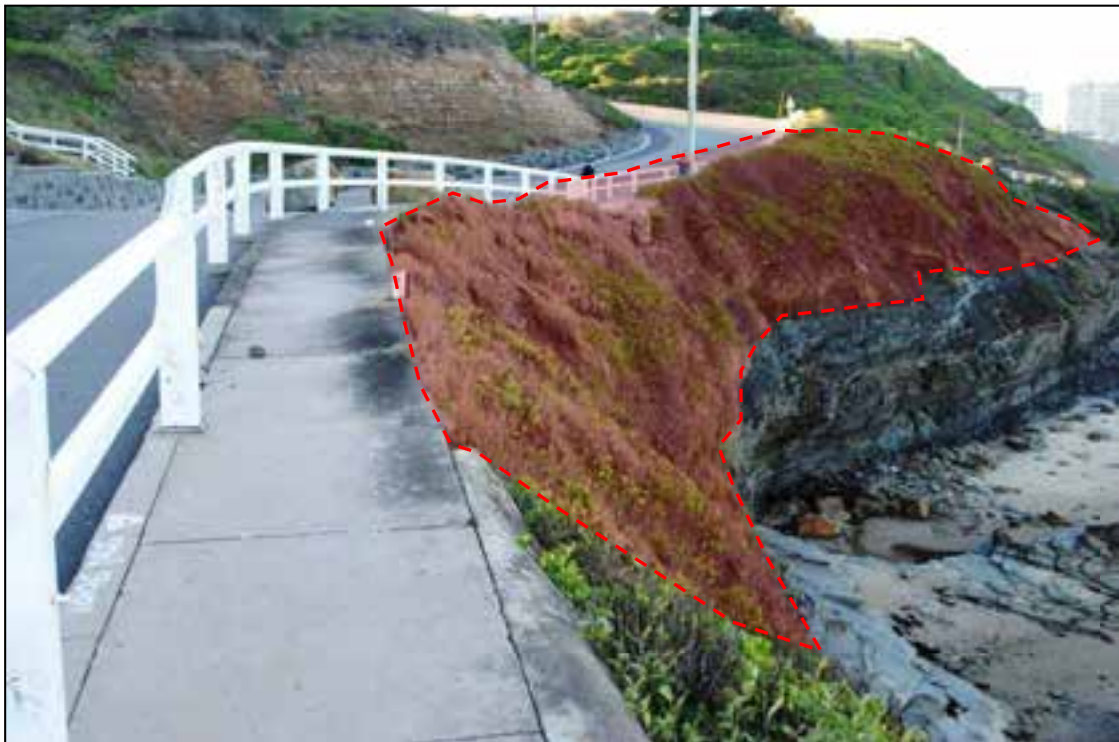
**Figure 12** *Geo-hazard #11 - Creep movement of Shortland Esplanade fill embankment, shown in red, has resulted in stepped/ cracked pavement. Fill embankment creep & instability and sea cliff regression has resulted in loss of access to concrete footpath.*

- ⑪ Hazard 11 - Tension cracks in Shortland Esplanade pavement indicate creep movement out of slope along bedding planes in Siltstone/Shale  
(See Figure 12 in Appendix B)

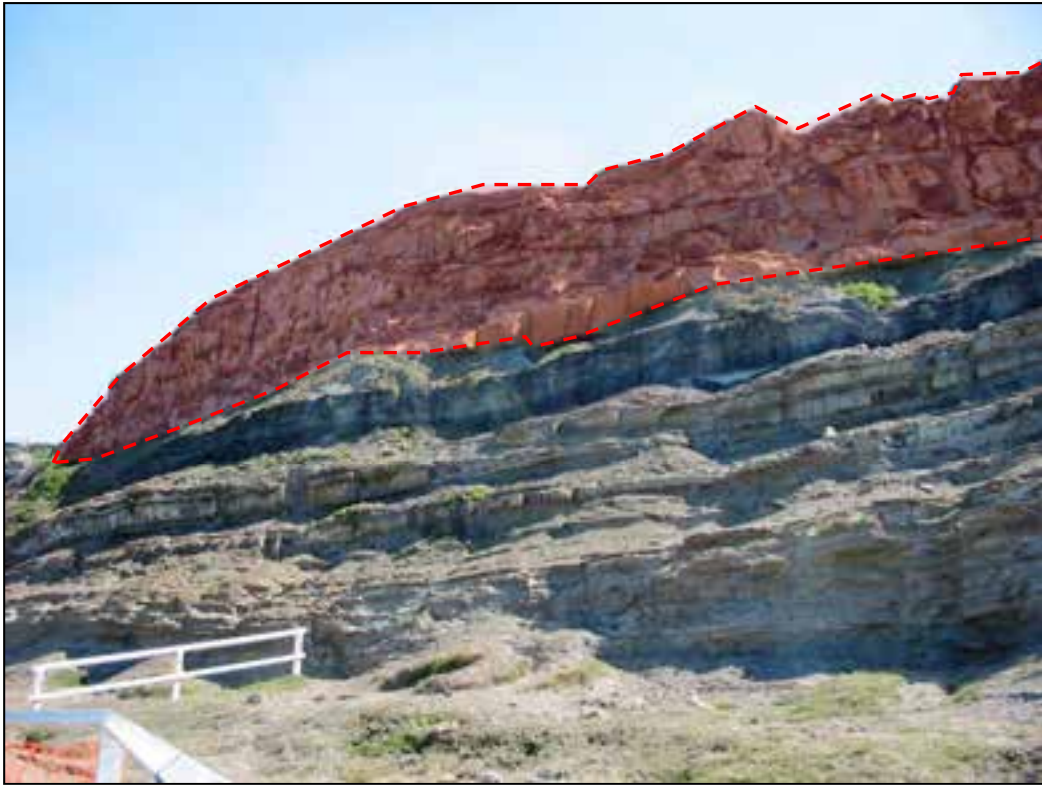
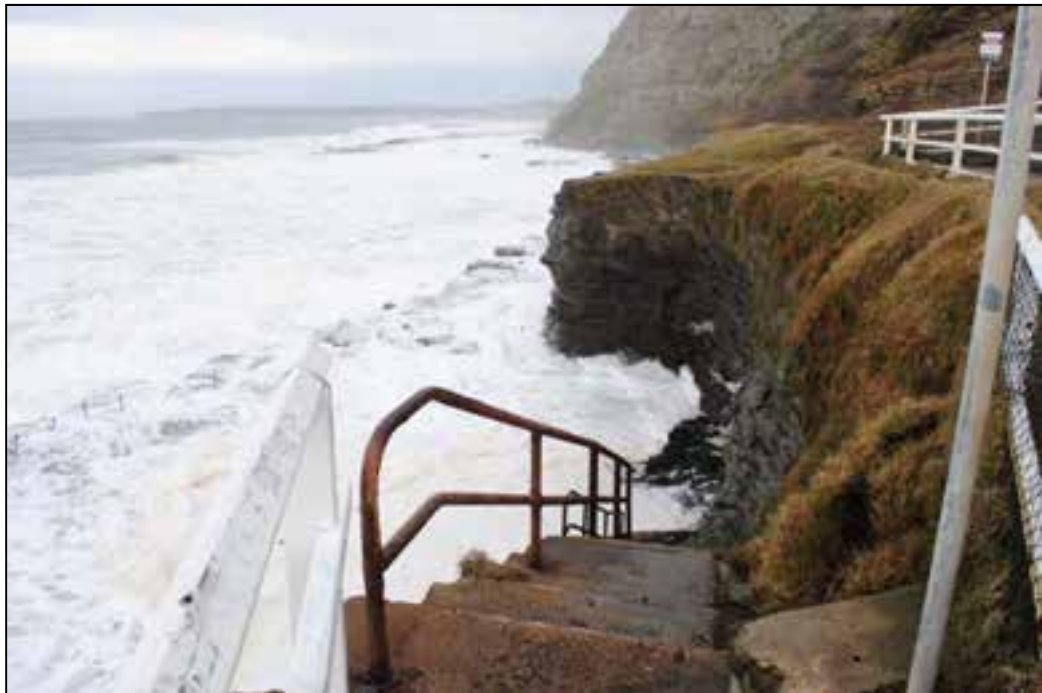
Geo-hazard #12a –Rock falls from cliff above Bogie Hole viewing area, due to erosion & weathering along open joints in a blocky sandstone unit, shown in red. This cliff/slope was ‘groomed’ after 2003 rock fall.

**Figure 13** Geo-hazard #12b – Increased frequency of rock falls due to increased wave attack on sea cliff adjacent to Bogie Hole rock platform.  
 (Photo shows storm swells approximately 1¾ hours past a 1.3m high tide. Wave set up approximates BMT WBM modelled year 2100 mean sea level)

- ⑫ Hazard 12 - Rock fall from slope above Bogie Hole into rock pool  
(See Figure 13 in Appendix B)

Bogie Hole	12	Rock fall from cliff impacts and/or partially blocks access to cliff top viewing area or pool area	Likely	Minor	Moderate	Very Rapid (5m/sec to 3m/min)	Rock fall in 2003 damaged cliff top outdoor furniture & timber fence, pool steps & railing and come to rest in pool. The rock face above the pool was cleared of unstable blocks after failure. 2011-12 inspections indicate erosion/weathering is producing more rock fall hazards.	Remove source unit for rock falls from crest of rock slope, or Construct rock fall catch fence along toe of rock slope.
Cliff Top Shepherds Hill-Strzelecki Lookout (Northern portion of the Proposed Memorial Walk)	13	Cliff top erosion/failure undermines/damages proposed raised walkway and/or viewing platform (Memorial Walk)	Unlikely	Minor	Low	Very Slow* (15mm-1.6m/yr)	*Individual rock falls are likely to fail very rapidly (5m/sec to 3m/min) Cliff top erosion/weathering of conglomerate crest has resulted in cliff top 'necks' less than 2m width at two locations along this section of cliff top.	Specific geotechnical investigation prior to development. Likley advice: 1. Found supports for cliff top walkway 600mm below G.L. and 2. Found supports for footbridges below the base of the 'friable' cliff top conglomerate unit; typically 7-10m thick

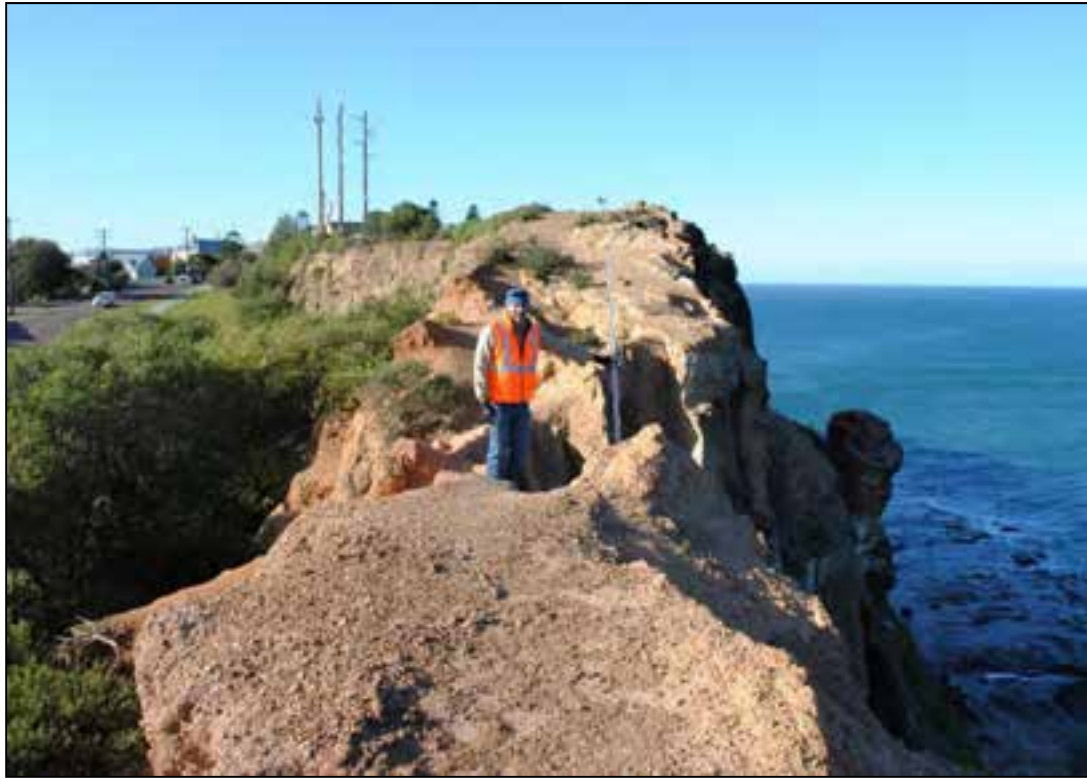
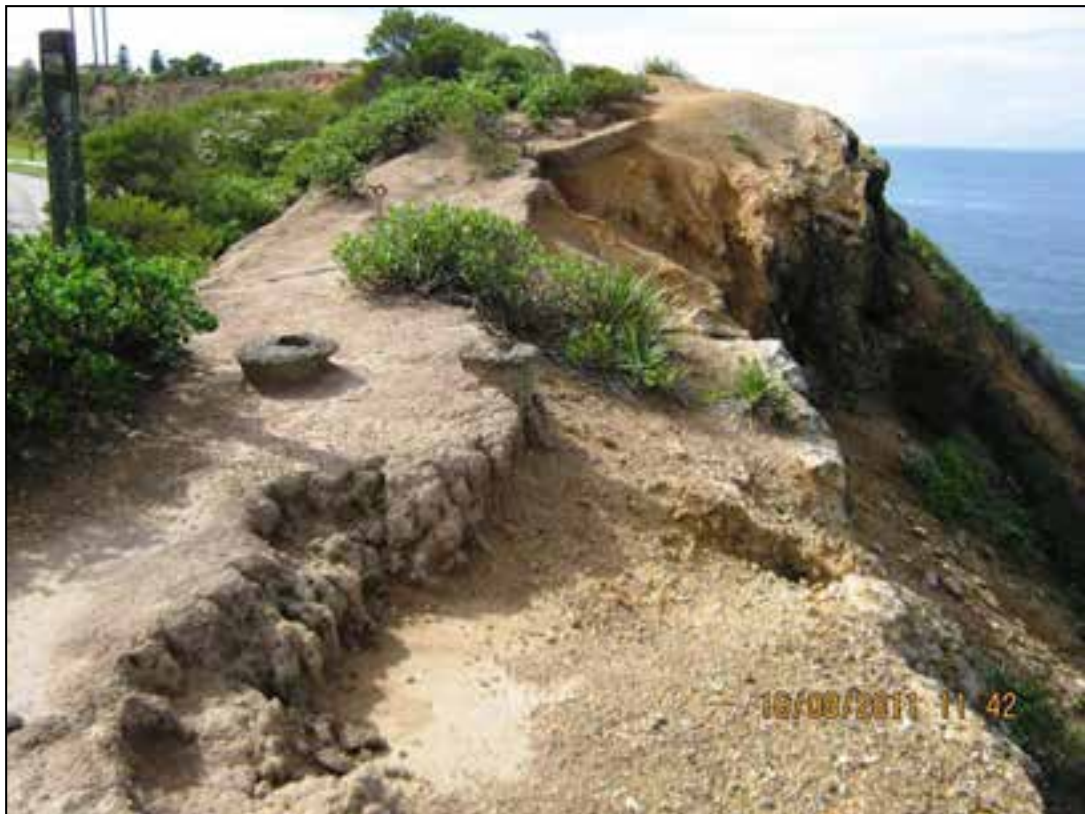
*Geo-hazard #13– Cliff top erosion, northern ‘neck’ above & southern ‘neck’ below*

**Figure 14** *Geo-hazard #13 – Cliff top erosion resulting in ‘necking’ of cliff top from Strzelecki Lookout to Shepherds Hill along the proposed alignment of the Memorial Walk.*

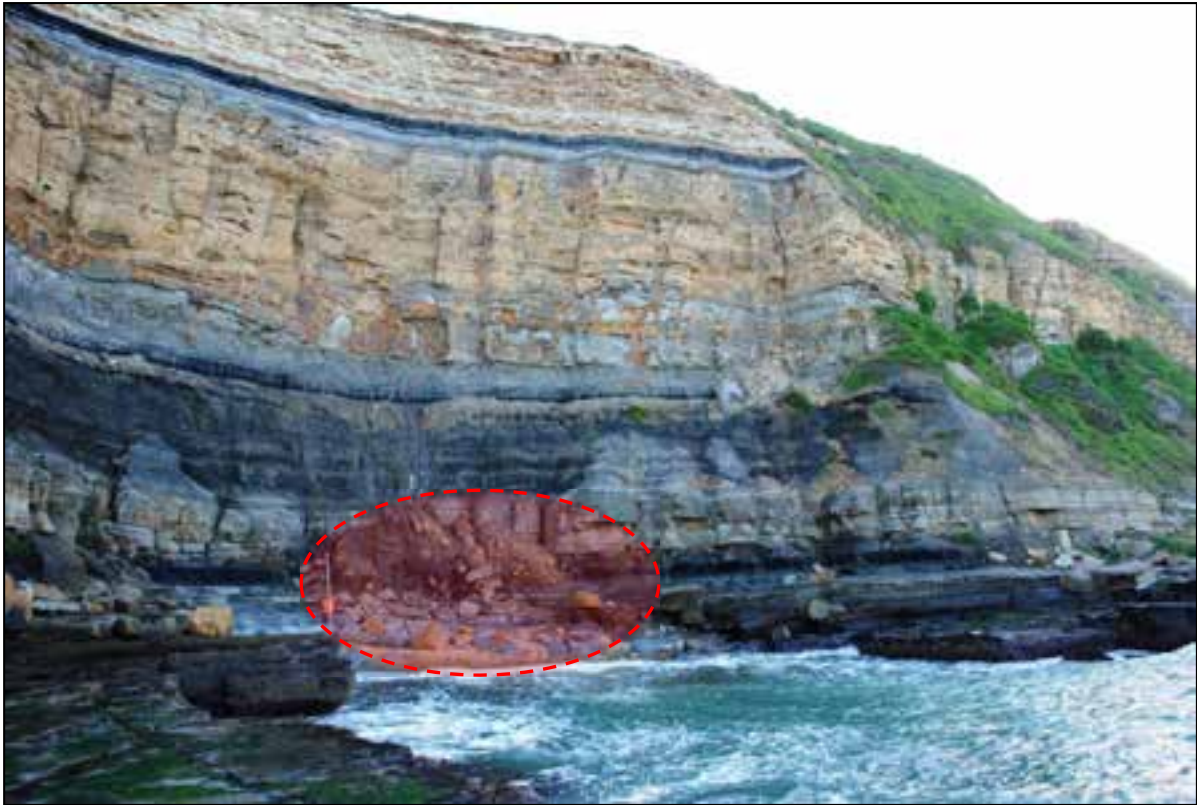
*Geo-hazard #14 – recent rock fall(s) and debris slide circled, covering narrow rock platform at toe of cliff face.*

**Figure 15** *Geo-hazard #14 – Accelerated cliff face retreat, shown in red. Hazard located below Shepherds Hill Trig Stn, adjacent to the proposed Memorial Walk alignment.*

- ⑭ Hazard 14 - Wave action combined with joint swarm in cliff face geology resulting in accelerated cliff retreat under Shepherds Hill, affecting proposed Memorial walk alignment (See Figure 15 in Appendix B)
- ⑮ Hazard 15 - Scouring and active slip failure of slopewash on cliff/slopes above Susan Gilmore Beach due to stormwater discharge onto cliff/slopes (See Figure 16 in Appendix B)
- ⑯ Hazard 16 - Yard Seam exposed to wave action causing rapid undercutting and mass movement threatening Bar Beach Car park eastern edge (See Figure 17 in Appendix B)

Cliff top Trig Stn, Shepherds Hill (Southern portion of the Proposed Memorial Walk)	14a	Cliff top erosion/failure undermines/damages proposed Cliff top safety barrier (Memorial Walk)	Unlikely	Minor	Low	Very Slow* (15mm-1.6m/yr)	*Individual rock falls are likely to fail very rapidly (5m/sec to 3m/min) Cliff top erosion/weathering of conglomerate crest has resulted in cliff top 'necks' less than 2m width at two locations along this section of cliff top.	Specific geotechnical investigation prior to development. Likley advice: Found posts for cliff top safety fence 600mm below G.L.
Rock platform /Beach below Trig Stn, Shepherds Hill	14b	Rockfall/landslide impacts and/or partially blocks 'notch' in rock platform/ beach below	Almost Certain	Insignificant	Low	Extremely Rapid ( $\geq 5\text{m/sec}$ )	Existing rock fall debris actually facilitates access across 'notch' in rock platform at high tide	Access at own risk, beware of falling rocks warning sign

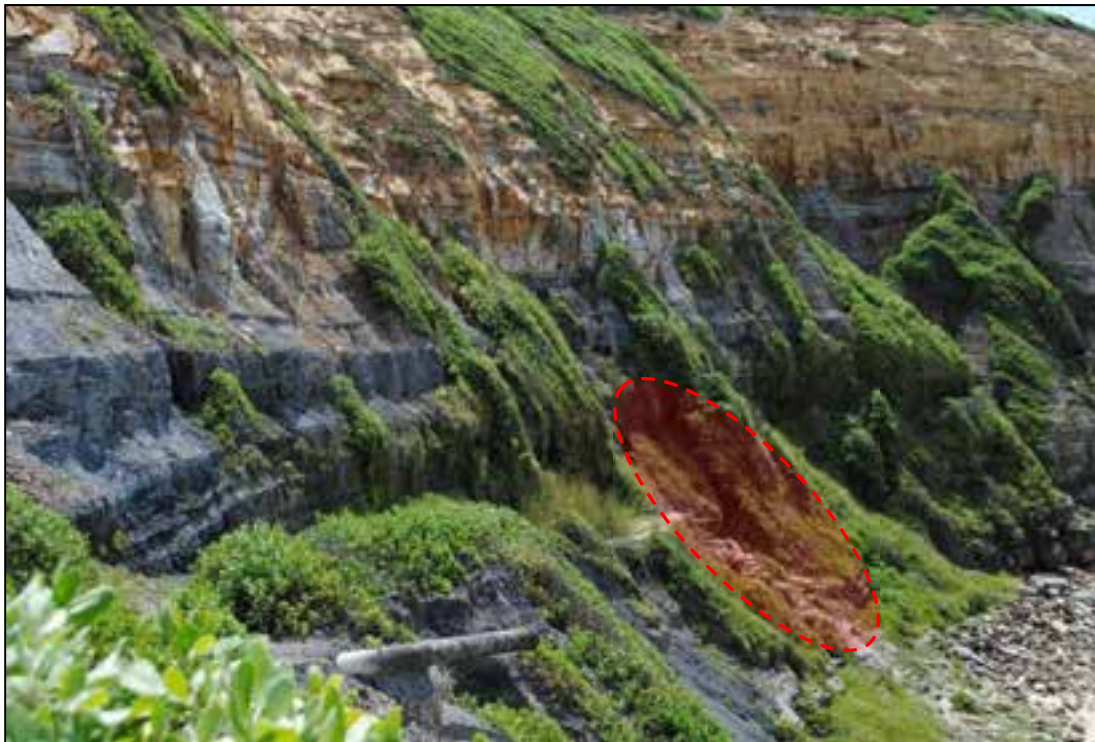
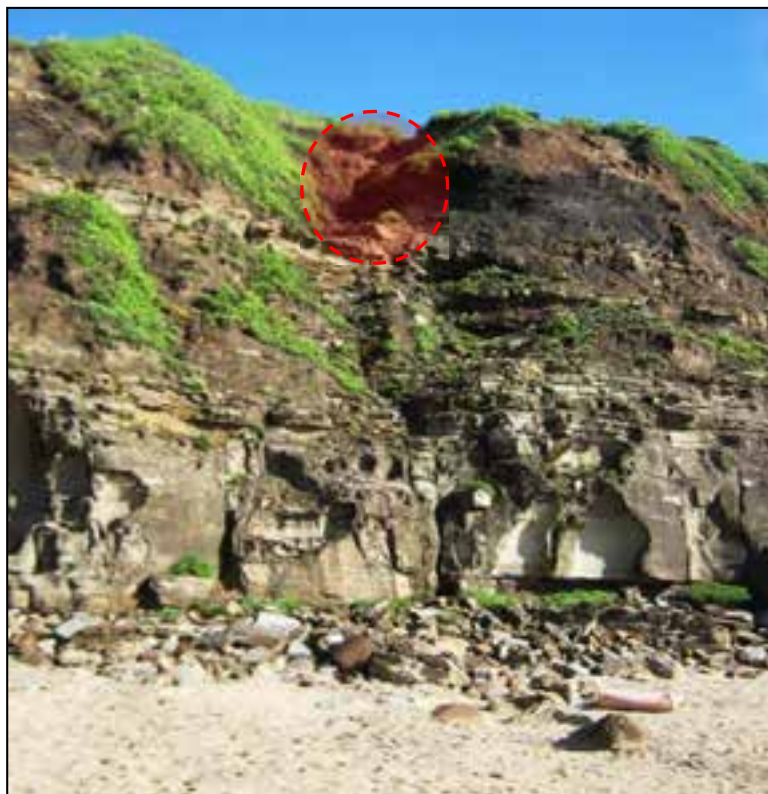
*Geo-hazard #15 – Landslide failure in May 2001 destroyed hillside staircase to Susan Gilmore Beach, circled.*

**Figure 16** *Geo-hazard #15 – Cliff / slope deeply scoured by stormwater discharge onto upper and mid-slope areas. Soil/ extremely weathered rock and Dudley Seam almost completely eroded in circled area by stormwater discharge.*

Susan Gilmore Beach	15	Cliff/slope erosion/failure impacts and/or partially blocks closed footpath and/or Susan Gilmore Beach	Almost Certain	Insignificant	Low	Rapid (3m/min to 1.8m/hr)	Debris slide in 2001 demolished a timber stairway that provided public access from the lower end of a concrete footpath down to the beach. On-going scour/erosion of cliff/ slope by uncontrolled stormwater discharge onto slope is contributing to slope instability.	Re-locate stormwater outlets to base of slope.

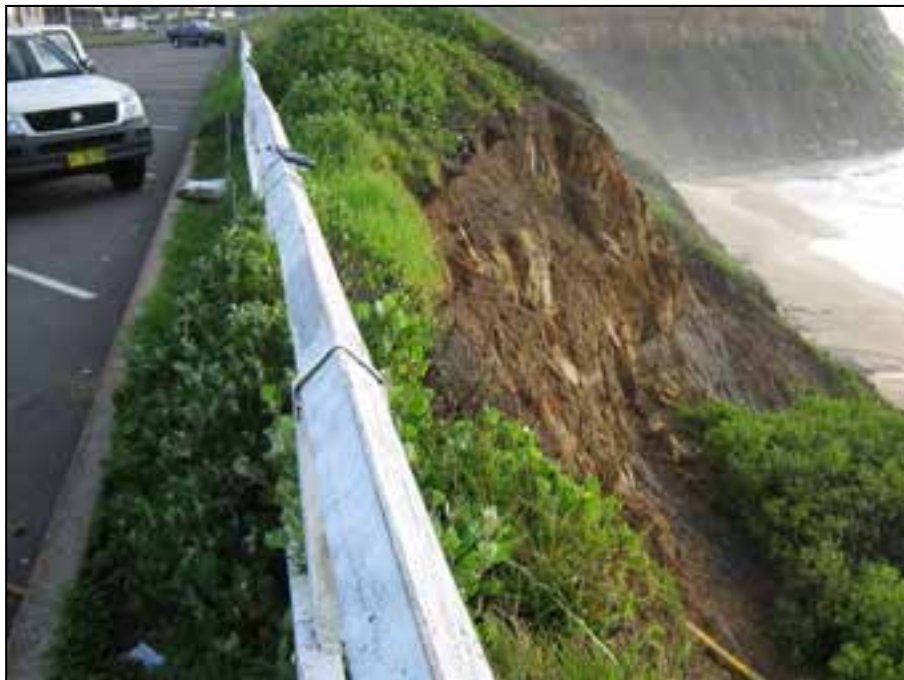
*Geo-hazard #16a – Yard Seam exposed to wave action at base of cliff leading to toppling of large (up to 4m<sup>3</sup>) blocks affecting the entire cliff face/ slope & threatening Bar Beach Car Park above.*

**Figure 17** *Geo-hazard #16b – Accelerated weathering/regression of the Dudley Seam & low strength rocks exposed mid-slope of cliff/slope are resulting in upper slope landslides threatening Bar Beach Car Park along crest of cliff/slope.*

Bar Beach-Susan Gilmore Beach Rock Platform	16b	Cliff/Slope erosion/failure impacts and/or partially blocks access to beach/rock platform below	Almost Certain	Insignificant	Low	Rapid (3m/min to 1.8m/hr)	Coal seam (Yard Seam) is exposed near base of cliff. Retreat of the coal seam due to wave action is undercutting overlying blocky sandstone and opening rock defects resulting in wedge failures and toppling. Past block falls are not preventing coal seam retreat under current conditions and it is anticipated the increasing frequency of wave attack with rising water levels will increase rates of mass movement/ landslides. Expected to result in retreat of cliff top affecting Bar Beach car park eastern area (i.e., towards cliff edge).	CoN to monitor slope stability on an annual basis and/or after rainfall events $\geq 1$ in 100yr. CoN to commission a detailed Landslide Risk Assessment if cliff top assets come under threat.

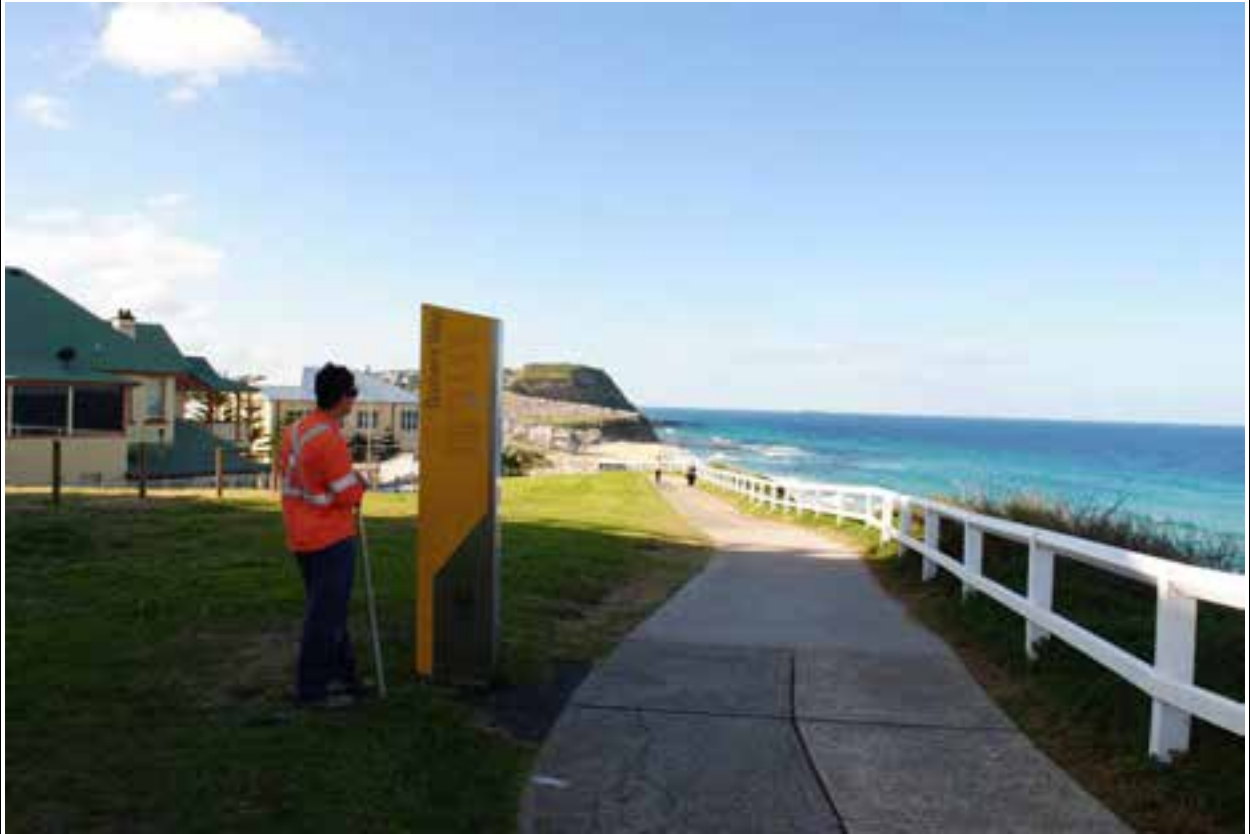
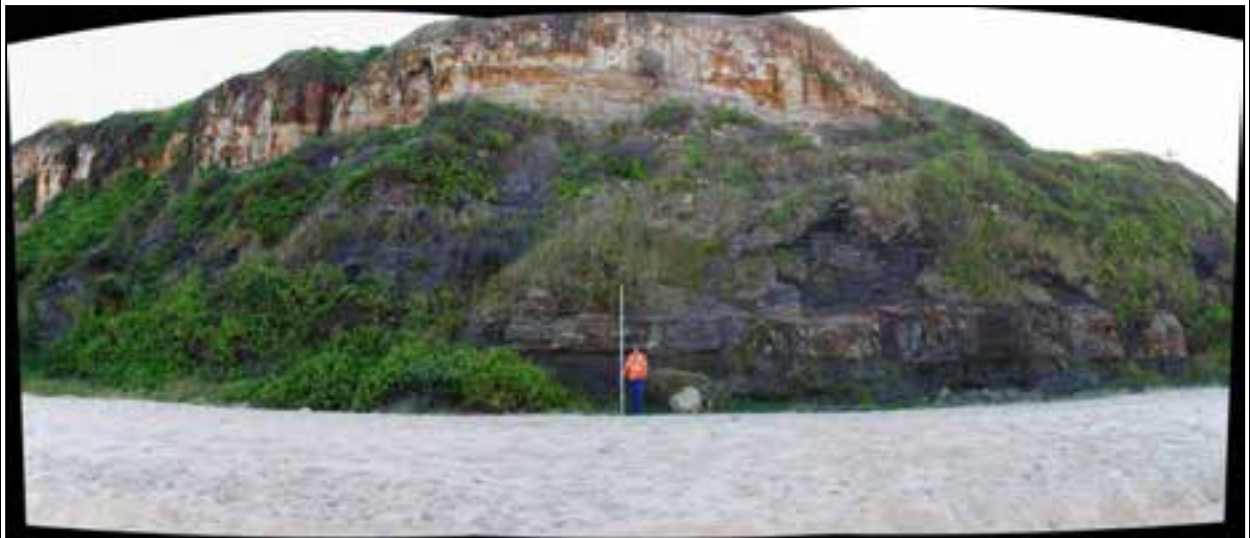
*Bathers Way above Geo- hazard # 17*

**Figure 18** *Geo-hazard #17– ‘The Cliff’ below Kilgour Avenue, past slide(s) debris and rock falls cover/ litter beach at toe of cliff/slope. Past instability has been associated with intense rainfall events and has resulted in sections of the beach being closed whilst slope stability has been re-assessed.*

17 Hazard 17 - Slope debris - landslides affecting beach amenity/access  
(See Figure 18 in Appendix B)

The Cliff Kilgour Avenue, Dixon Park	17	Rock fall/ landslide impacts and/or partially blocks public access to beach below	Almost Certain	Insignificant	Low	Rapid (3m/min to 1.8m/hr)	Landslide in June 2007 high rainfall event prevented access to 300m x 25m beach area until debris cleared away by CoN.	As above
Lloyd St Cliff/ Slope, Merewether	18	Rock fall/ landslide partially blocks public access to Merewether baths and/or beach below	Likely	Minor	Moderate	Rapid (3m/min to 1.8m/hr)	A landslide of over crest spoil during the June 2007 high rainfall event damaged three fixed outdoor dining fixtures at Merewether Baths. Still some 15m length of over crest spoil threatening Merewether Baths picnic area.	CoN to remove remaining over crest spoil on slope above Merewether Baths picnic area, then protect and re-vegetate as done after 2007 failure.
Hickson Street Cliff / Slope, Merewether	19a	Cliff top erosion/failure affects residential development	Likely	Minor to Medium	Moderate to High	Very Slow* (15mm-1.6m/yr)	* Individual rock falls are likely to fail very rapidly (5m/sec to 3m/min) Existing brushwood fence is currently 'suspended' over ragged bare rock face. The ragged edge of a 5m high bare rock face is only 3-6m from two existing residences No.34A and 38A Lloyd Street.	CoN to monitor cliff top regression on an annual basis and/or after rainfall events of $\geq 1$ in 100yr intensity. CoN to commission a detailed Landslide Risk Assessment if cliff top residences come under threat.
