# Newcastle Coastal Zone Hazards Study

## *Final Report*

Prepared For: City of Newcastle

Prepared By: BMT WBM Pty Ltd (Member of the BMT group of companies)

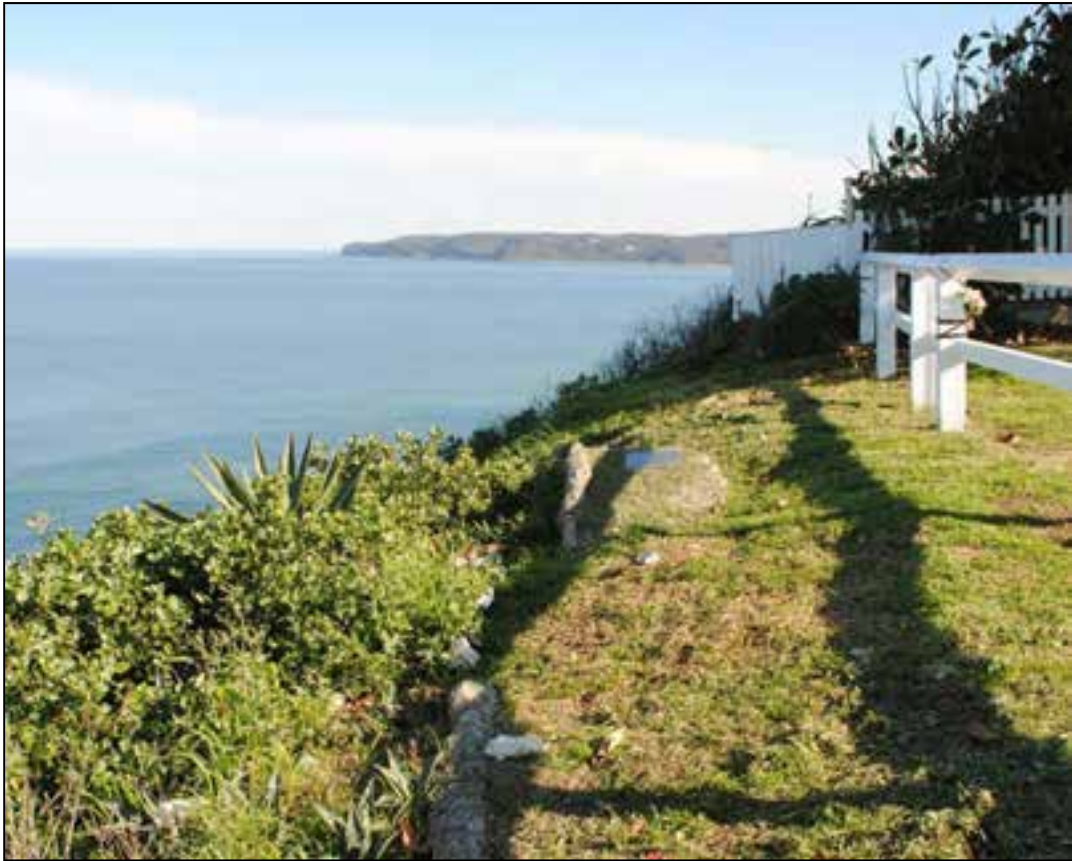
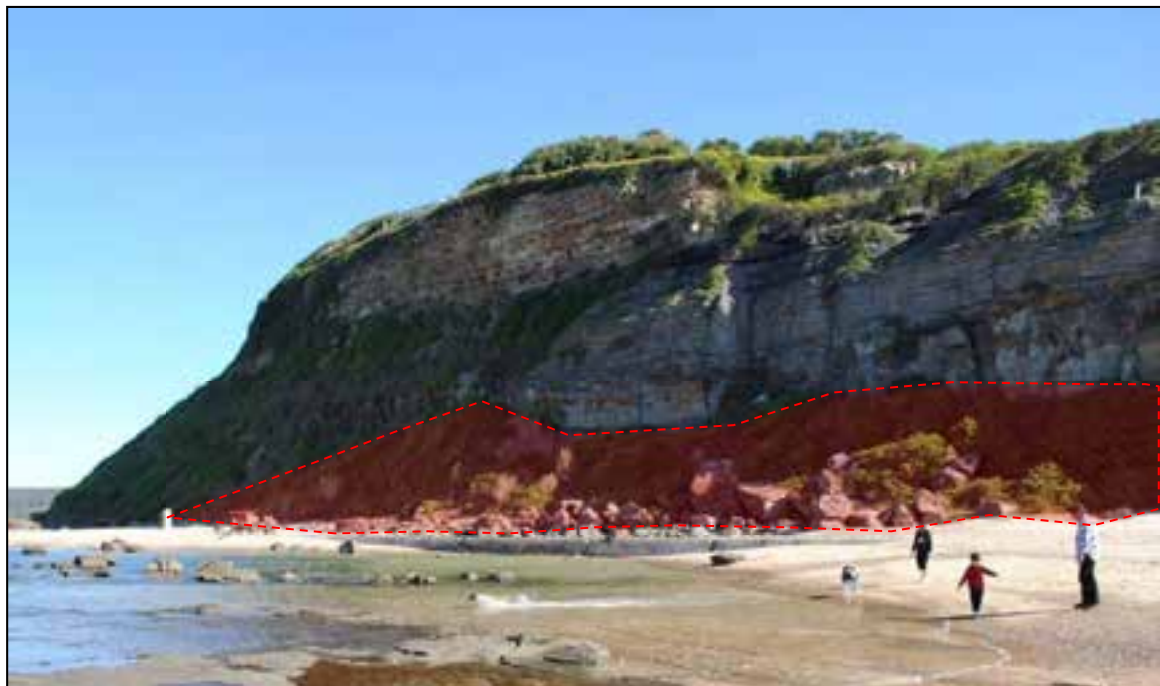
*Geo-hazard #18 – Lloyd Street cliff / slope erosion along crest is within 2-3m of the boundaries of cliff top development*

**Figure 19** *Geo-hazard #18 – Lloyd Street cliff face instability resulting in rock falls and mixed debris slide debris, shown in red. Hazard affects beach and southern end of Merewether Baths.*

- ⑱ Hazard 18 - Rock falls/mixed debris slides from Lloyd Street cliff/slope tend to coincide with intense rainfall events eg June 2007 affecting beach and Merewether Baths amenities (See Figure 19 in Appendix B)
- ⑲ Hazard 19 - Hickson Street Fault, cliff top regression threatening residential development (See Figure 20 in Appendix B)

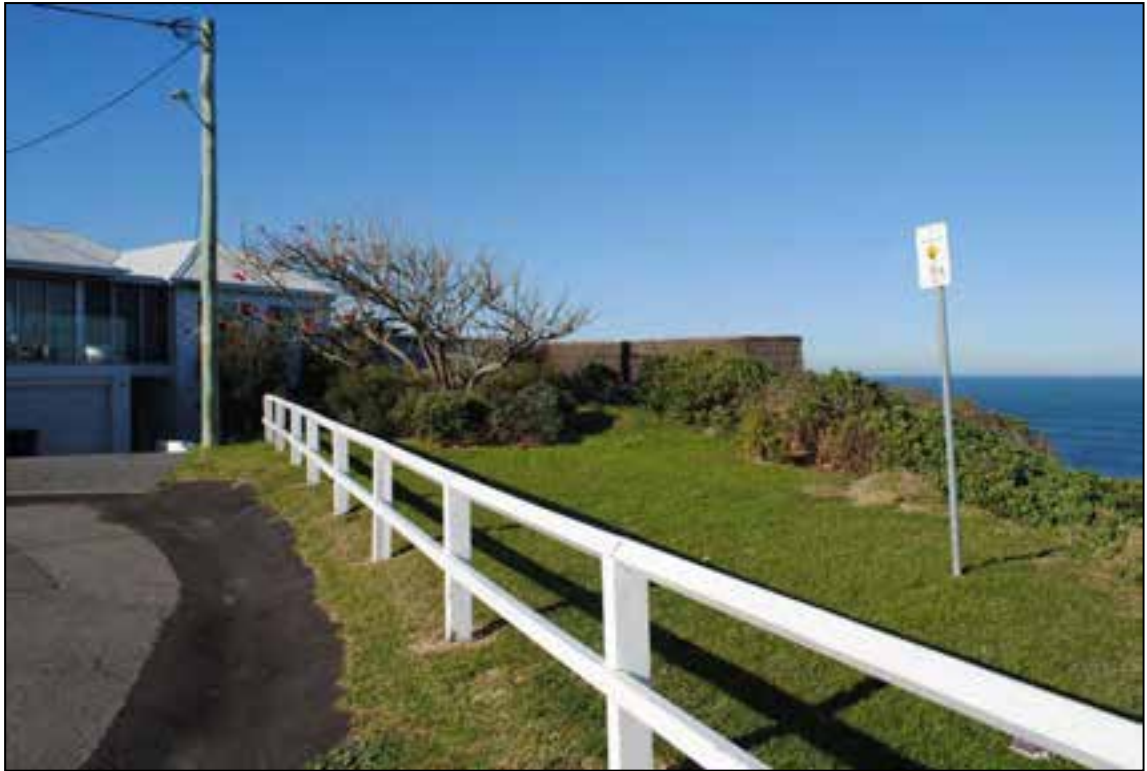
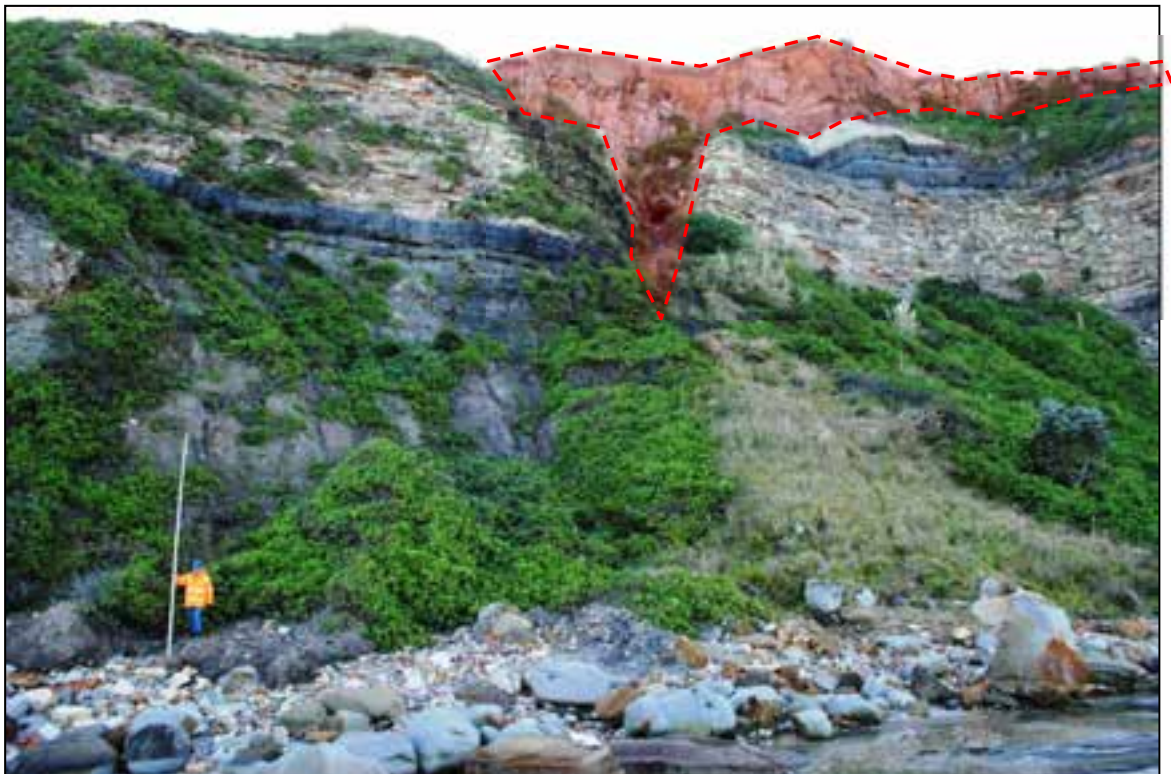
View of cliff top development above Geo-hazard # 19. Right hand-side panel of Brushwood fence in centre of picture is 'suspended' over ragged bare rocky cliff edge.

**Figure 20** Geo-hazard #19 – Accelerated cliff face retreat along Fault line & cliff top, shown in red. Edge of cliff crest comes within 3-6m of existing cliff top residences.

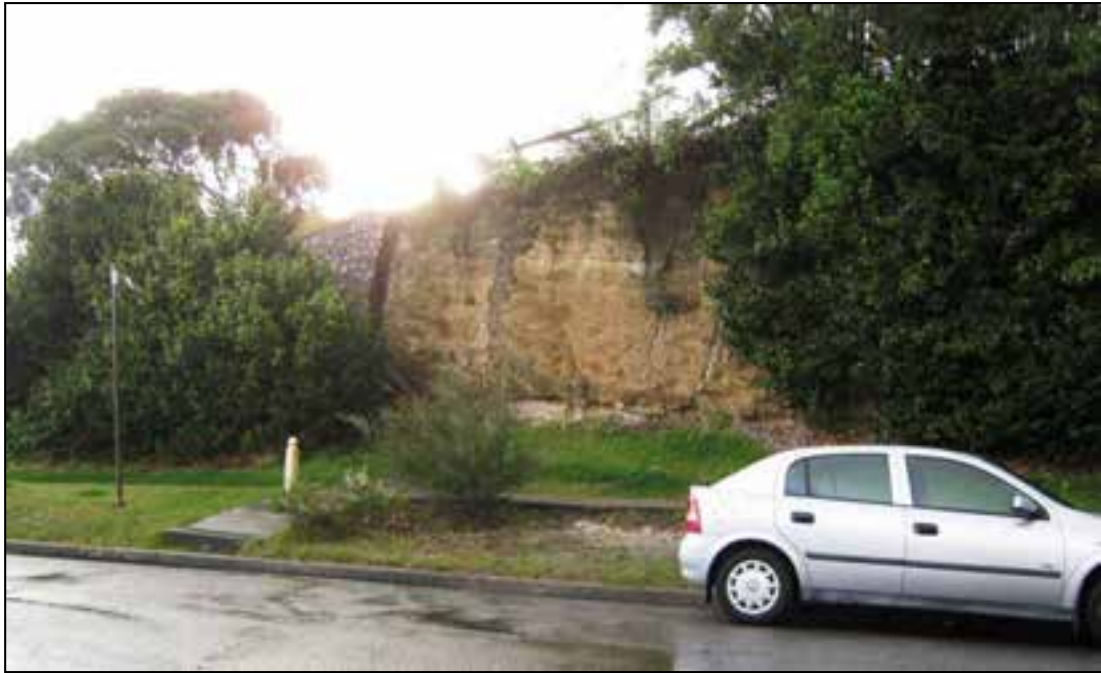
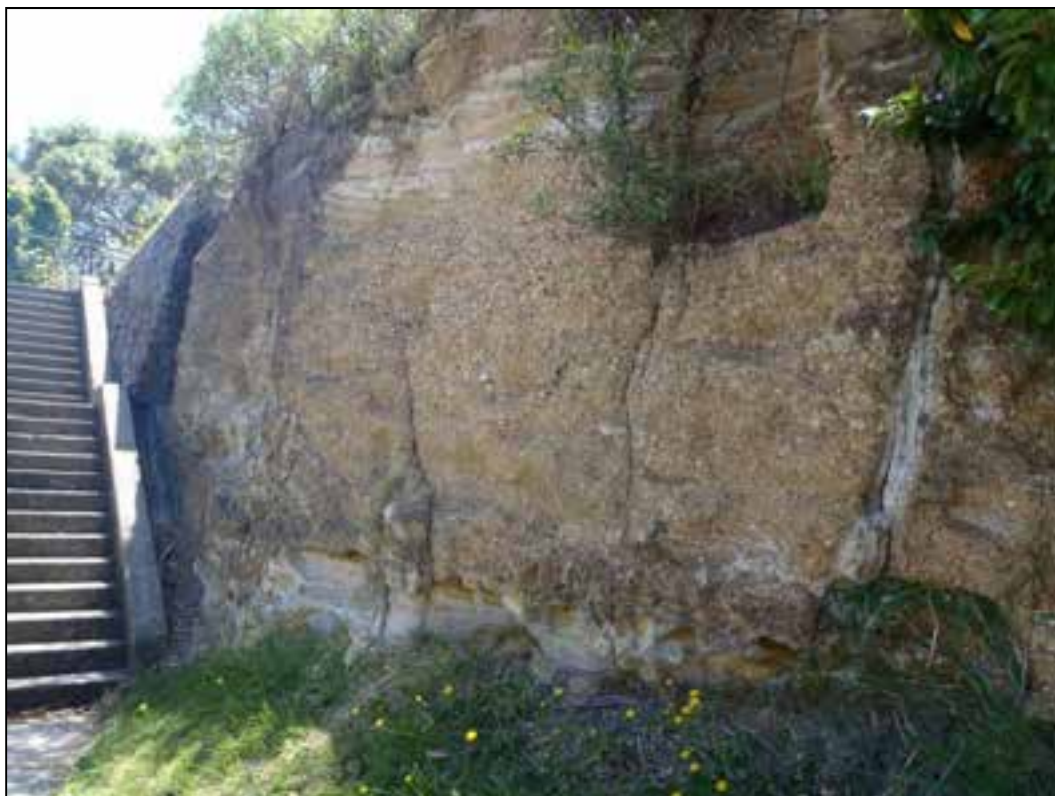
*Geo-hazard #20 – Rock fall(s) from Obelisk cliff face onto pedestrian footpath.*

**Figure 21** *Geo-hazard #20 – close up of rock face & stairs, shows rock mass defects and vegetation growing in rock defects. Tree roots in rock face defects appear to be the cause of most rock falls. Observed rock fall blocks mostly  $\leq 300\text{mm}$  in diameter and have come to rest within 2m of cliff face*

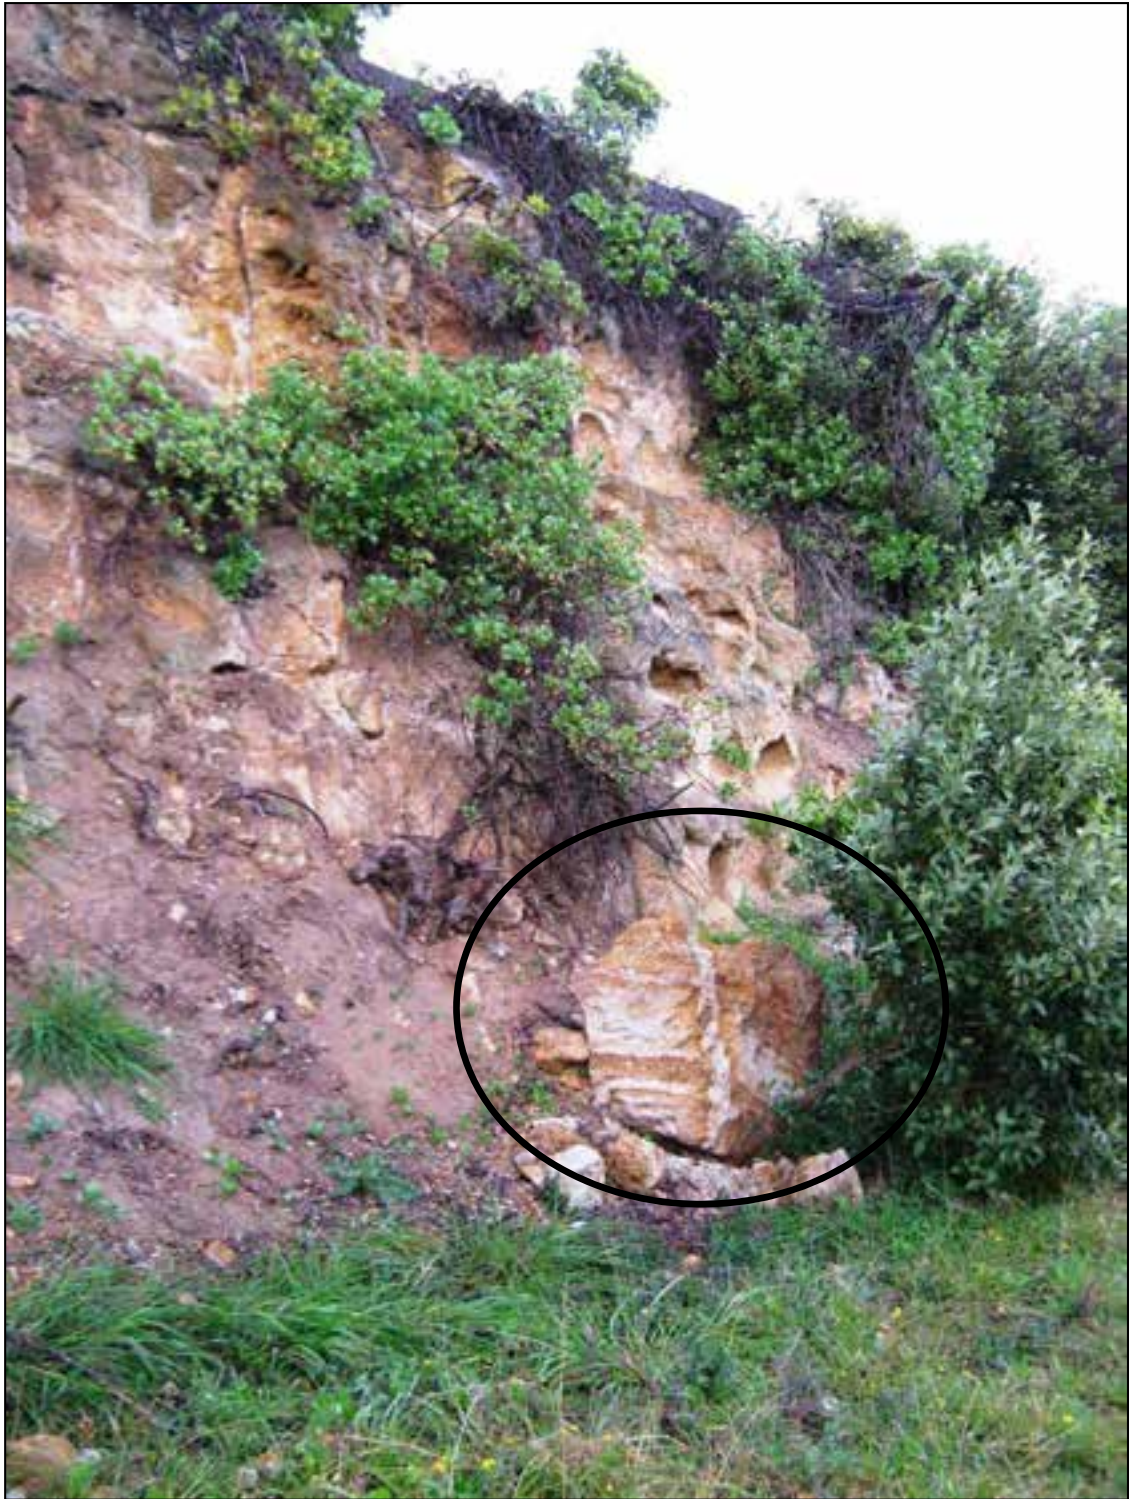
**Figure 22** *Geo-hazard #21 – Rock falls from north face of Obelisk Hill. Fallen block ~1m in dimension circled. Observed rock falls have come to rest within 2m of rock face.*

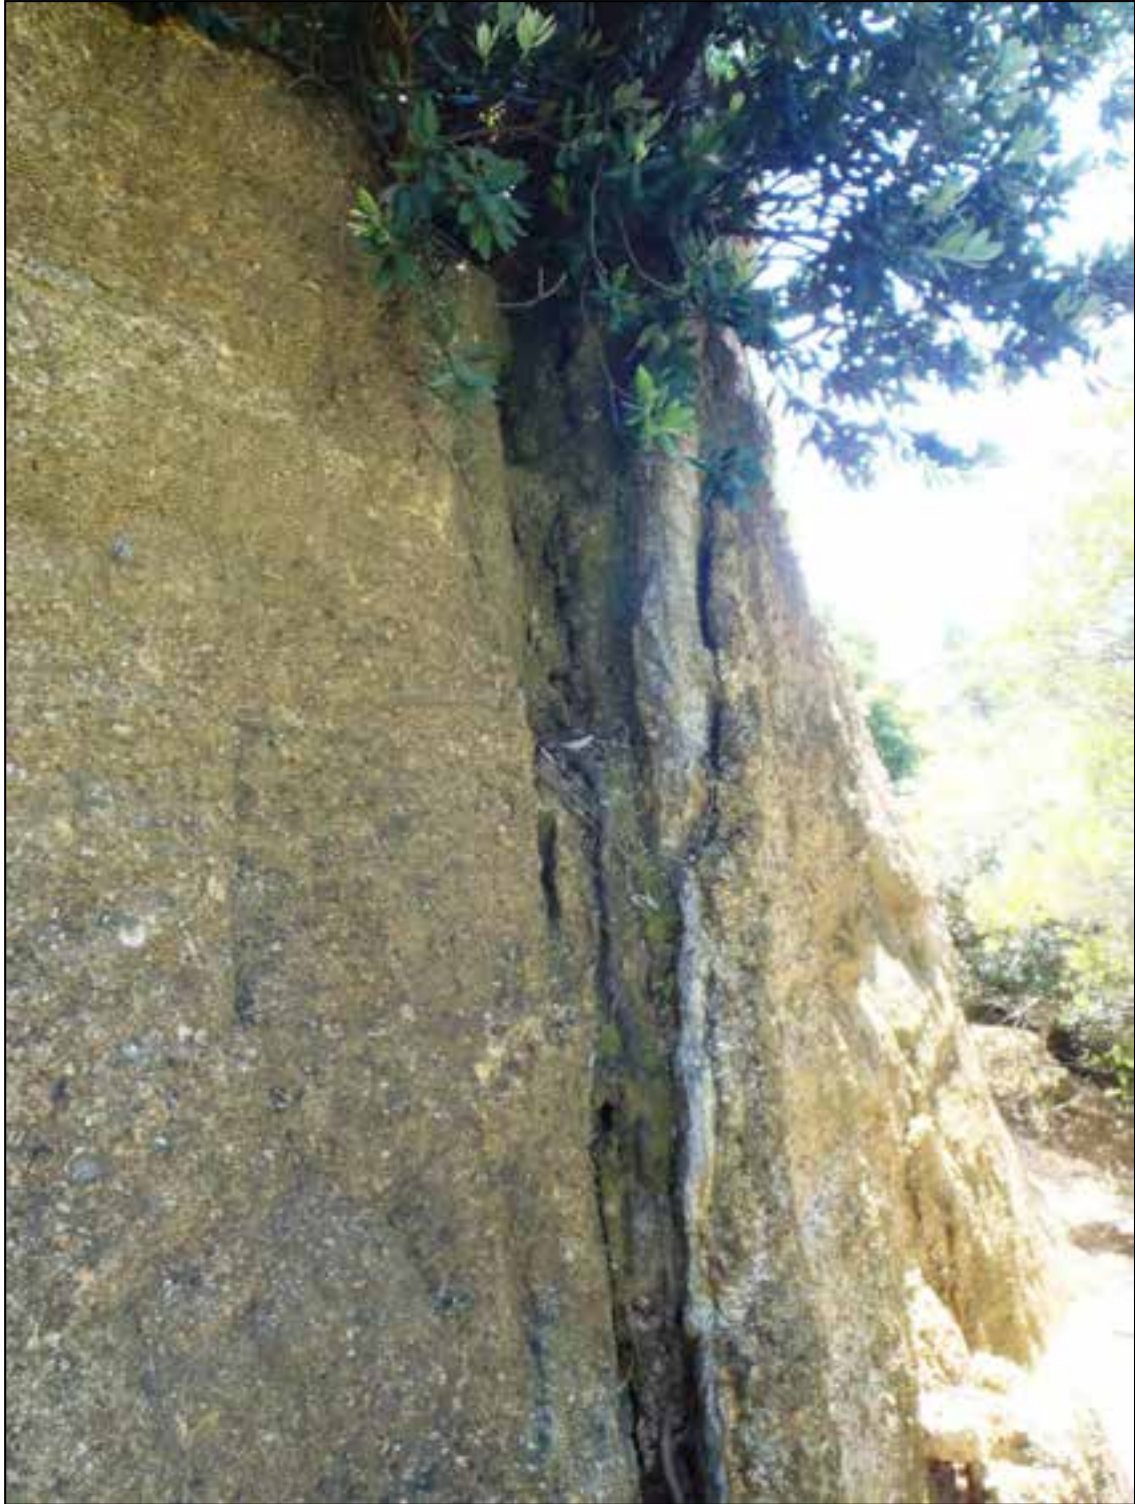
**Figure 23** *Geo-hazard #22 – Rock falls from south face of Obelisk Hill, due to tree root ‘jacking’ open and weathering of joints, as shown above. Observed rock falls have all come to rest within 3m of face.*

Obelisk Hill, Tennis Courts	22	South Face: Rock fall/ debris slide due to weathering and 'root jacking' impacts or partially blocks access to Tennis Courts	Unlikely	Minor	Low	Very Rapid (5m/sec to 3m/min)	Previous rock falls blocks up to 0.3m in dimension have typically come to rest within 1-3m of the rock face. Tennis Court fence is at least 4m from toe of Obelisk rock face.	CoN to remove/poison trees growing in rock defects, monitor rock face condition and remove or support unstable blocks as needed.

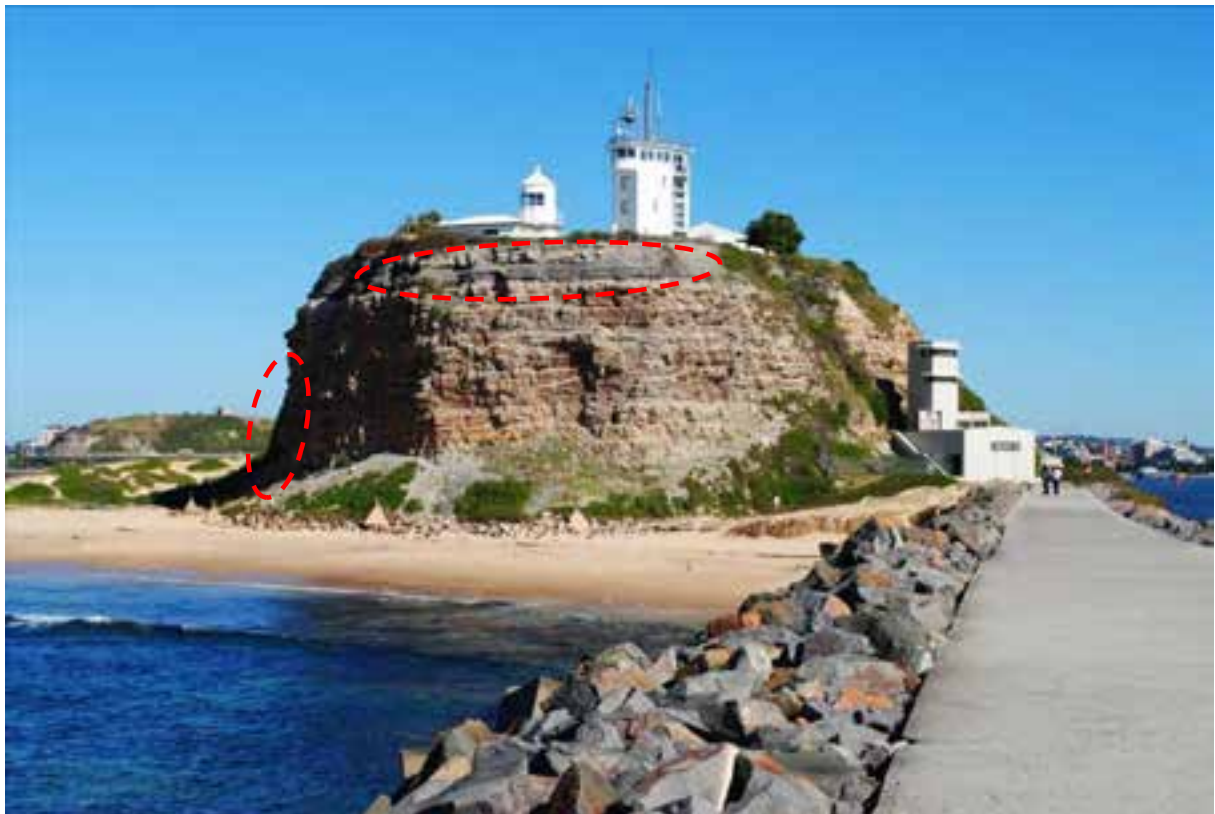
**Figure 1** *Nobbys headland from the breakwater, approx 1900 and 2012.  
Areas of apparent cliff line regression circled.*

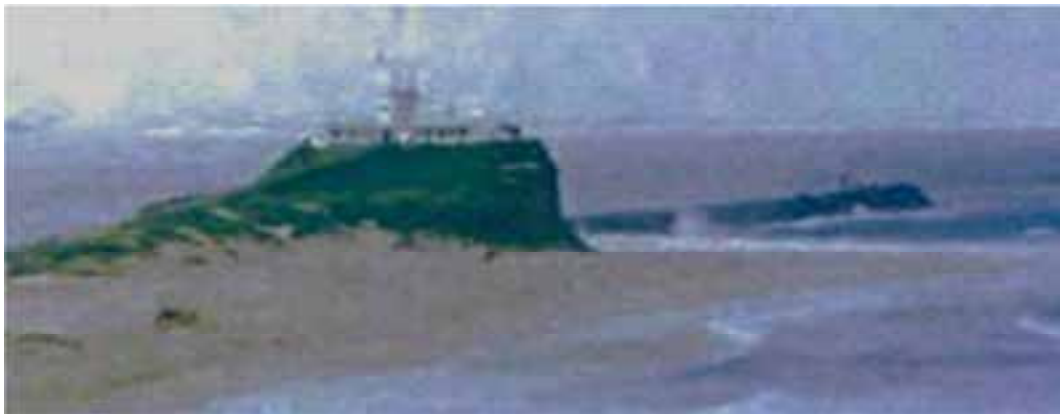
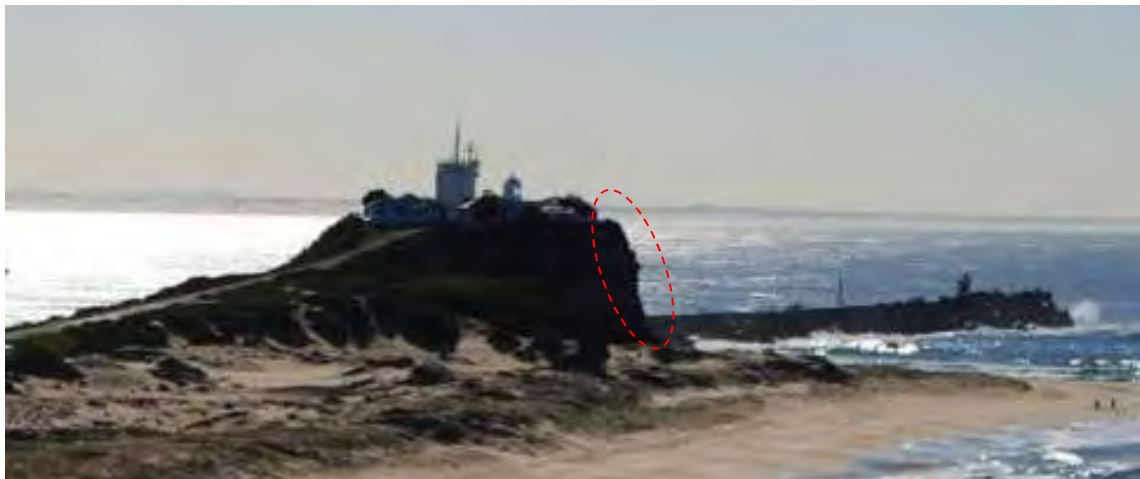
**Figure 2** *Nobbys Headland from the south: 1887, 1998 and 2011 (from top). Evidence of apparent cliff line regression circled.*

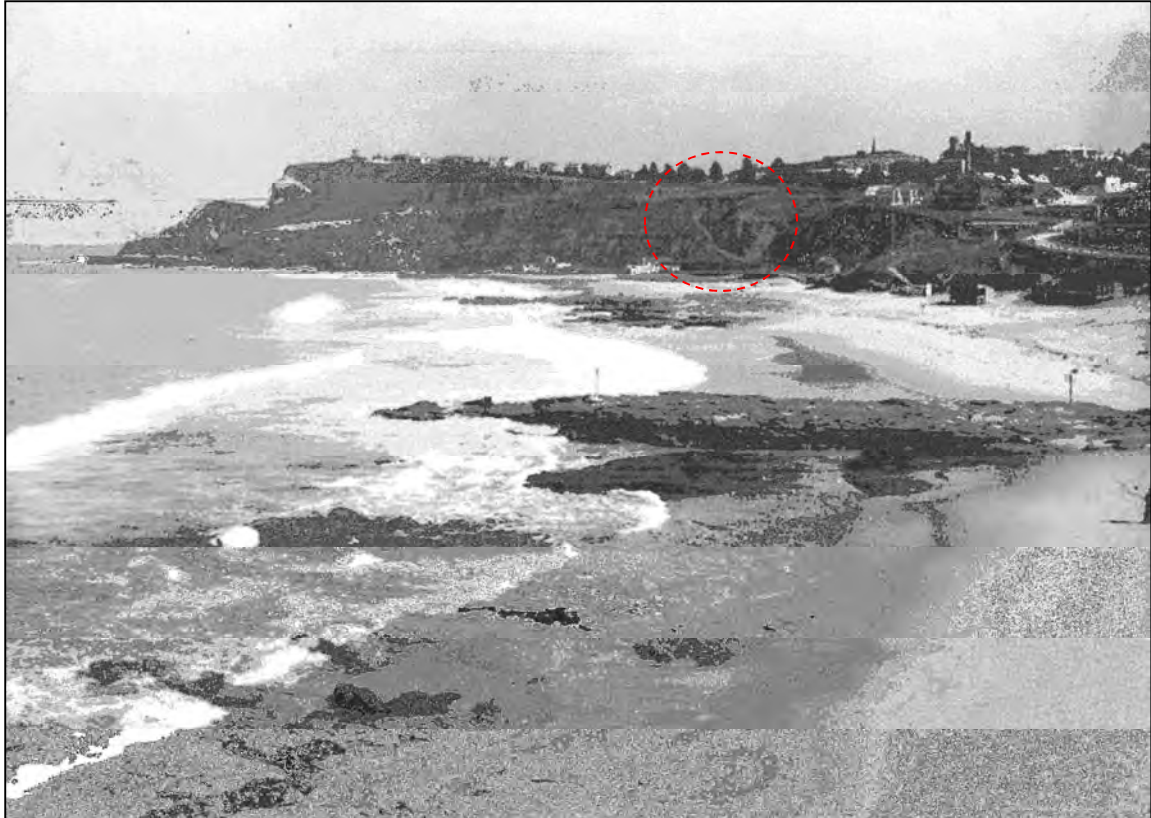
**Figure 3a** Signal Hill - South Newcastle 1907, cliff face pathway circled

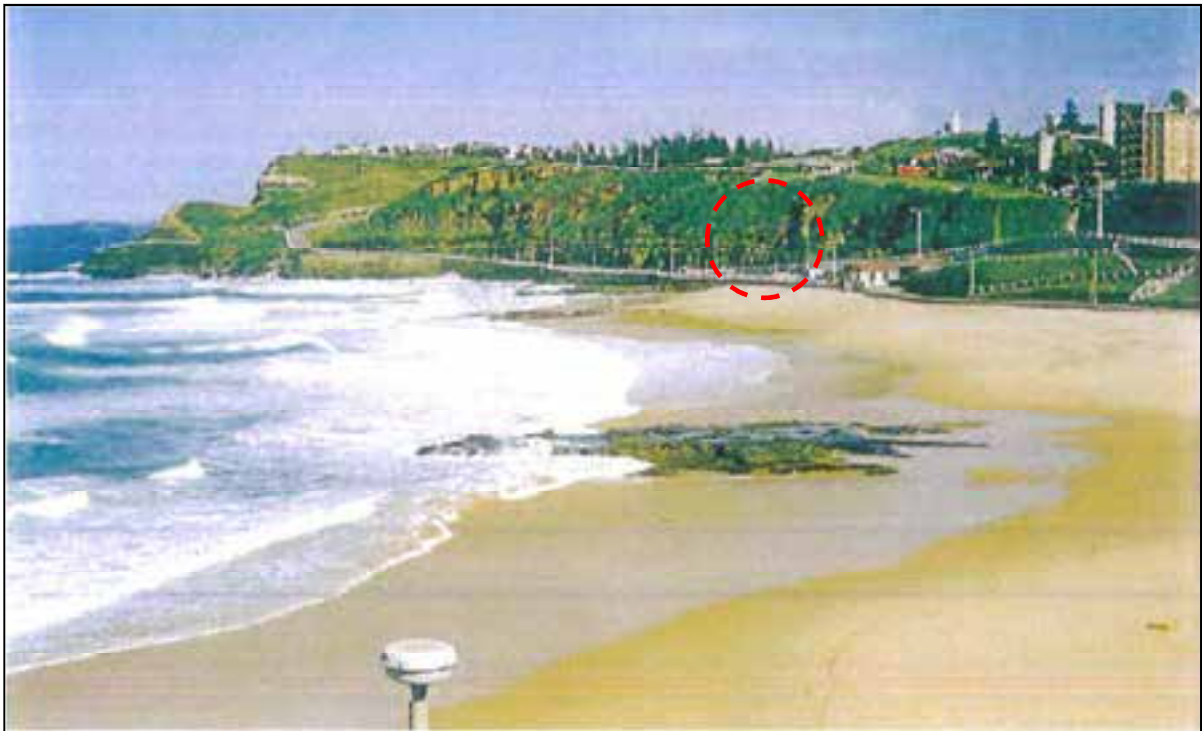
**Figure 3b** Signal Hill - South Newcastle 1998. Note the 1907 cliff face pathway is now barely discernible in the circled area.

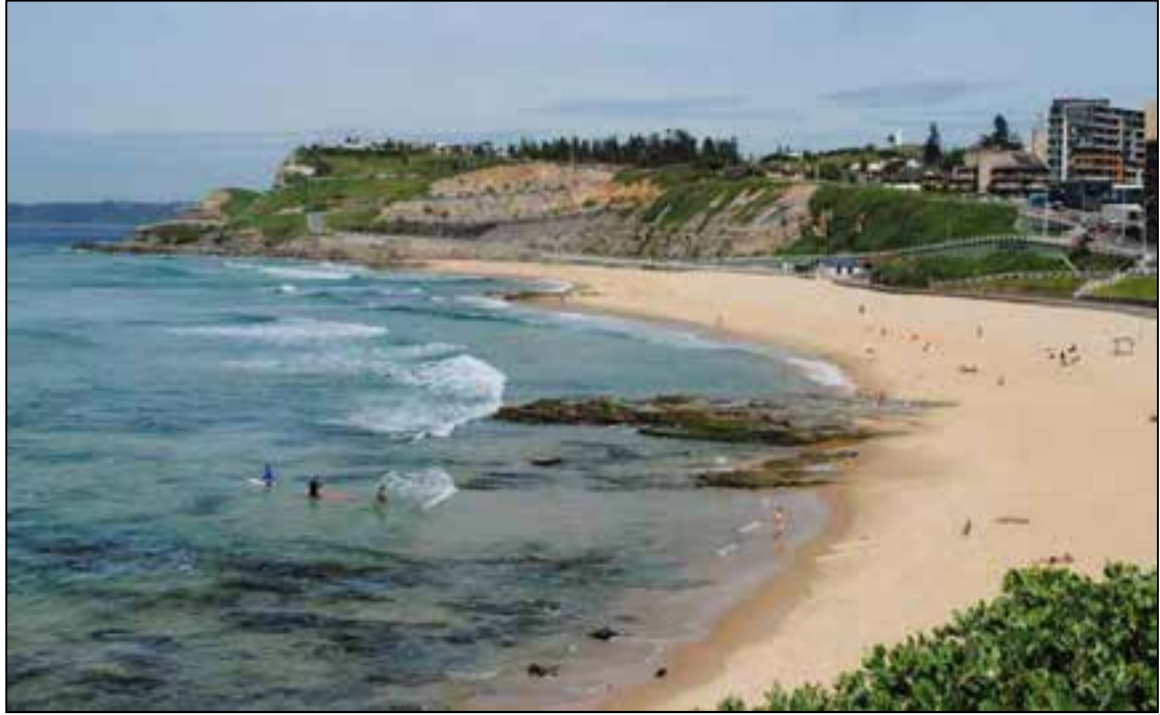
**Figure 3c** *South Newcastle & Signal Hill headland: 1907, 1998, 2012 (from top).  
South Newcastle cliff face extensively re-shaped in 2005 as part of cliff stabilisation works.*

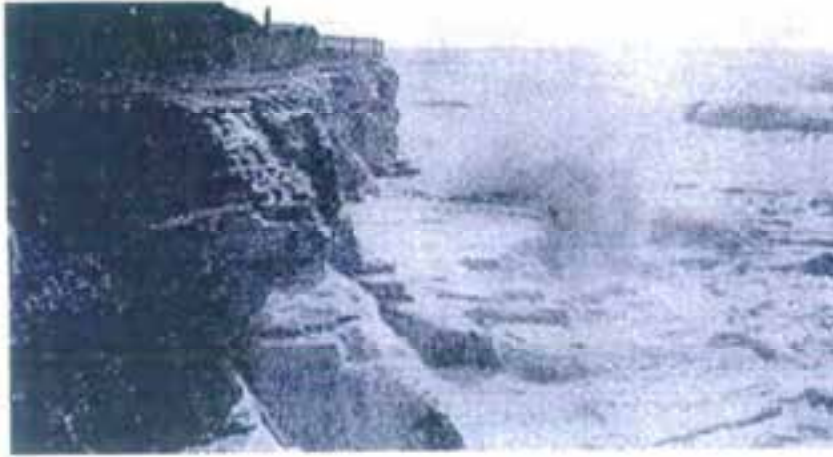
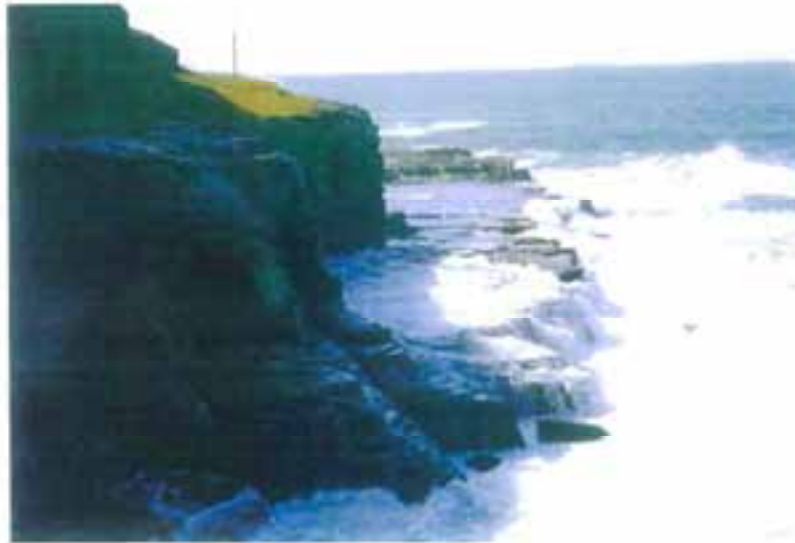
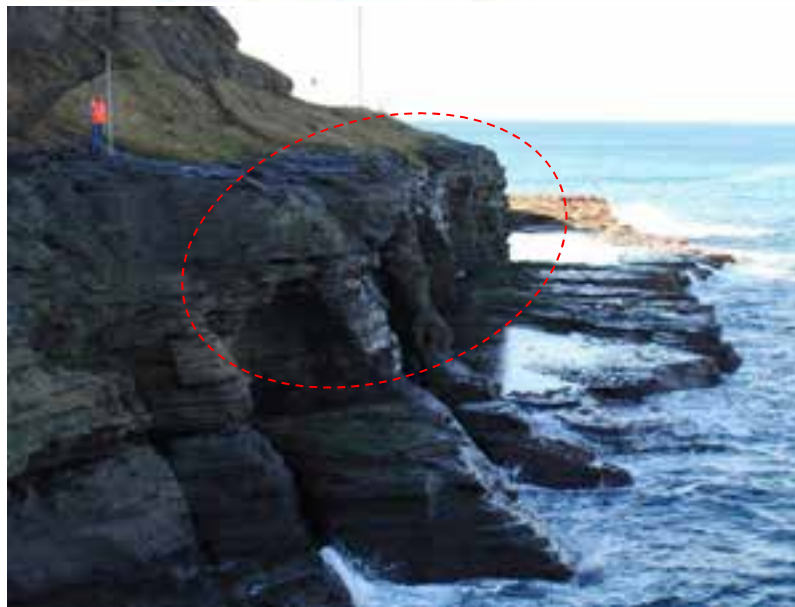
**Figure 4** *Bogie Hole: 1908, 1998, 2011 looking north (from top).  
Area of apparent cliff line regression circled.*

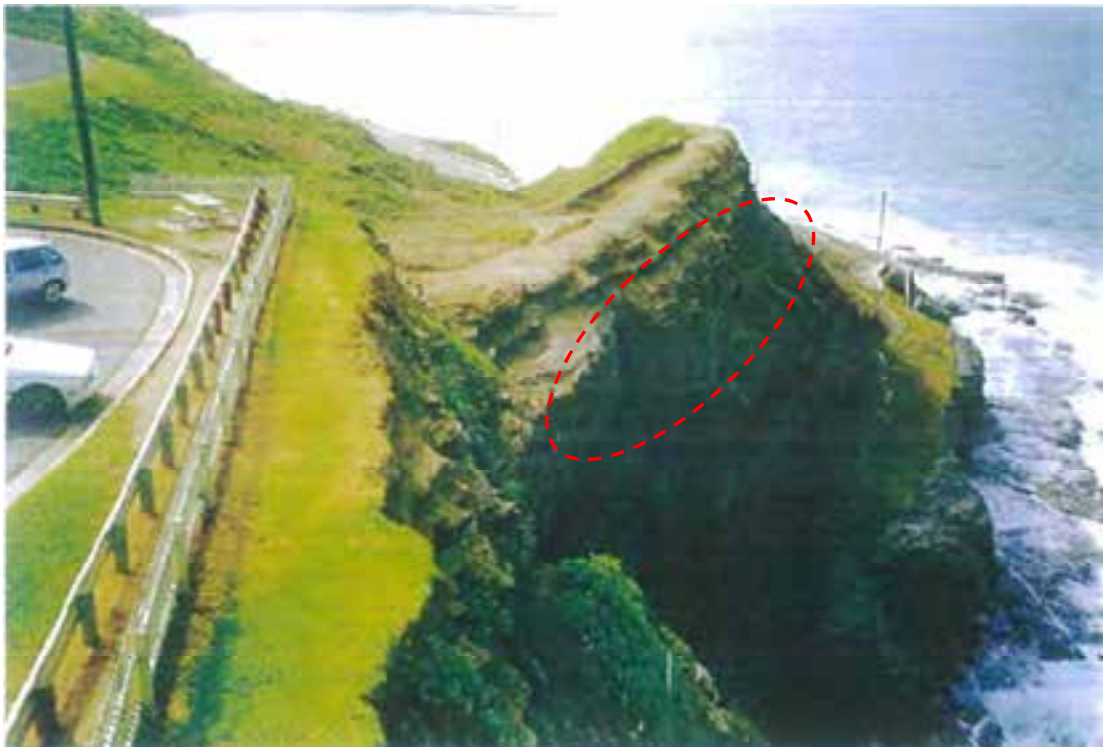
**Figure 5b** *Cliff/slope above Bogey Hole: 1998 looking north*

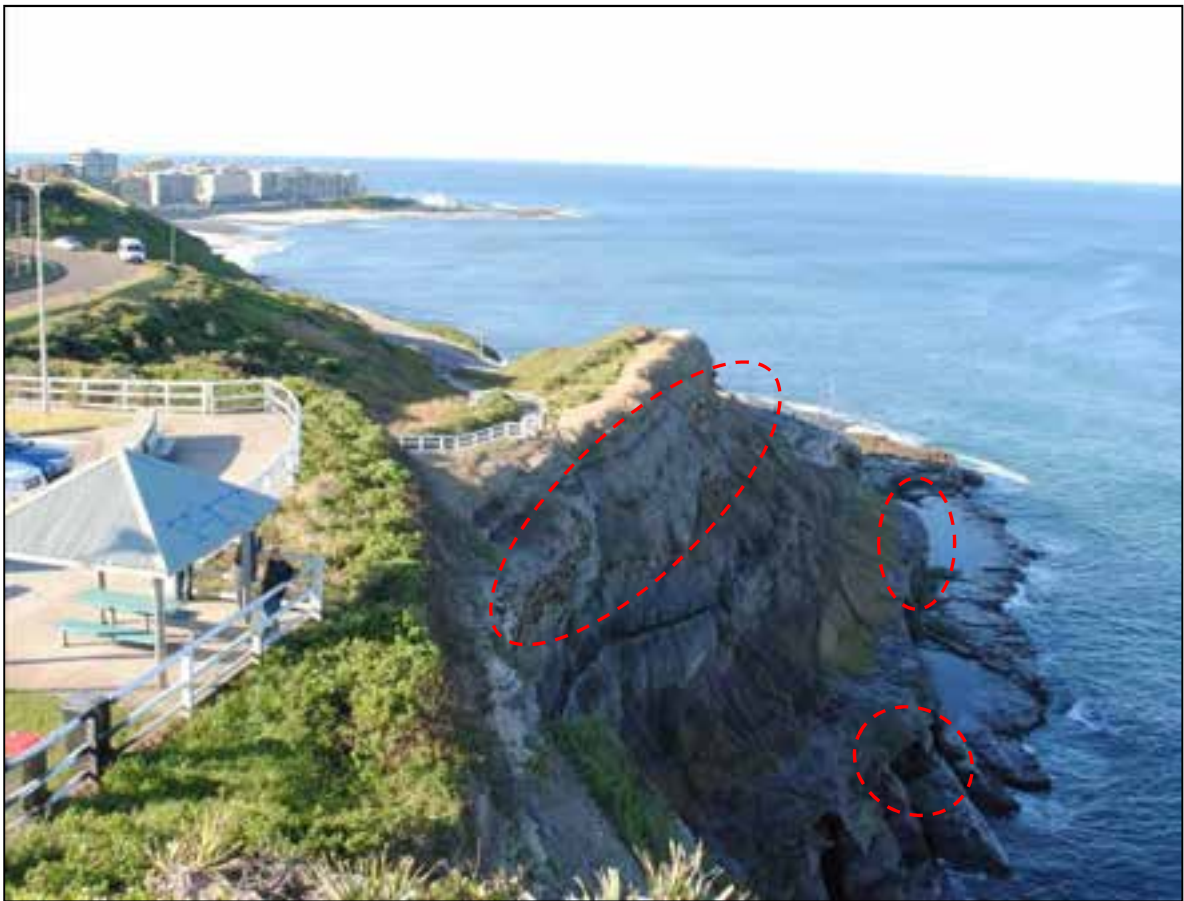
**Figure 5c** *Cliff/slope above Bogey Hole: 1896, 1998 & 2011 looking north.  
Areas of apparent cliff line regression circled.*

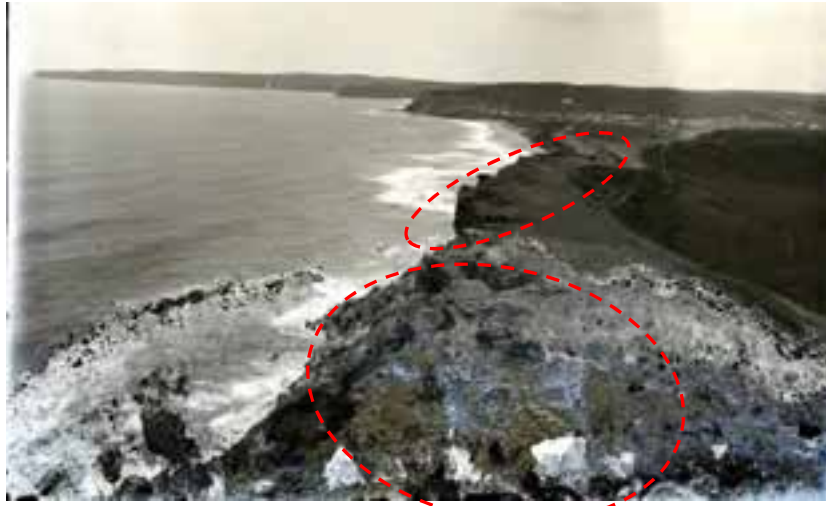
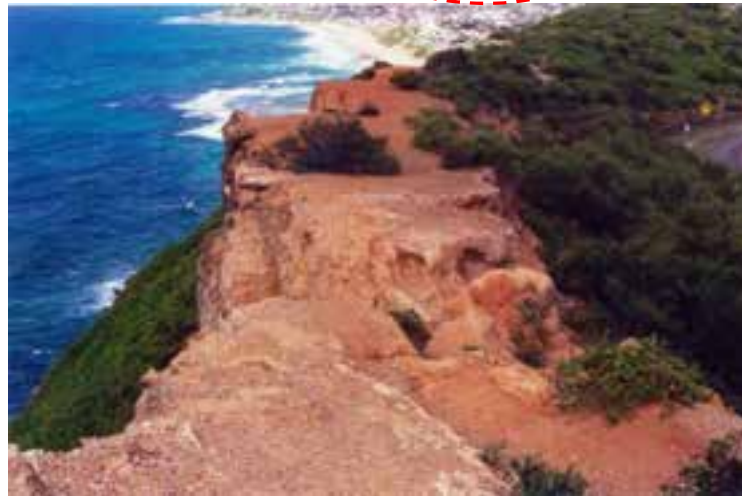
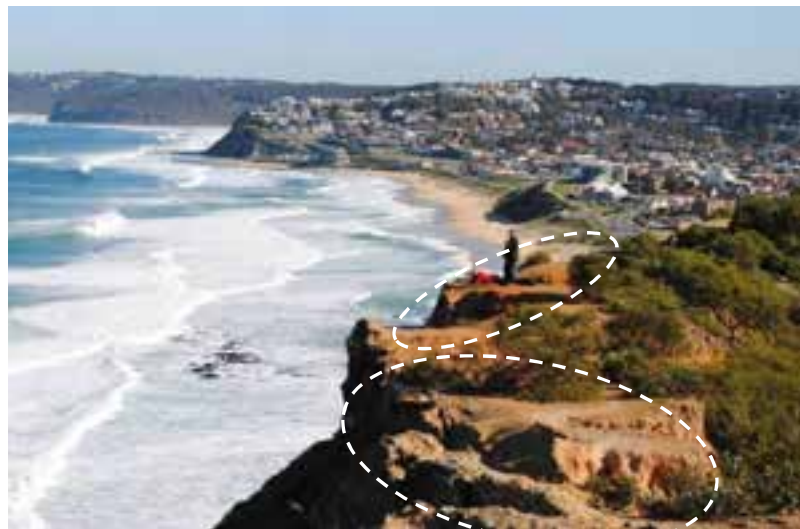
**Figure 6** Eroded ridge from Strezlecki to Shepherds Hill: 1900, 1998, 2012.  
Areas of apparent cliff top regression circled.

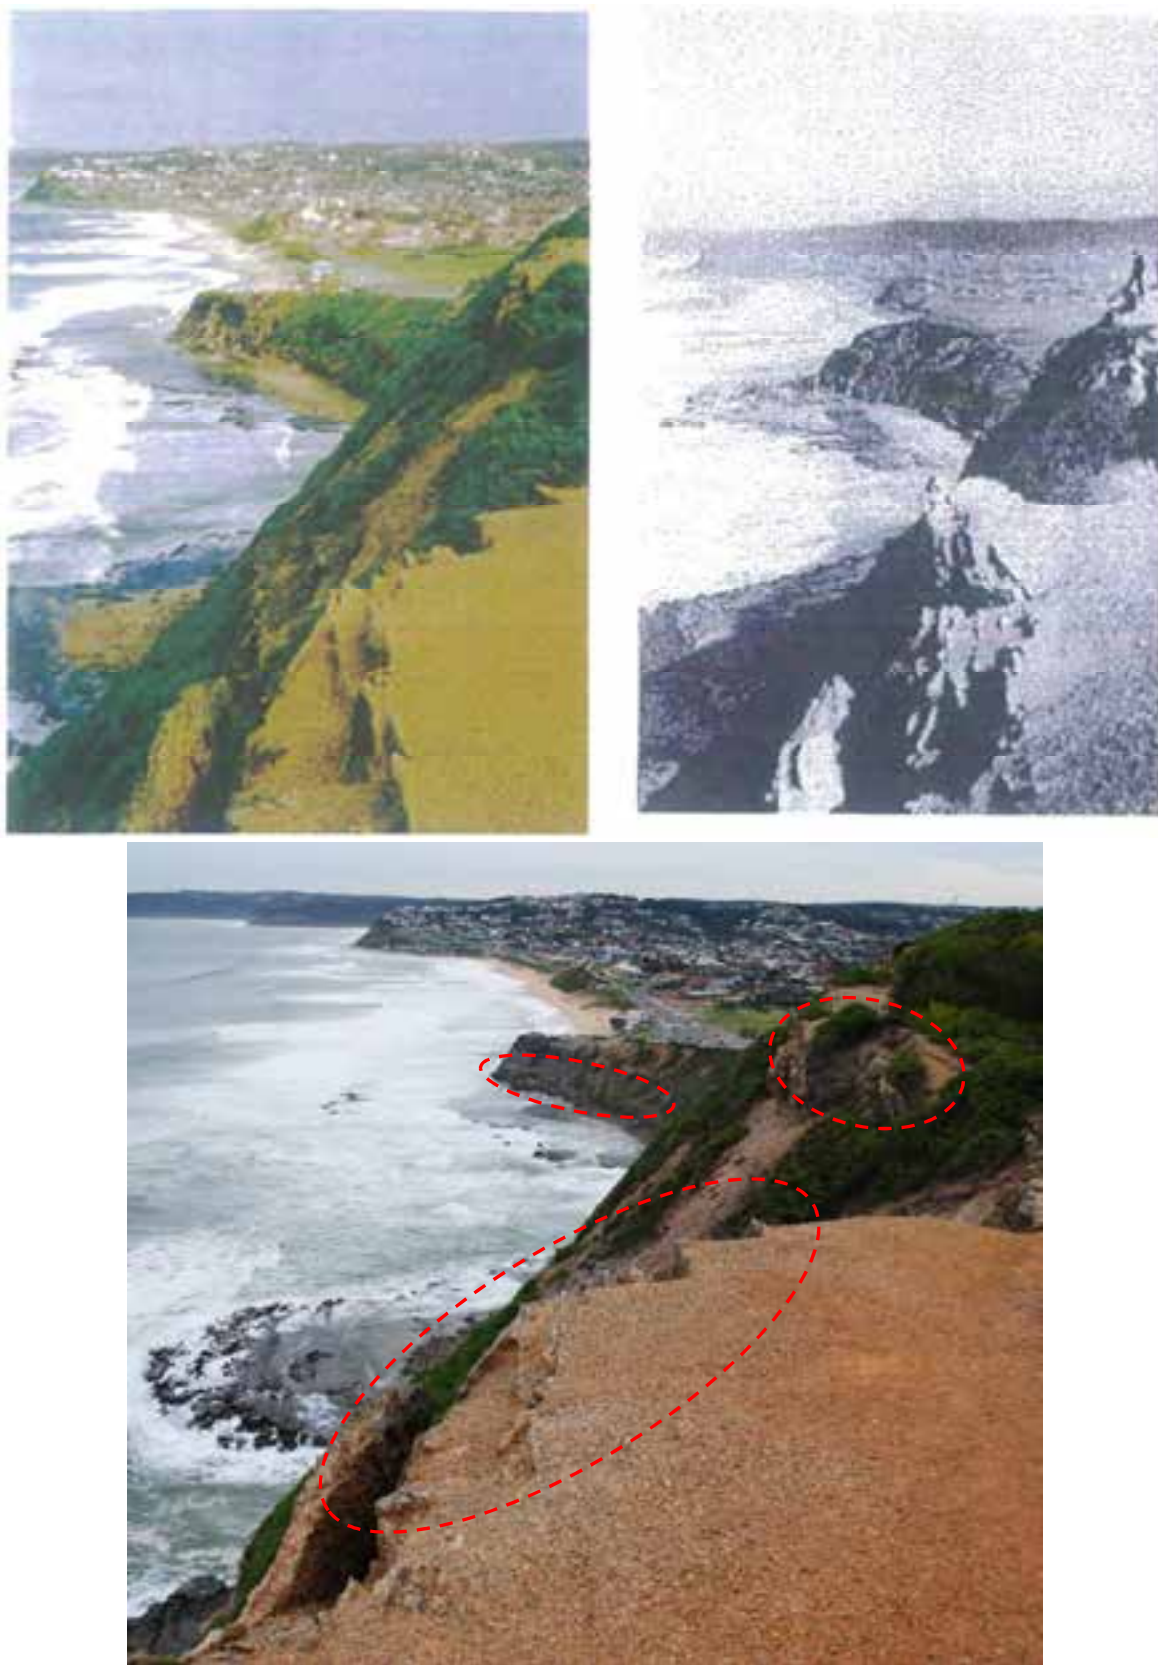
**Figure 7** *Shepherds Hill, south towards Bar Beach: 1998, 1900 & 2011 (clockwise from top left). Area of apparent cliff line regression, circled.*

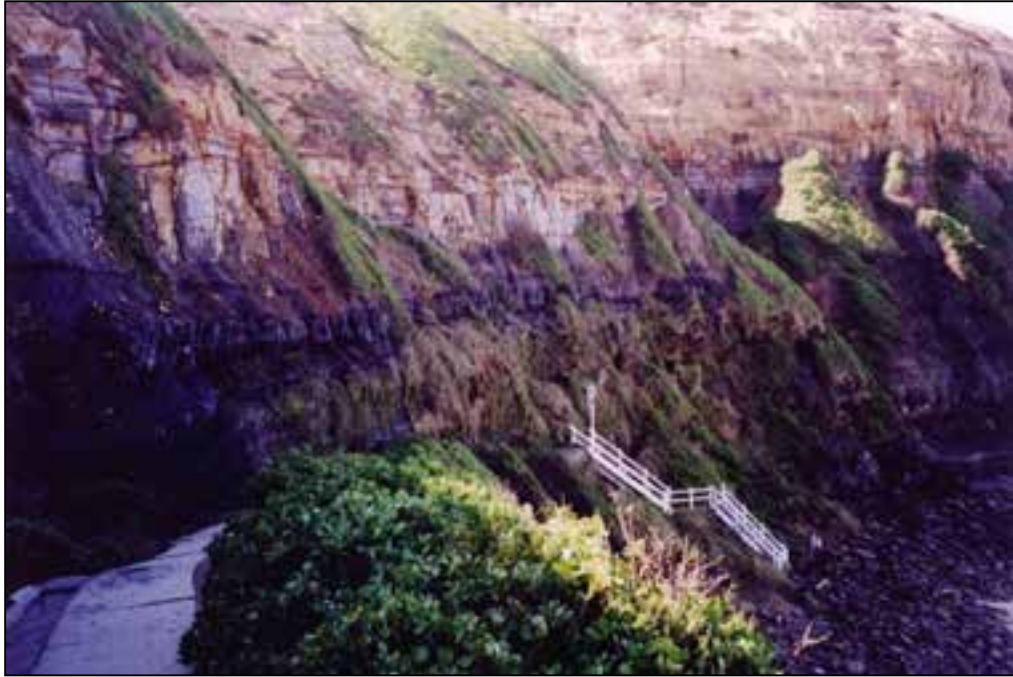
Feb 1999 wooden steps down to SGB beach still intact,

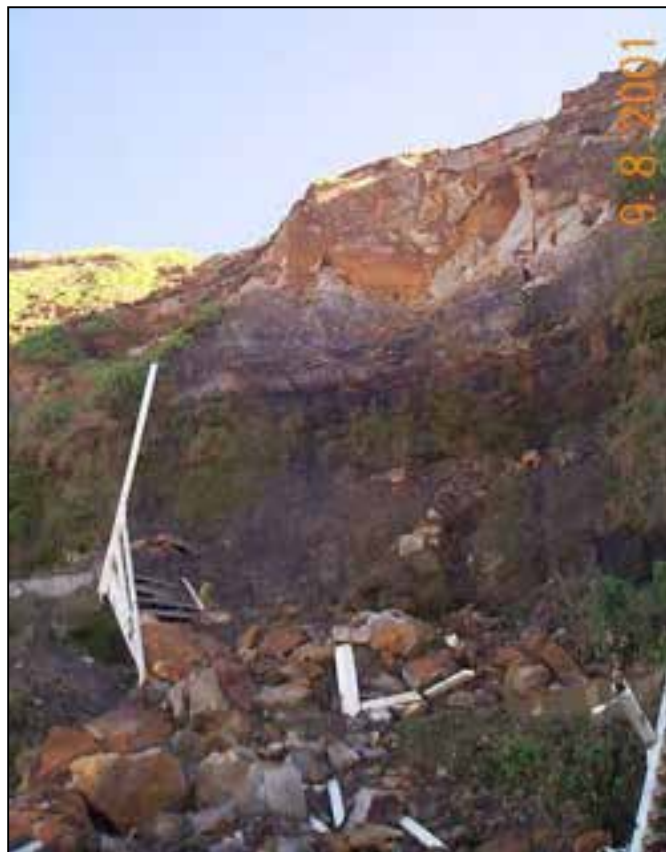
August 2001 wooden stairs to SGB destroyed by a rock slide.

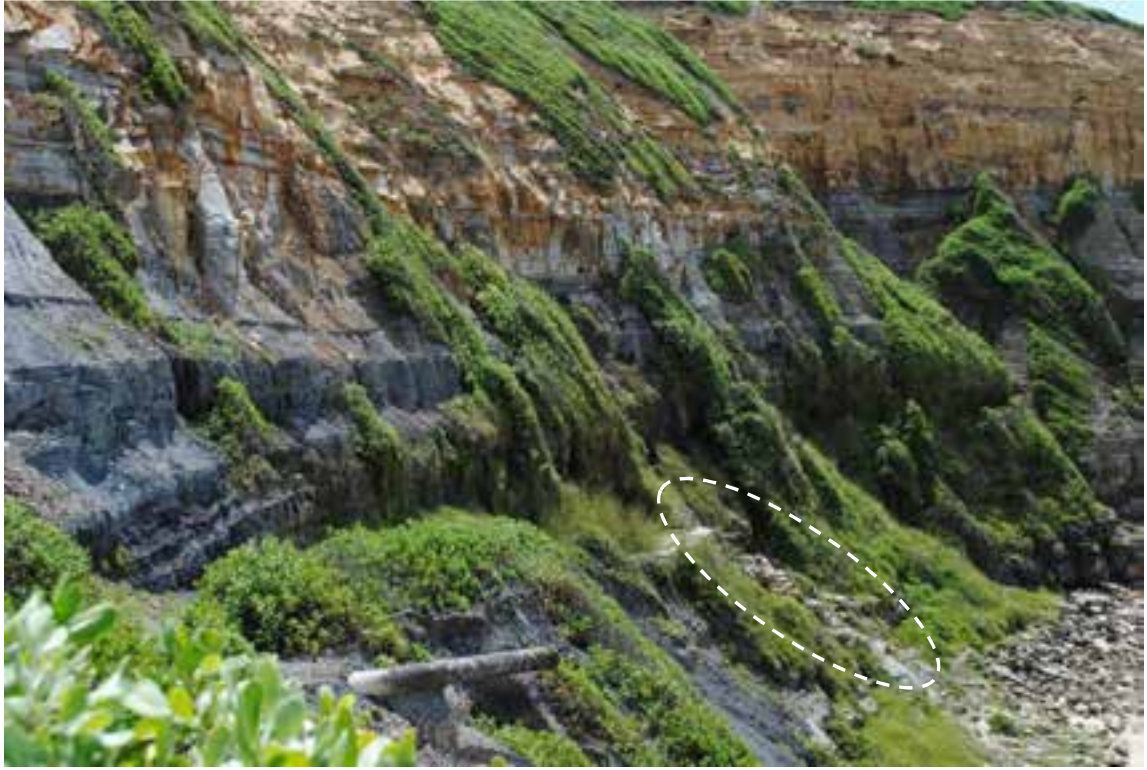
**Figure 8**      *Site of destroyed wooden steps (circled) above Susan Gilmore Beach in 2012*
