# Newcastle Coastal Zone Hazards Study

## *Final Report*

Prepared For: City of Newcastle

Prepared By: BMT WBM Pty Ltd (Member of the BMT group of companies)

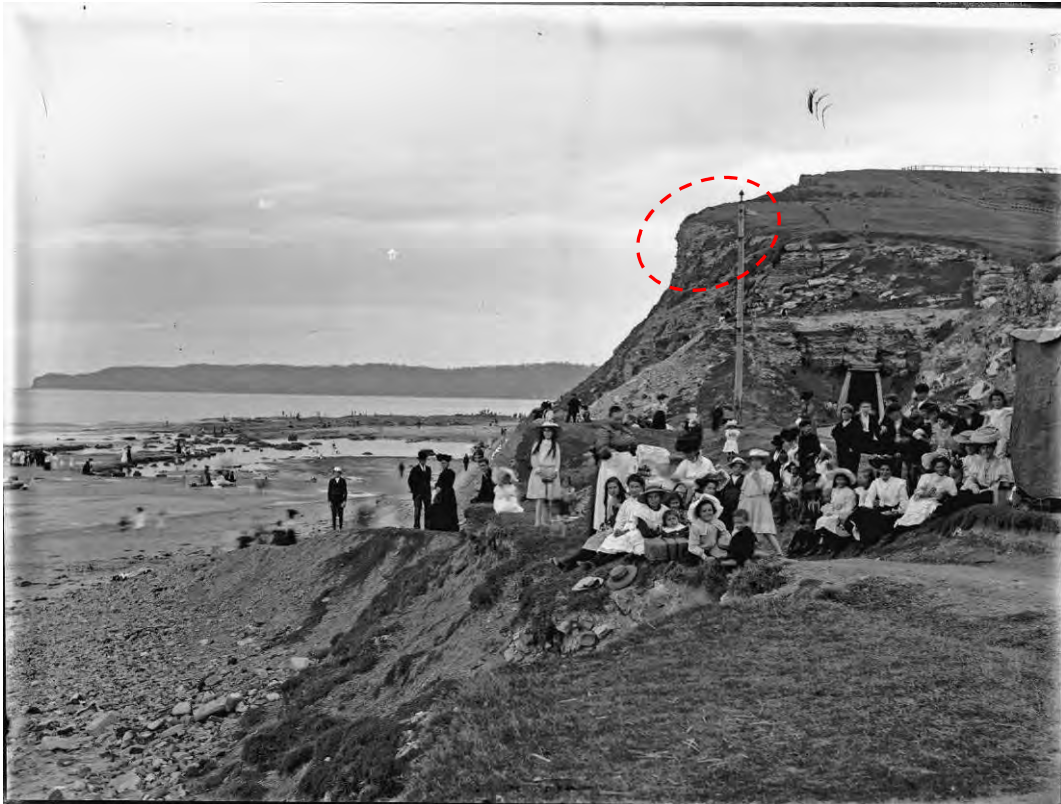
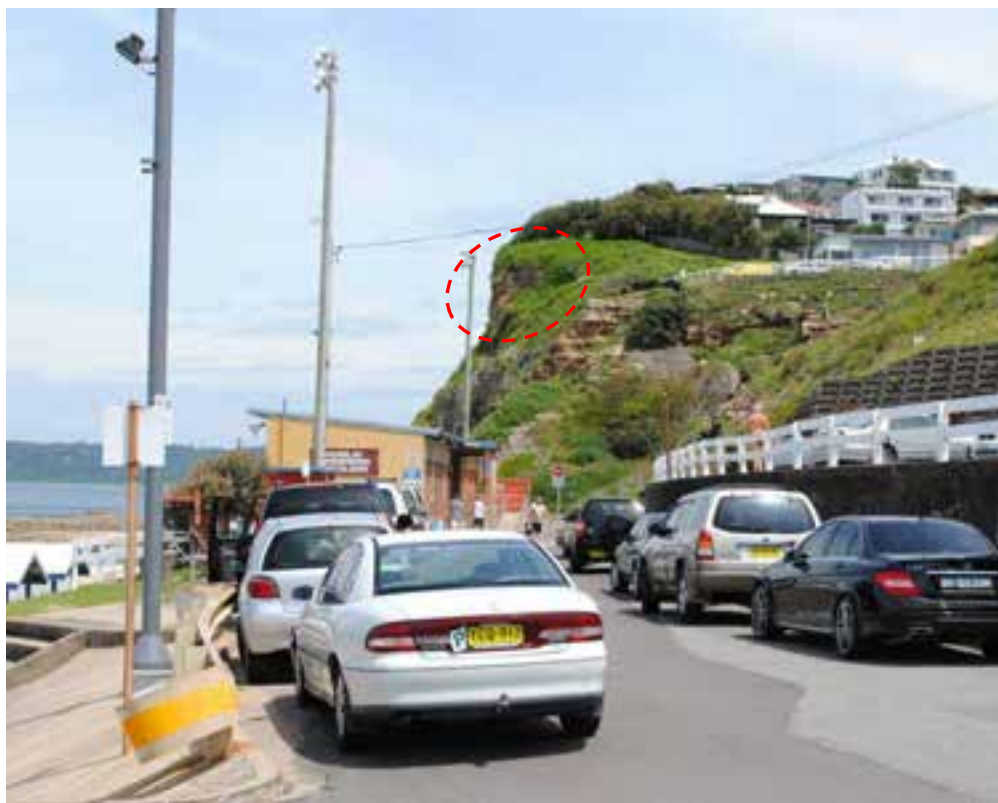
**Figure 9** Looking south at Lloyd St Merewether cliff, approx 1900 and 2012. Area of apparent cliff top regression circled.

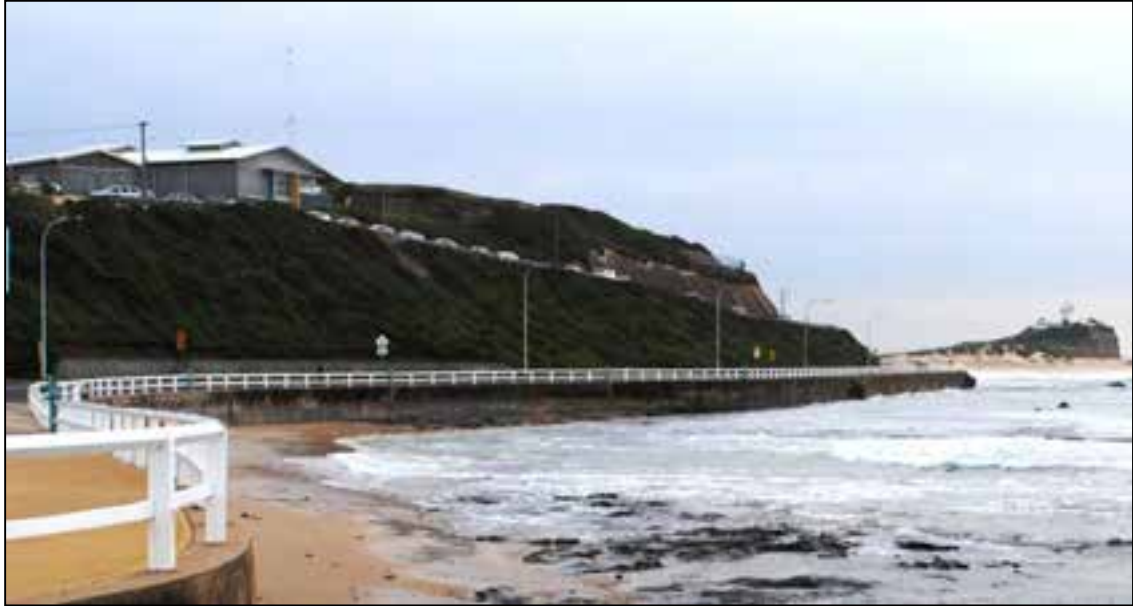
**Figure 1** Fort Scratchley's Eastern Sea Wall will be exposed to increased wave action, as shown 1½ hours past a 1.3m high tide, approximating BMT WBM modelled year 2100 mean sea level.

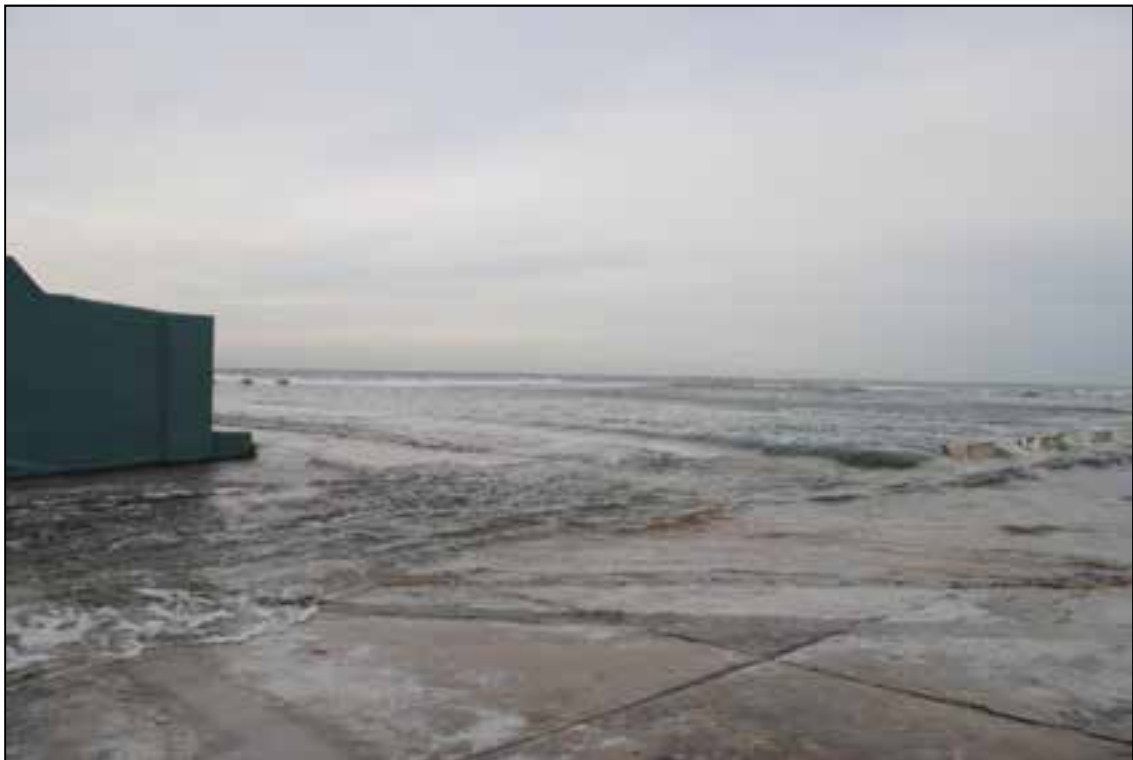
**Figure 2** Risk Site #4 – Newcastle Baths inundated approximately 1½ hours past a 1.3m high tide; , approximating BMT WBM modelled year 2100 mean sea level.

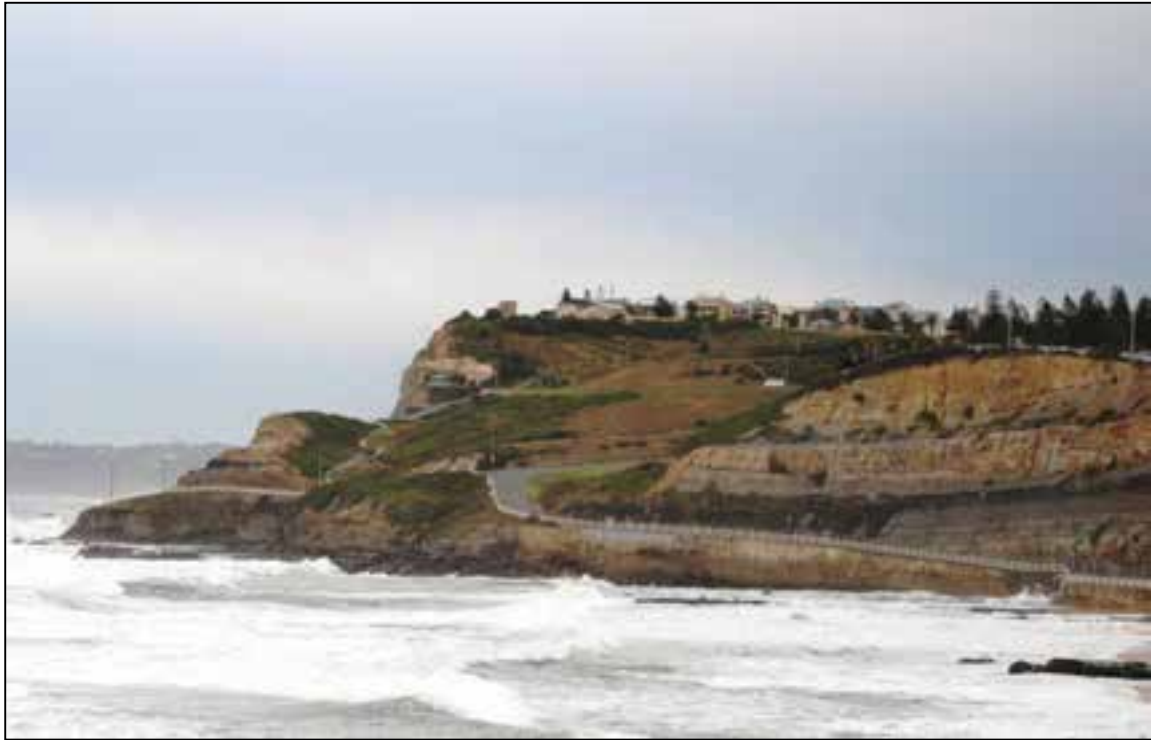
**Figure 3** *Bogie Hole & South Newcastle sea wall subject to constant wave action; approximately 1¼ hours past a 1.3m high tide, approximating BMT WBM modelled year 2100 mean sea level.*

The rock platform and ocean pool at the Bogie Hole, as shown on **Drawing 2** in **Appendix A**. A photograph illustrating the projected sea level rise is presented in **Photographs 3** and **4** in **Appendix D**. It is anticipated the projected sea level rise will result in reduced access to the Bogie Hole pool due to increasing frequency of inundation as sea levels rise and increased deterioration rate of amenities.

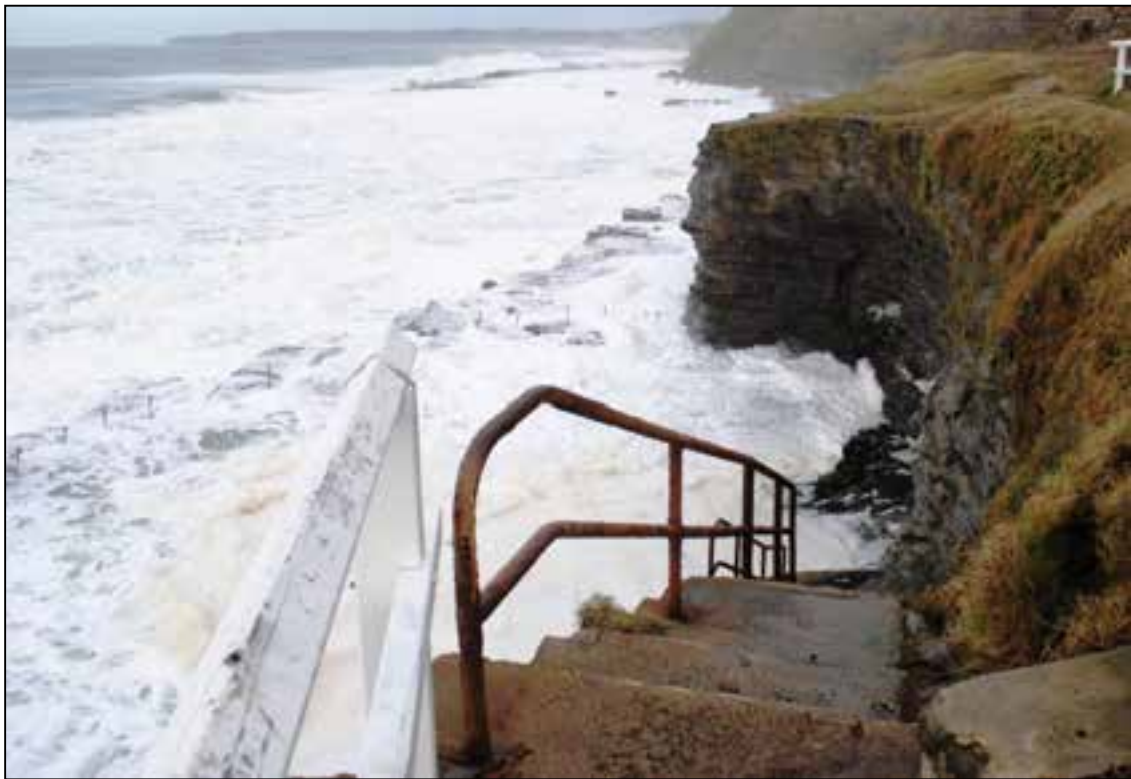
**Figure 4** *Bogie Hole inundated by wave action, with loss of amenity approximately 1¼ hours past a 1.3m high tide; approximating BMT WBM modelled year 2100 mean sea level.*

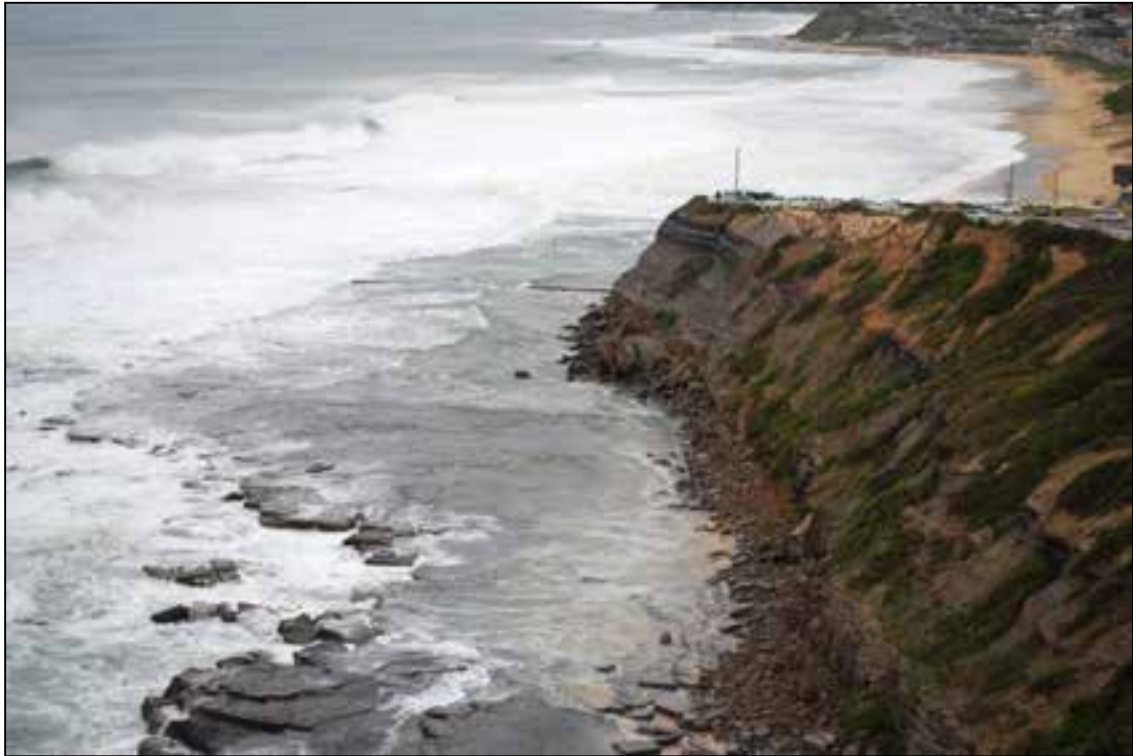
**Figure 5** *Rock Platform below Bar Beach Car Park & lookout, inundated, approximately 1¼ hours past a 1.3m high tide; approximating BMT WBM modelled year 2100 mean sea level.*

The rock platform between Bar Beach and Susan Gilmore Beach is located as shown on **Drawing 3** in **Appendix A**. A photograph illustrating the projected sea level rise is presented as **Photograph 5** in **Appendix D**. It is anticipated the projected sea level rise will result in reduced access from Bar Beach to Susan Gilmore Beach and the rock platform under Shepherds Hill.

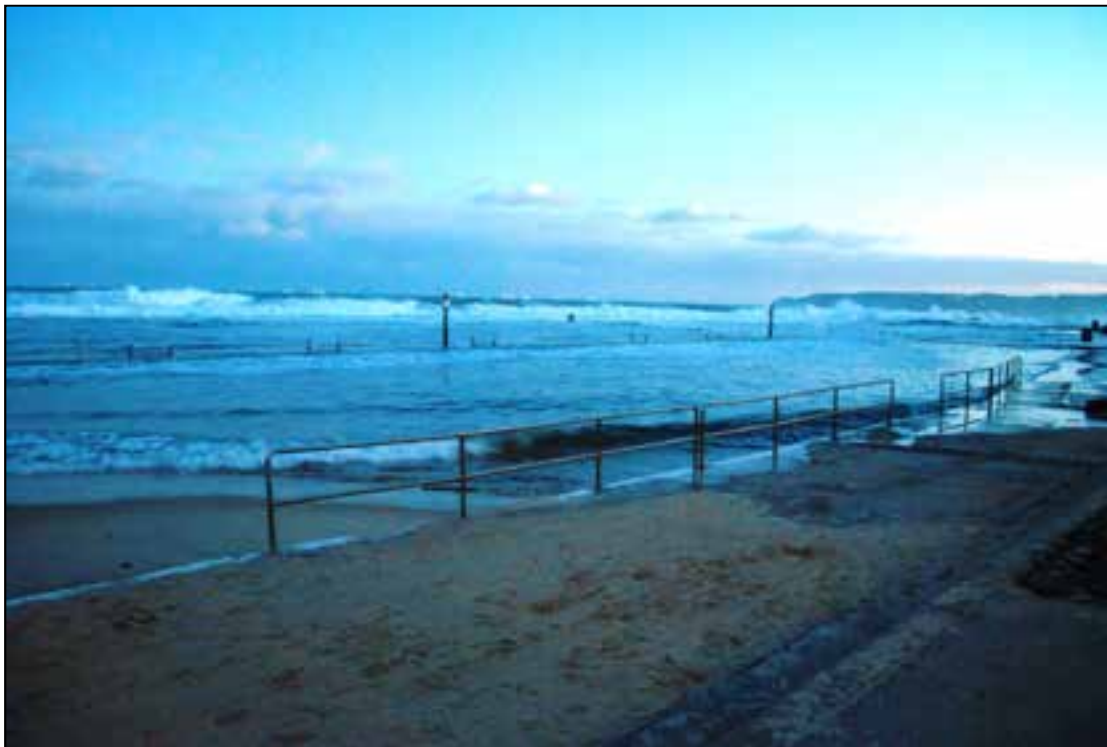
**Figure 6** *Merewether Baths inundated with loss of amenity, approximately 2 hours before a 1.9m high tide. Illustrates BMT WBM modelled year 2100 mean sea level.*

presented as **Photograph 6** in **Appendix D**. It is anticipated the projected sea level rise will result in reduced access to the Merewether Baths pools due to increasing frequency of inundation as sea levels rise and increased deterioration rate of amenities.

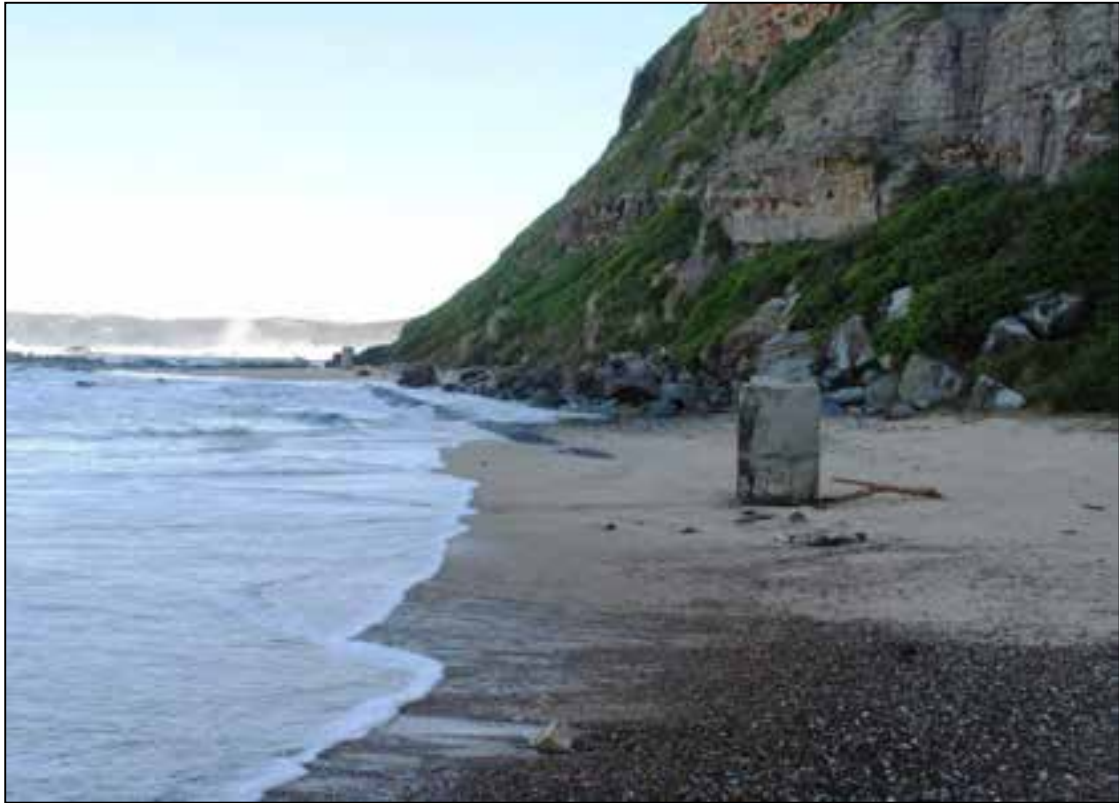
**Figure 7** *HWC Sewer inundated at sea levels approximating BMT WBM modelled year 2100 mean sea level – some vents at sea level allow pipeline to be flooded with sea water.*

A section of the Hunter Water Corporation Merewether to Burwood sewer line is located on rock platform under the Hickson-Lloyd Street cliff. The location of the most vulnerable section of the pipeline is shown on **Drawing 4** in **Appendix A**. A photograph illustrating the projected sea level rise is presented as **Photograph 7** in **Appendix D**. It is anticipated that the projected sea level rise will result in more frequent flooding of the sewer pipeline.

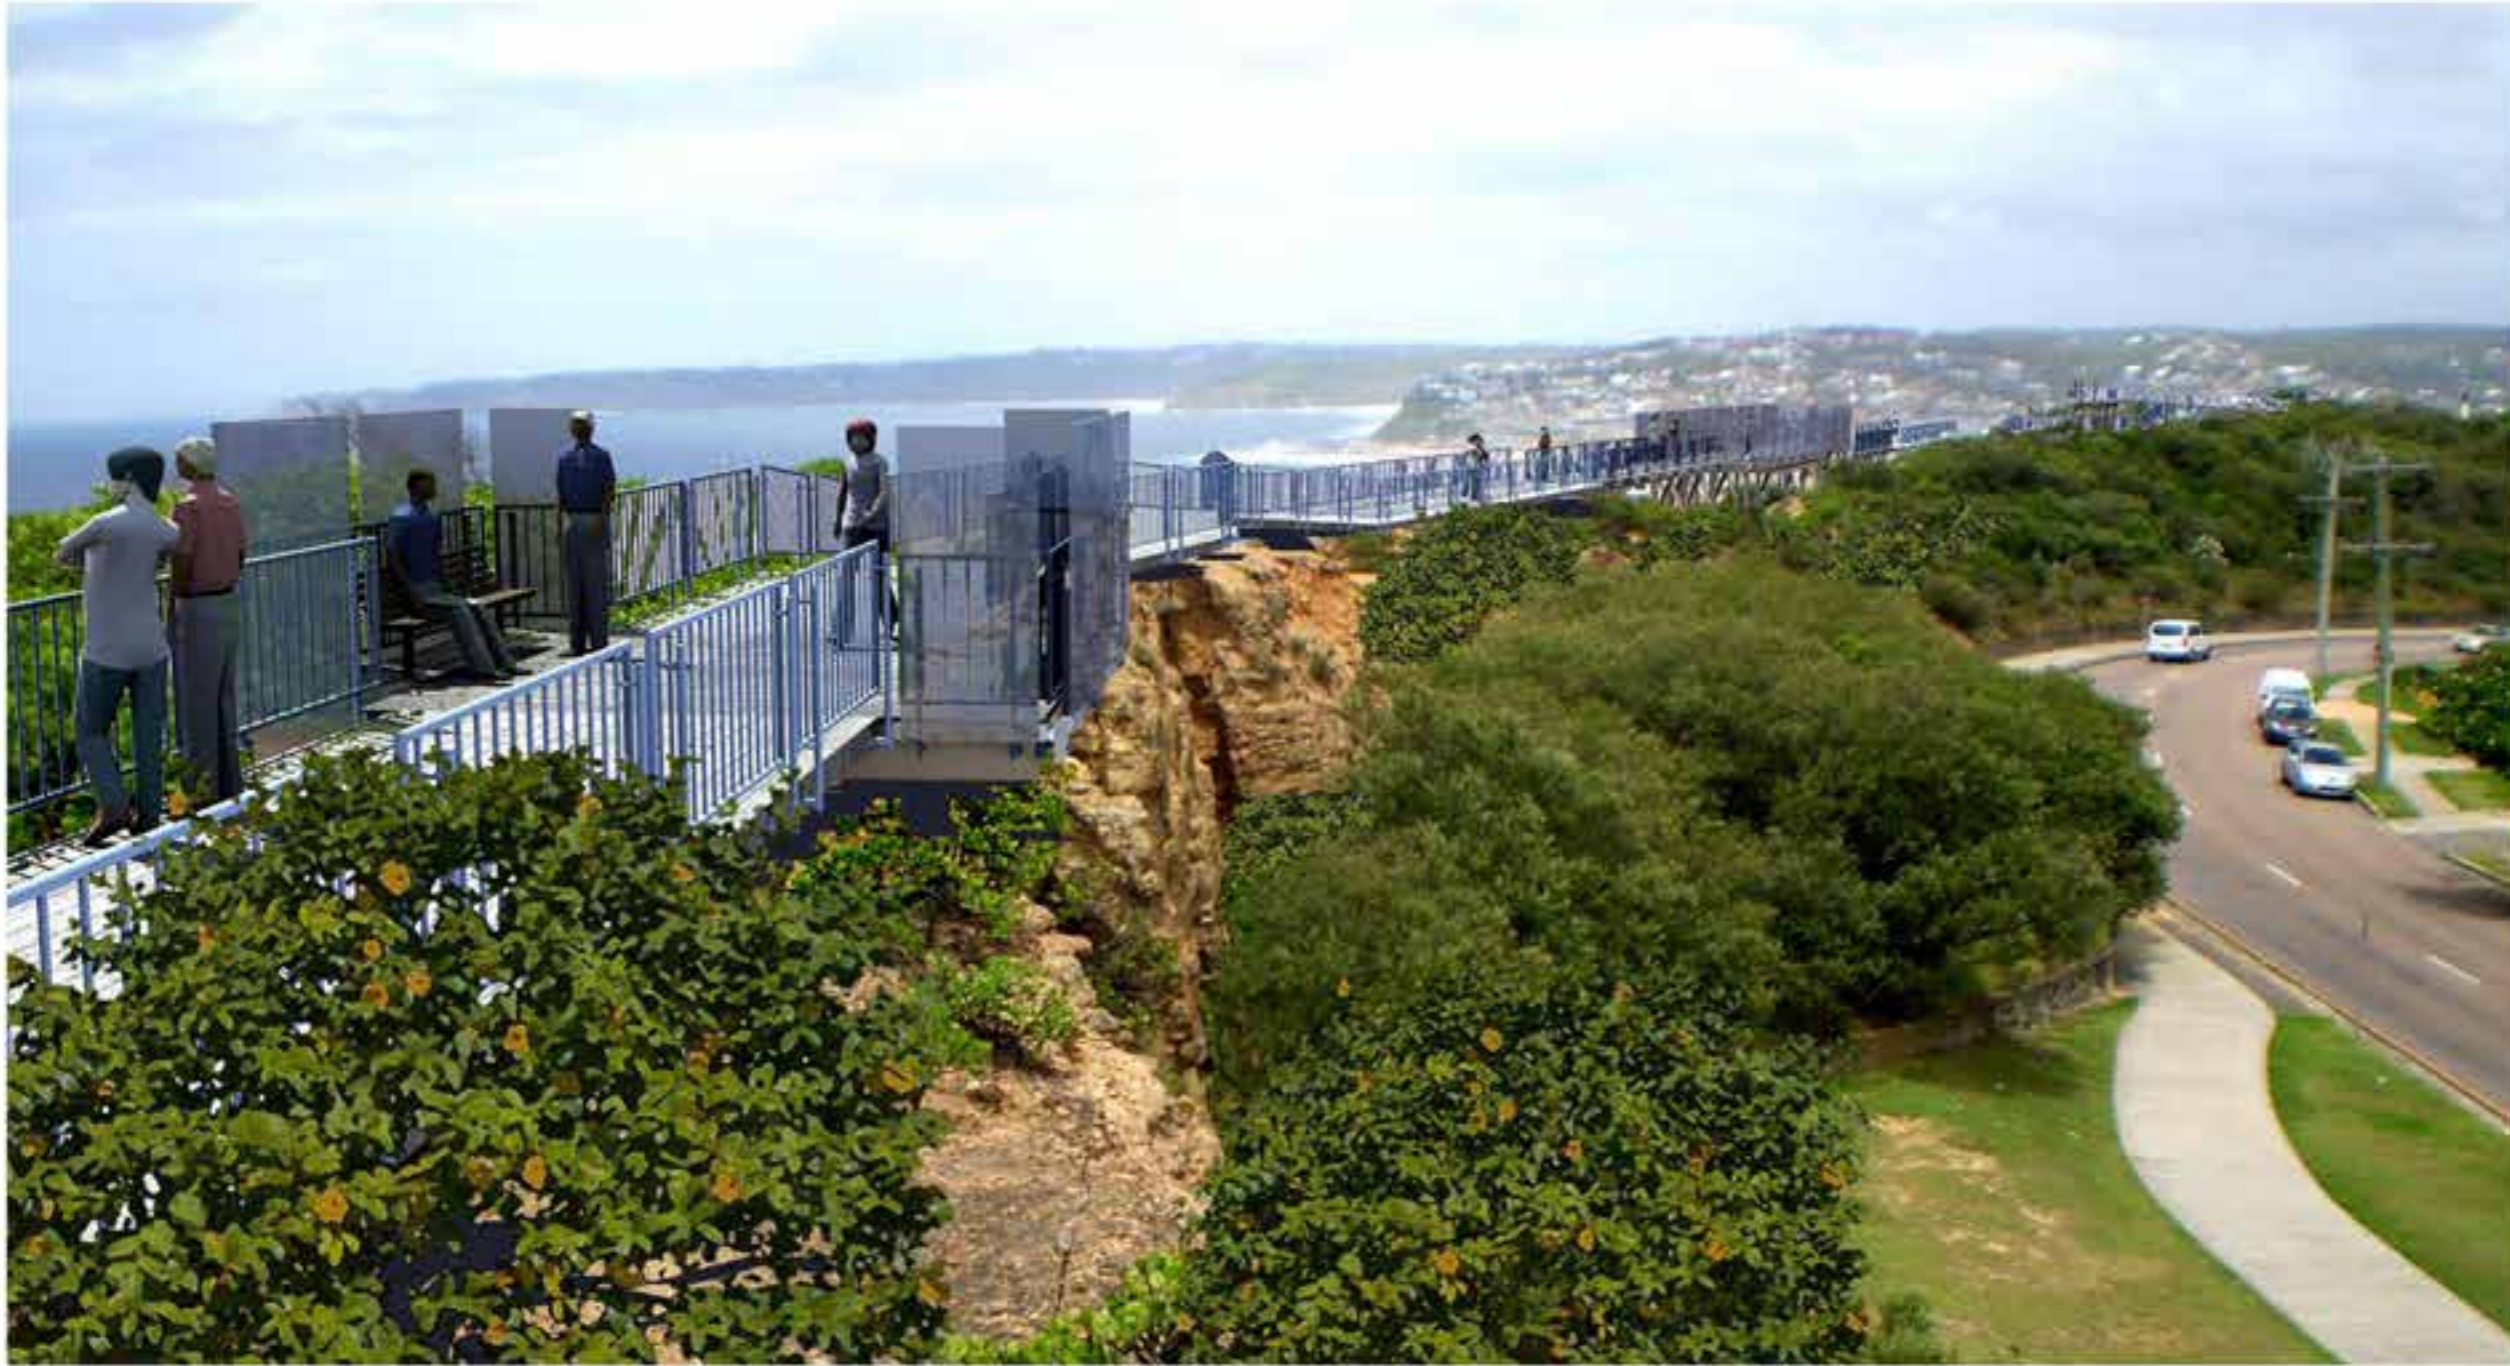
**VIEW OF TYPICAL REST AREA**
